THE SERVICE LIFE OF THE REPAIR WELDED JOINT OF Cr-Mo / Cr-Mo-V

This paper presents the evaluation of the service life of dissimilar repair welded joint from Cr-Mo/Cr-Mo-V steel after 200,000 h service under creep condition. The investigations of microstructure using scanning electron microscopy, investigations of mechanical properties at room and elevated temperature as well as creep tests of the basic material from Cr-Mo and Cr-Mo-V steel and welded joint from these steels were carried out. The investigations allowed the time of further safe operation of the repair welded joint in relation to the residual life of the materials to be determined. The evaluation of residual life and disposable residual life, and thus the estimation or determination of possible time of further safe operation, is crucial when the elements are operated much beyond the design work time.

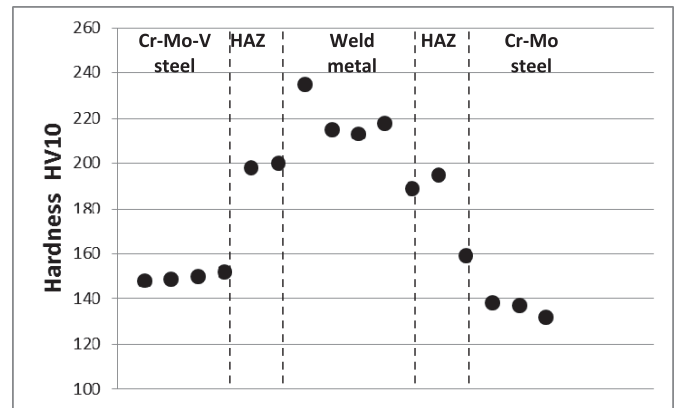
Fig. 1. Results of hardness measurements of dissimilar circumferential repair welded joint (Cr-Mo-V/Cr-Mo)

The hardness measurement through individual zones of the joint revealed no sudden changes. The maximum difference in hardness from Cr-Mo steel parent material through HAZ, weld, HAZ to Cr-Mo-V steel parent material is approx. 110 units and does not exceed the maximum acceptable value of 350 HV10.

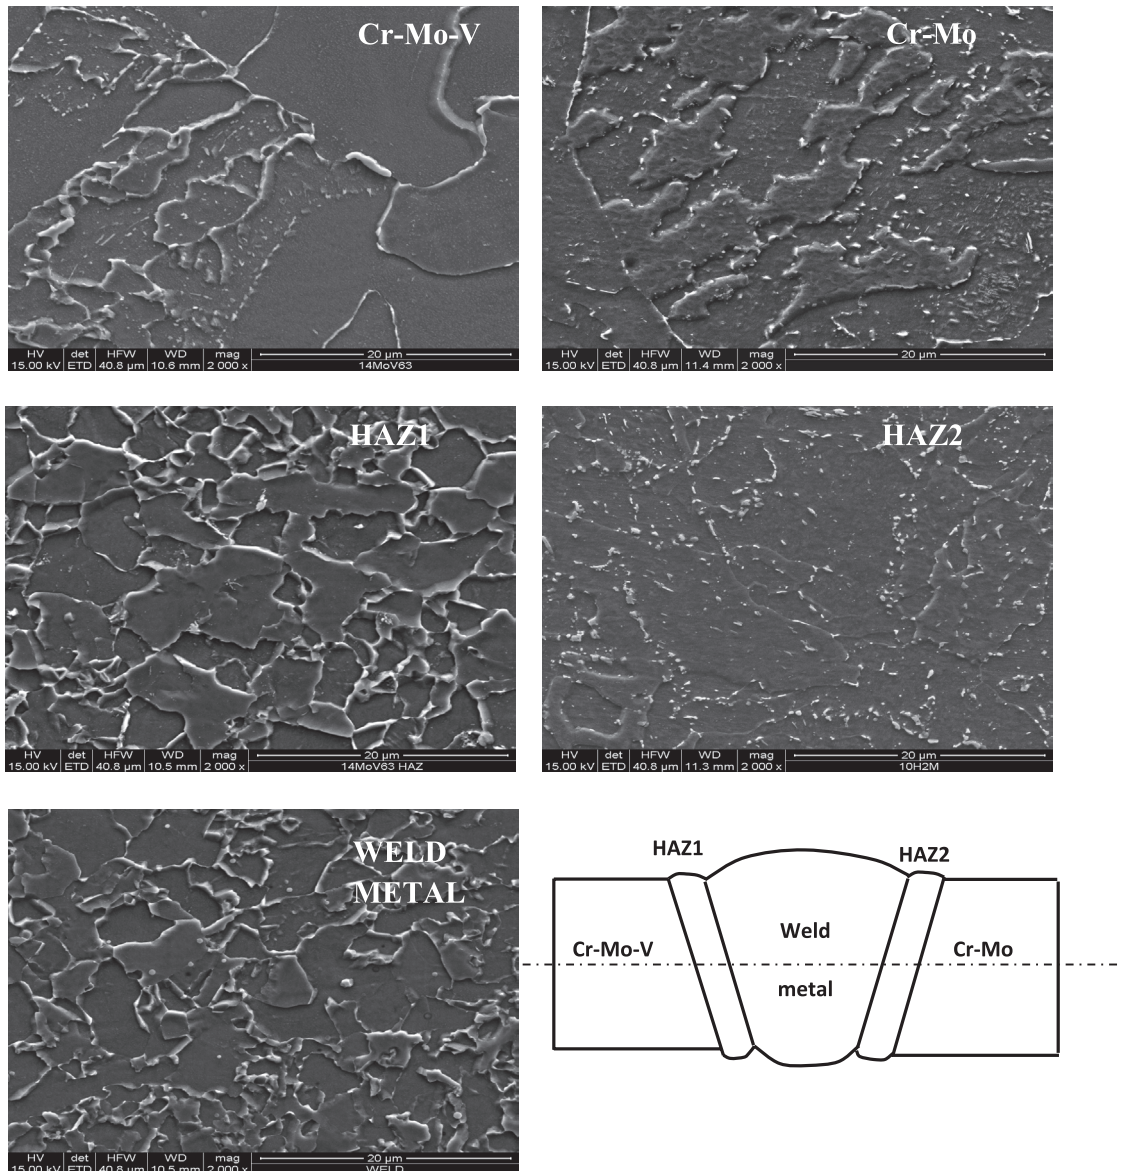
Fig. 2. Microstructure of the material of repair welded joint elements

Test area	Description of microstructure Material condition – exhaustion degree
Parent material 13HMF steel	<p>Ferritic-bainitic microstructure. Partially coagulated bainitic areas. Precipitations of different size at the ferrite grain boundaries. Inside the ferrite grains, there are very fine evenly distributed precipitates.</p> <p>No discontinuities and micro-cracks are observed in the microstructure.</p> <p>No initiation of damaging processes is observed.</p> <p>Bainitic areas: class I, precipitates: class a <u>Damaging processes: class O</u></p> <p>CLASS 1/2, EXHAUSTION DEGREE: approx. 0.3</p>
Parent material 10H2M steel	<p>Ferritic-bainitic microstructure. Partially coagulated bainitic areas. Fine precipitations at the ferrite grain boundaries. Mostly very fine precipitations inside ferrite grains.</p> <p>No discontinuities and micro-cracks are observed in the microstructure.</p> <p>No initiation of damaging processes is observed.</p> <p>Bainitic areas: class I, precipitates: class a <u>Damaging processes: class O</u></p> <p>CLASS 1/2, EXHAUSTION DEGREE: approx. 0.3</p>

Heat-affected zone, weld – repair joint	<p>Heat-affected zone microstructure.</p> <p>No discontinuities and micro-cracking are found in the microstructure.</p>

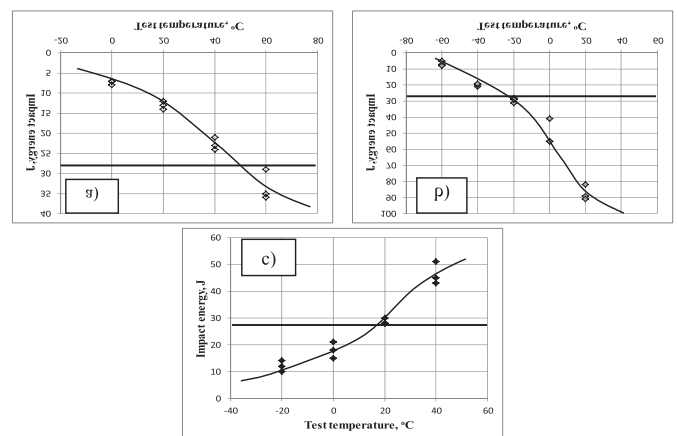
The value of impact strength and brittle fracture appearance transition temperature depends on the condition of microstructure and corresponding exhaustion degree of the examined material. With increase in the degree of degradation, the brittle fracture appearance transition temperature moves towards the higher values. This trend is much more distinct for the long-term service of the Cr-Mo-V steel than of the Cr-Mo one. The brittle fracture appearance transition temperature determined for the examined conditions is +50°C for Cr-Mo-V, -20°C for Cr-Mo and +20°C for the weld material (Fig. 3).

Fig. 3. Brittle fracture appearance transition temperature determined for: a) Cr-Mo-V steel, b) Cr-Mo steel, c) repair weld material.

For the elements from materials that do not meet the requirements for brittleness threshold of 27J at room temperature and strength properties, the appropriately modified procedure for conducting water pressure tests should be used and the necessity of possibly modifying the boiler start-up and shut-down procedure should be considered. This will allow to avoid possible unexpected breakdowns due to the lack of ability to transfer the required excessive loads [25,26].

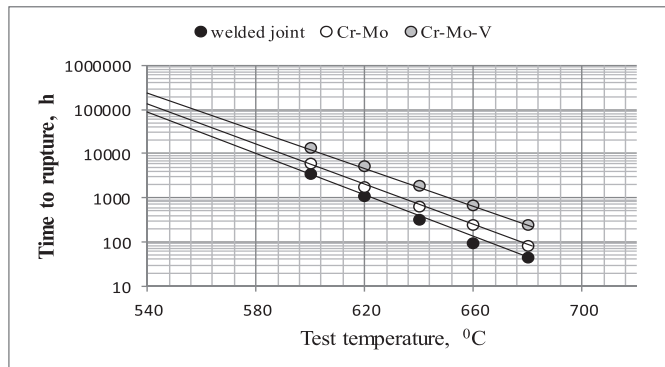
stress level $\sigma_b=55$ MPa, corresponding to the assumed working stress σ of further service. The test results are presented as the relationship $\log tr = f(T_b)$ at $\sigma_b \approx \sigma$, in Fig. 4.

The residual life determined based on abridged creep tests are summarised in column 2 of Table 4, whereas the disposable residual life of the examined elements estimated on this basis for the adopted parameters of further service $Tr = 540^\circ\text{C}$ and $sr = 55$ MPa is summarised in Table 4, column 3, and it represents the forecast of the remained time of further safe operation.

Fig. 4. Characteristics of temporary creep strength for Cr-Mo and Cr-Mo-V steels and repair welded joint after more than 200,000 h service
