Research paper

From legend to discovery – historical and geotechnical conditions related to the discovery of tunnels under The Castle Hill in Szczecin

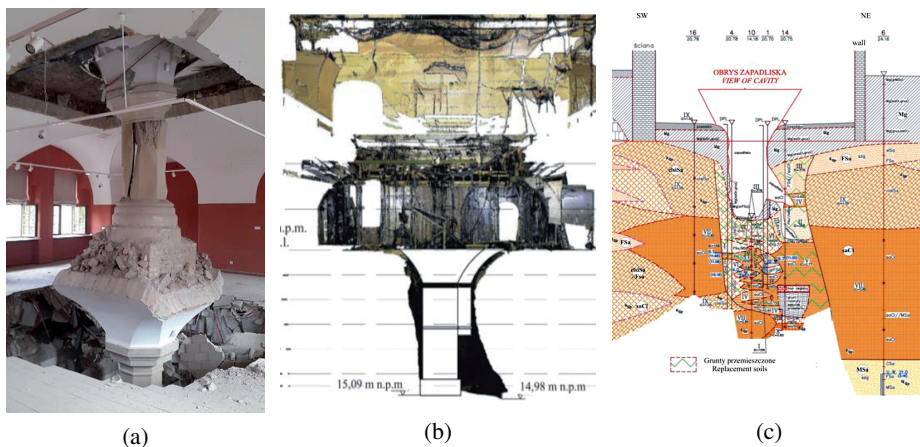
The Castle became famous after the failure, which occurred on 11th of May 2017. The failure was very sudden, lasting just few seconds. Its occurrence was registered by the surveillance cameras, with a sudden collapse of a column. The rooms in which the failure

In the central part of each room, i.e. in the basement, as well as at the ground, first and second floors, a massive column supporting the ceiling of a given level was located. Investigation conducted after the collapse indicated that the pillar has dropped down by one level, without rotating (Fig. 1a), while the basement part collapsed under the ground (Fig. 1b). Most of the rubble fallen down into the basement, which became partially buried and not accessible for a time. A significant inclination of the bottom of the cavity towards western direction and a niche inside, probably of antropogenic origin, were documented (Fig. 1c).

Fig. 1. a) Pillar condition after the failure [4]; b) simulation of the position of the column after the disaster based on laser scanning [2], c) part of the geological cross-section below the column [5]

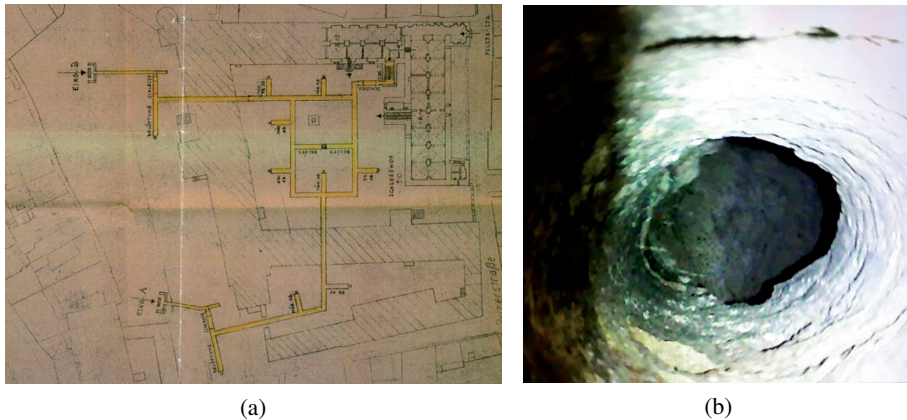
Fig. 2. (a) Plans from 1943 for shelters with tunnels under the Castle – construction of a shelter, for max. 1480 people, under the Castle’s courtyard, with tunnels of total length approx. 760 m with two entrances at the foot of the slope and an entrance from the Castle [3]; (b) the view on the void in the borehole at a depth of approx. 13.5 m b.g.l. [8]

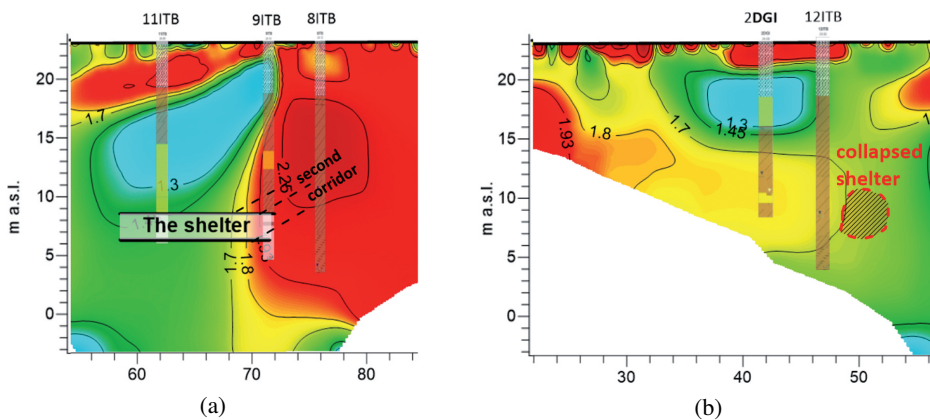
Fig. 4. Fragment of the profile ERT_3 along the terrace: (a) anomaly due to buried shelter, (b) anomaly with included outline of a tunnel/shelter [8]

Similar to the border described earlier, the boundary between the anomalies was also encountered at the ERT_3 profile, along the length of 50 meters. Borehole (12ITB) made in this place showed the presence of a collapsed corridor of the shelter (Fig. 4b). It was also confirmed in profile SRT (Fig. 5).

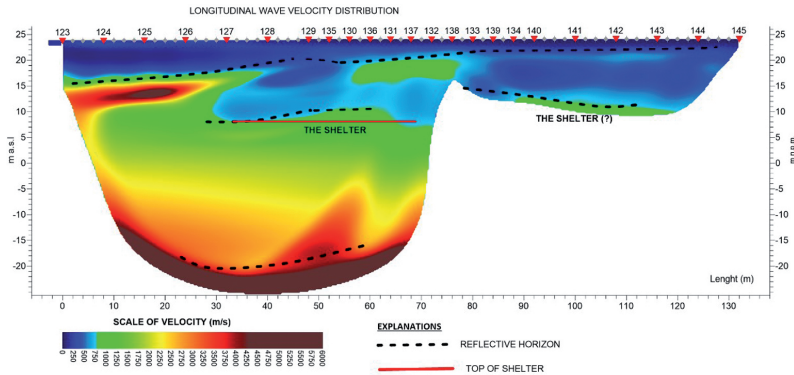
Fig. 5. Profile SRT_D3, along NE terrace, west – east direction [9]

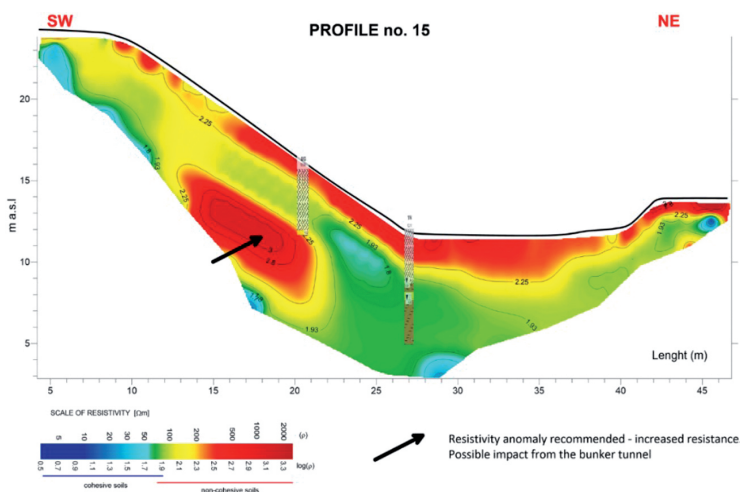
In 2D sections, several anomalies with very high resistances were distinguished, which may indicate the presence of an underground shelter under the slope. The high resistance of the subsurface zone may also indicate a significant share of brick rubble fill building the slope in these places. The electric resistivity anomaly caused by the influence of the underground shelter was indicated. At this height (on a layout), an underground tunnel structure was found on the terrace through the 9ITB borehole (Fig. 6).

Fig. 6. ERT_7, approx. 17 m west from the NE corner of the terrace [8]

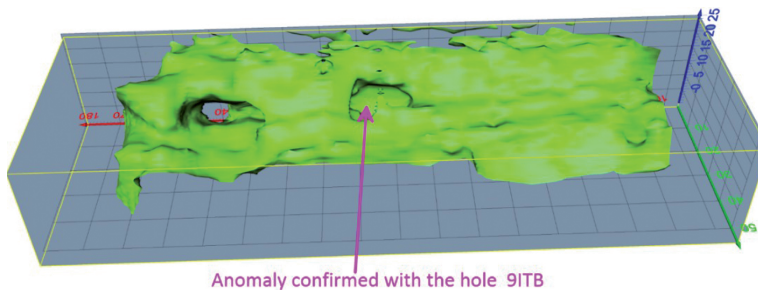
The compilation of all ERT profiles (supported by GPR profile – in terms of potential voids) allowed for the development of a three-dimensional image within the slope. The 3D visualization (Fig. 7) allowed for the separation of two distinct electrofusion anomalies in the slope foot area, which are most likely caused by the presence of two buried exits from the shelter or, according to the preserved documentation, of ventilation shafts. The two anomalies on the left side, indicated in Fig. 9, occur approx. $12 \div 17$ m to the west of the stairs built in the NE corner of the terrace. On the other hand, the indicated anomaly in the middle of the slope correlates with the underground bunker that was identified by the 9ITB borehole.

Fig. 7. An example of a 3D visualization of geophysical test results (spatial representation of resistance for a value of $140 \Omega\text{m}$), a visible profile along the northern slope, which describes anomalies indicating the course of tunnels and one of the exits from the shelter (on the east side of the slope)

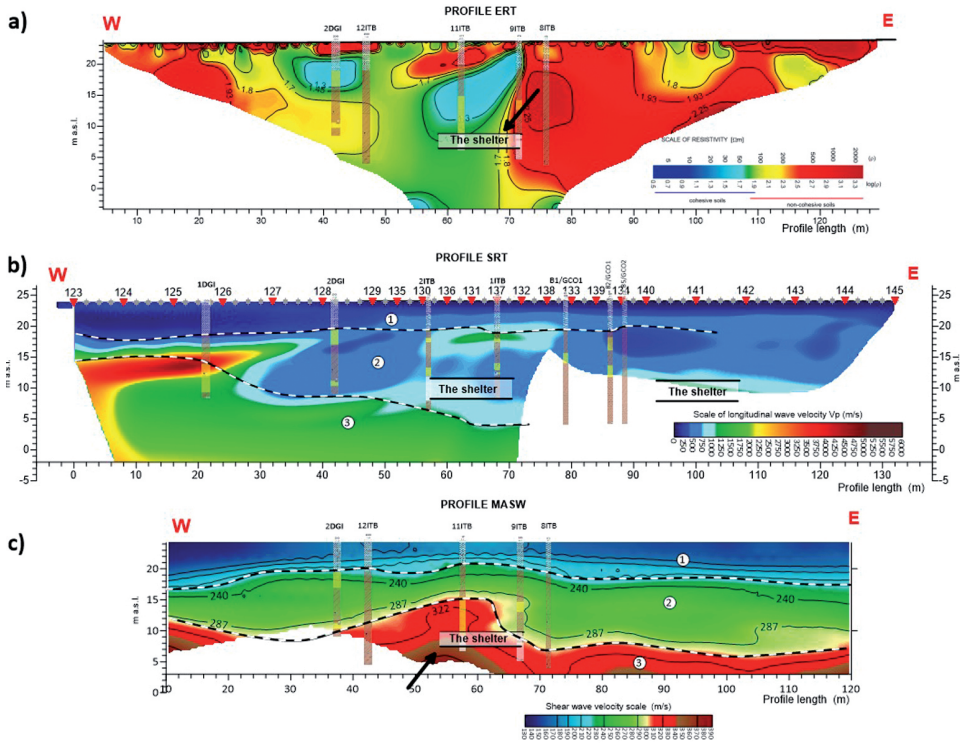
Nevertheless, in the tunnel zone, a clear contrast of electrical resistance is observed – passage from about a few dozen Ωm to over $1000 \Omega\text{m}$. This place is indicated by an arrow (Fig. 8a). The SRT cross-section (Fig. 8b) shows the velocity distribution of the longitudinal wave. The conditions of measurements using this method, in urban conditions (numerous disturbances from urban traffic and the operation of various devices), do not give certainty for the accuracy of timing the first ascensions of waves, and thus the modeling of the cross-section of the velocity of longitudinal waves [18, 19]. The tunnel is marked indistinctly, as a zone of increase in the speed of seismic waves, which are reflected from the reinforced concrete casing. In addition, the correlation of hole profiles with the obtained distribution of the velocity of longitudinal waves allows for the separation of three layers (embankments, clays, sands), while the location of the velocity limits between them does not coincide exactly.

Fig. 8. List of geophysical profiles (described in text), interpreted layers: 1 – embankments, 2 – clays, 3 – sands

The MASW cross-section (Fig. 8c) shows the distribution of the velocity of the transverse wave. It is a seismic method, giving the best results in seismic noise conditions [16]. The determination of the velocity of transverse waves is generally based on the diagram of the dispersion curve (graph of the dependence of the phase velocity of the Rayleigh wave, frequency increase) [20–22]. In the analyzed cross-section near the tunnel found, an increase in the speed of transverse waves can be noticed, which are probably generated by the reinforced concrete casing of shelters (this place is indicated by a black arrow in Fig. 8c). In addition, the positions of seismic boundaries correlate quite accurately with the profiles of boreholes.

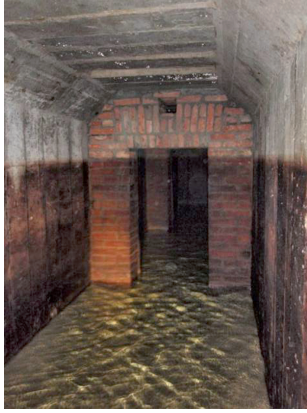
Fig. 9. View of the lock under the western part of the northern slope – visible water at the bottom of the tunnel and traces of historical or periodic levels of its occurrence (Photo: T. Godlewski, 2021)

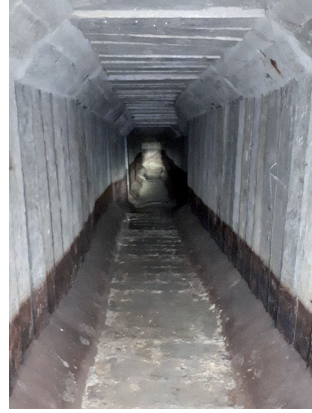
Fig. 10. View of the tunnel running along the northern slope – visible level of maximum flooding of the tunnel (Photo: T. Godlewski, 2022)

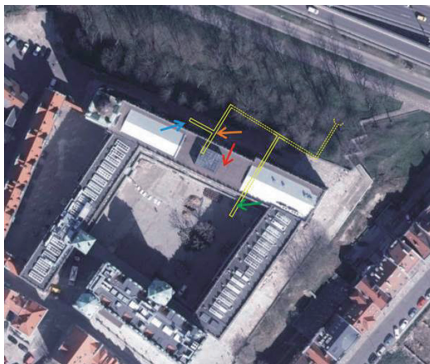
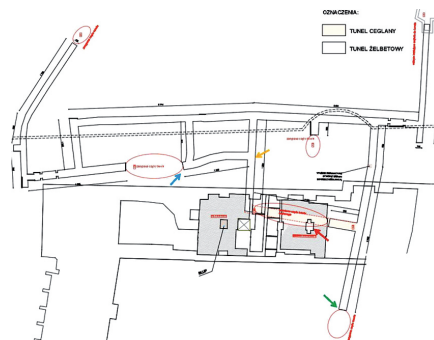
At the site where the existence of the tunnel network was first confirmed (borehole 9 ITB – orange arrow in Fig. 11), a detailed camera inspection revealed the existence of an intersection from which three corridors depart in mutually perpendicular directions (north, west, south). Thus, it has been shown that the previously discovered cavern in the area of the

Fig. 11. View from above (a) of the Pomeranian Princes Castle – indicated (in yellow) an outline of the confirmed and probable presence of underground tunnels in the area of the terrace and the slope, based on the 2020 studies carried out [8, 9]; b) the established inventory of tunnels on the basis of direct exploration [24] – the red arrow indicates the site of the disaster and the collapse within the brick tunnel. The others are explained in the text

location of the sinkhole from the 1970s (blue arrow in Fig. 11) is closely related to the course in the vicinity of these tunnels. These objects, in the base of the Castle hill, due to the nature of the structure (the use of a temporary casing made of bricks, prior to the execution of the reinforced concrete structure – with the disturbed ground zone around) and the conditions related to their implementation (numerous leaks, especially at the unfinished stages, voids at the face) constitute drainage points and privileged groundwater flow directions. These conditions led to the formation of local voids and erosive cavities along the tunnel structure, which was confirmed by numerous inspections.

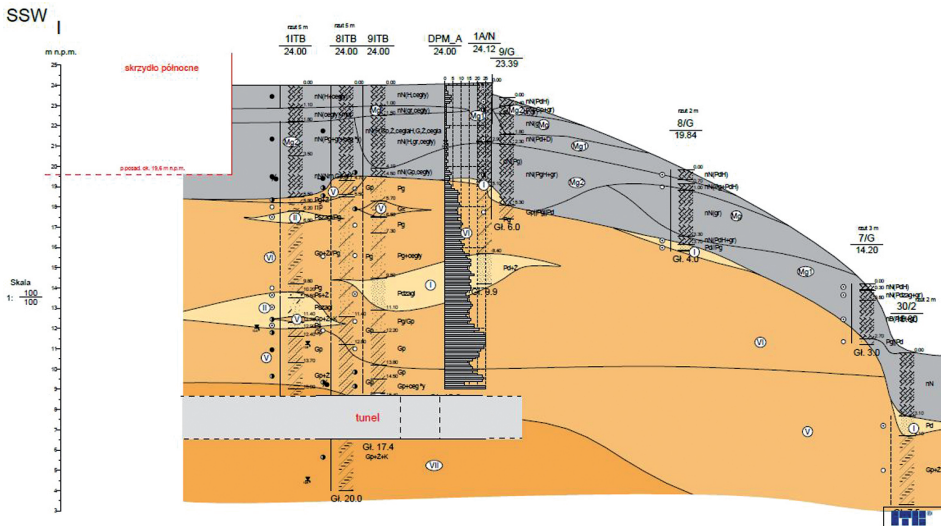
The performed tests did not confirm the construction of the entire tunnel system, as planned according to archival German plans. It can be assumed that the plans, for some reasons (including unfavorable ground conditions or the advancing war front), have not been fully implemented. The findings disclosed during the investigation indicate the possibility that the tunnel builders were "surprised" and could significantly contribute to the development of the analyzed failure. Within the scope of the previously described findings, it is necessary to indicate the geological conditions (soil and water) related to the genesis and the current situation of the building at the Castle Hill. Under a layer of centuries-old fill grounds (6÷8 m thick), this substrate is made up of Pleistocene glacial till deposits (Fig. 12).

Fig. 12. Part of the geological cross section from the castle to the north slope, with a visible location of the tunnel under the embankment layer (gray) within the moraine formations (brown) [9]

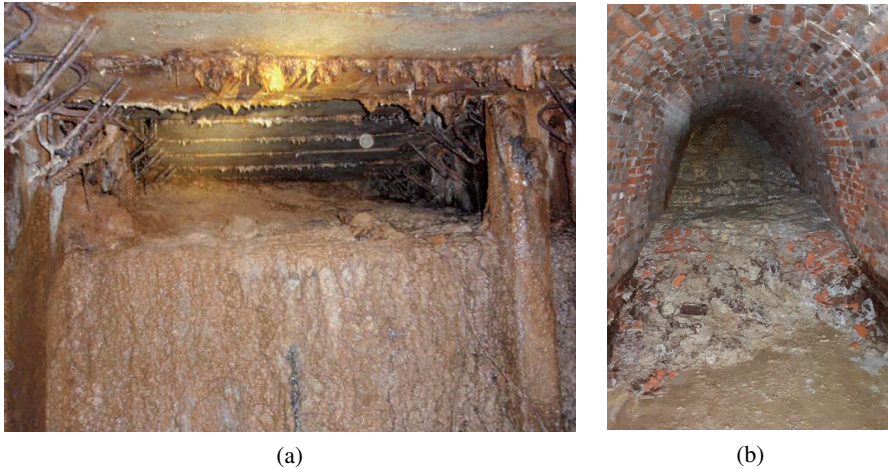
The carried out investigation of the tunnels (Fig. 11), apart from an attempt to "avoid" the problem in the courtyard – as evidenced by numerous revealed side corridors, revealed the presence of older structures located under the northern wing of the Castle (Fig. 13b). Directly at the failure location (red arrow in Fig. 11), an oval tunnel with traditional lining (made of bricks) was found, with a visible sinkhole, which was the result of the catastrophe. The tunnel is partially flooded, there are visible traces of fresh and long-lasting infiltrations. The bricks are falling apart in some places, and the walls of the tunnel show bulges and deformations.

This discovery directly indicates the nature of the catastrophe (sinkhole), revealing the place where the ground shifted from under the column. The presence of a brick tunnel and its sensitivity to changes in environmental conditions (in terms of humidity) indicate the course of the phenomenon, i.e. the formation of a sinkhole as a result of loss of the tunnel linings's load-bearing capacity. In the course of further analyzes, the factor that triggers the visible effects should be determined.

Fig. 13. a) The view of the face of the unfinished tunnel under the courtyard (behind the green arrow according to Fig. 11) – you can see the inflows, the phenomenon was of a sudden nature as evidenced by the extent of the ceiling of the already constructed lagging in relation to the position of the provisional protection, b) view of the oval brick tunnel along the north wing – a visible collapse directly located below the failure site (red arrow according to Fig. 11), (Photo: T. Godlewski)
