**Research paper****Safety issues related to the use of closed profiles  
in steel girders****Marcin Górecki<sup>1</sup>, Małgorzata Snela<sup>2</sup>,  
Ewa Błazik-Borowa<sup>3</sup>, Anna Halicka<sup>4</sup>**

**Abstract:** This paper analyses the stress state in the walls of a closed steel profile caused by freezing water filling the interior of the profile. The study focuses on a specific case of two damaged girders, where the failure was attributed to freezing water trapped inside the upper chords of the girders. The analysis revealed that the resulting stresses exceeded the steel's strength, leading to deformation and rupture of the upper chord profiles. The article describes the damage observed in the girders, including outward deformation of the walls and cracks along the bending edge. The presence of water and corrosion products inside the profiles was confirmed through inspections. Finite element calculations were performed to assess the pressure effects, showing that the tensile stresses in the corner of the profile exceeded the yield and tensile strength of the steel. The article concludes that damage caused by freezing water expansion is unpredictable and emphasises t

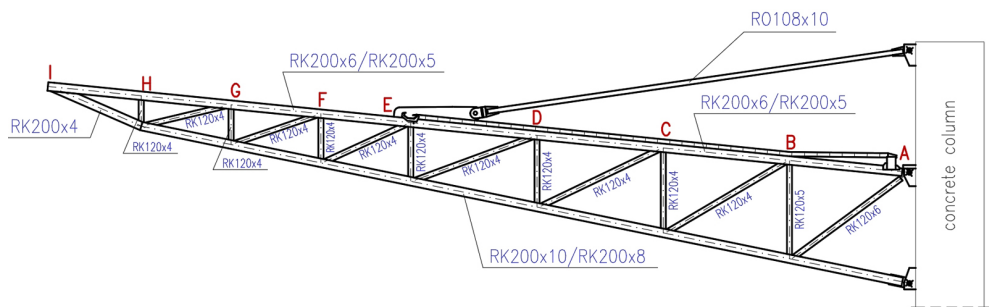
Fig. 1. Diagram of the damaged truss girder – upper chord made of square tube RK200

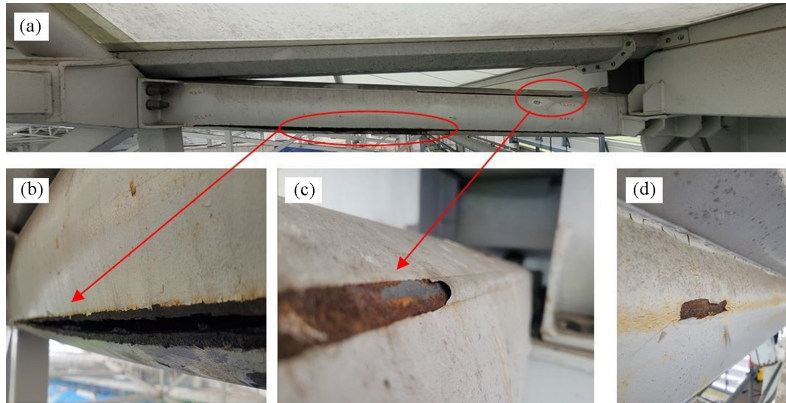
In the first damaged girder, deformation of the cross-sectional shape of the upper chord profile was observed – walls were “pushed out” outward over a length of four consecutive spans from A to E (Fig. 2). These deformations were sectional, occurring along the sections of the chord between successive nodes. In the nodes, the section is “constrained”: in the plane of the girder by columns and bracings, out of the plane by node plate stiffeners.

Fig. 2. Deformation of the tubular profile of the first of the inventoried girders and damages caused by deformations: (a) view of the end span AB of the upper chord, (b) crack along the lower edge of the bend, (c) chipping of the paint coating and corrosion on the upper edge of the bend, (d) cracks and chipping of the paint coating on the wall BC section profile

A continuity loss of the upper chord profile material was also found in the extreme span as a crack along its lower bend edge (Fig. 2b). This crack was approximately 950 mm long and about 12 mm wide at its widest point. Water seeped from the crack, revealing signs of corrosion on the tube's inner surface. Swelling of the paint coating was observed on the profile edge (Fig. 2c) and peeling of the paint layers on the side walls was noted (Fig. 2d).

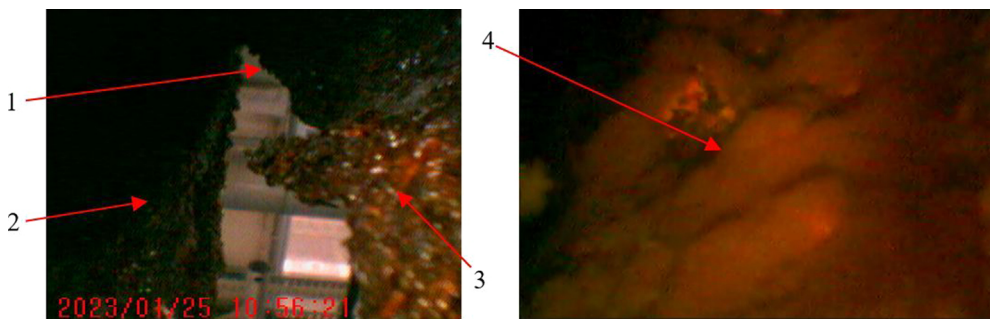
Using the damage in the form of the profile rupture, an inspection of the upper chord profile interior was conducted using a Mitcorp Prelude videoendoscope. The inspection confirmed the presence of water and algae in the profile. The water level was determined during the inspection to be reaching the lower end of the crack section. Corrosion products were found on the internal surfaces of the tubular element walls, and loose corrosion products were observed on the lower surface of the profile wall, indicating a significant degree of corrosion of all profile walls (Fig. 3).

Fig. 3. Interior image of the upper chord obtained via videoscope: 1 – crack, 2 – rust, 3 – loose corrosion products, 4 – algae in the water retention zone

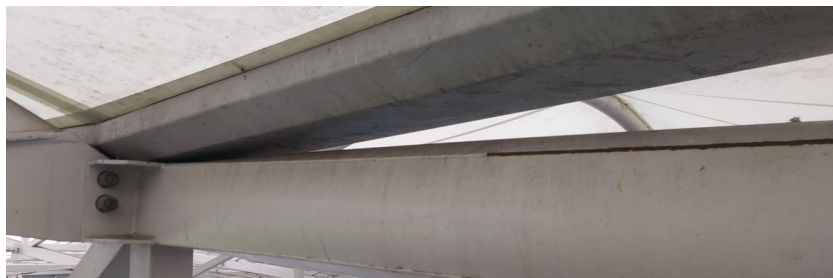
The second damaged girder also exhibited outward deformation of its walls (Fig. 4) over several spans. Similar to the first girder, these deformations were segmental, appearing over the length of the chord sections between successive nodes. Paint coat flaking was observed along the bending edge and weld seam of the tube, with corrosion visible at these points.

Fig. 4. Deformation of the tubular profile of the second damaged girder

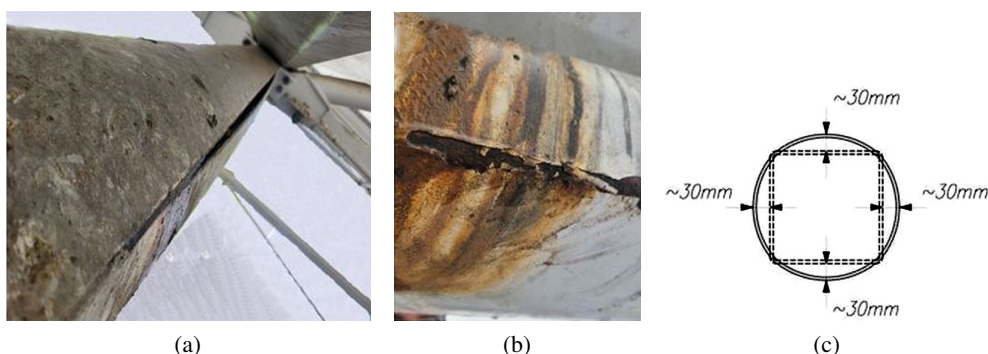
In the second damaged girder, similar to the first, a crack in the upper chord profile was found in the extreme span along the upper bend edge (Fig. 5a). Water was visible through the crack, flowing out and streaming along the side and bottom walls of the upper chord (Fig. 5b).

Fig. 5. Damage to the second girder caused by deformations: (a) crack along the upper bend edge, (b) paint coating flaking and corrosion on the lower bend edge, (c) inventory of wall deformations

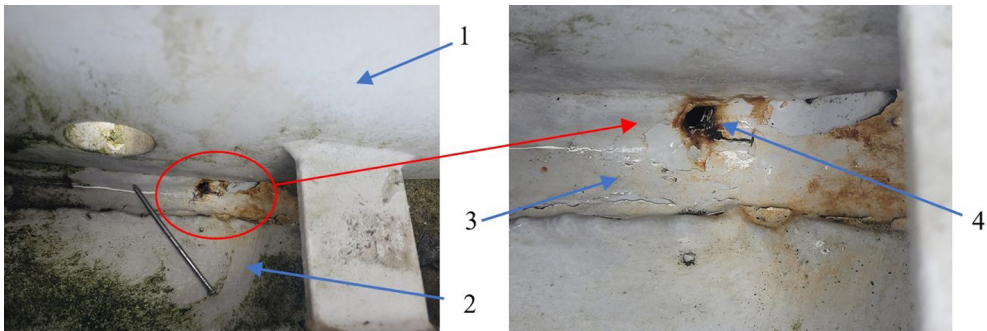
Seeking the water ingress point, a discontinuity was found in the butt weld connecting the node plate used for rod attachment to the upper chord surface (Fig. 6) at node E (Fig. 1). Water penetrated through this discontinuity into the upper chord, flowing down its slope to the extreme span, then filled the entire section and froze, causing the described damage. The described weld discontinuity is a welding non-conformity in the form of a crater at the end zone of the node plate. At this point, the plate used for rod attachment passes through the upper chord walls. The crater was likely due to improper weld termination during the welding process, possibly related to a sudden power cut-off and arc extinguishment.

Fig. 6. Discontinuity of the weld connecting the gusset plate to the upper chord of the girder:  
 1 – gusset plate, 2 – upper surface of the upper chord, 3 – fillet weld, 4 – crater

- Damage caused by freezing water expansion is a type of damage that cannot be predicted by designers,
- The presented example highlights the importance of weld quality control in steel structures.

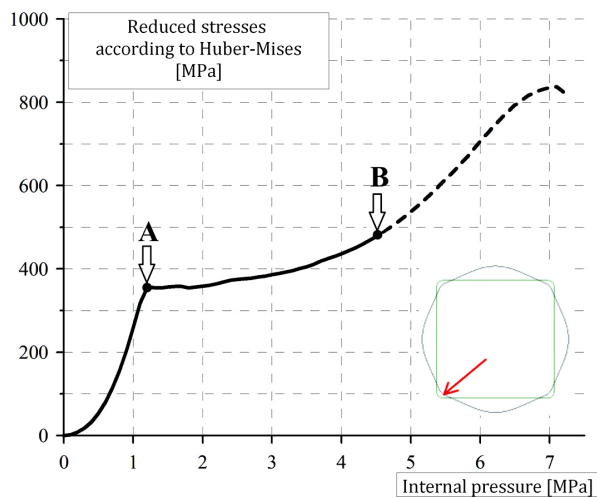
Figure 8 shows the calculated dependence of the tensile stresses in the tubular profile on its bent edge and the internal pressure. It shows that the tensile stresses in the corner exceed the yield strength at approximately 1.2 MPa and the tensile strength at approximately 4.6 MPa. This actually happened: upon reaching tensile strength, a crack occurred in the corner at the bend edge.

Fig. 8. Relationship between reduced stresses at the profile edge and internal pressure

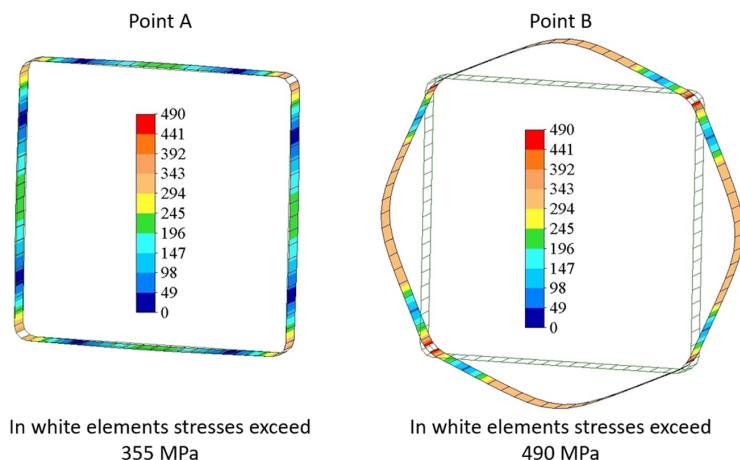
Figure 9 shows the stress state maps in the section under the load indicated by points A and B in Fig. 8. Uncoloured (white) elements are visible, where stresses exceed either the yield strength or the tensile strength. These areas correspond to the corners where the crack occurred.

Fig. 9. Stress maps in the tubular section under different loads

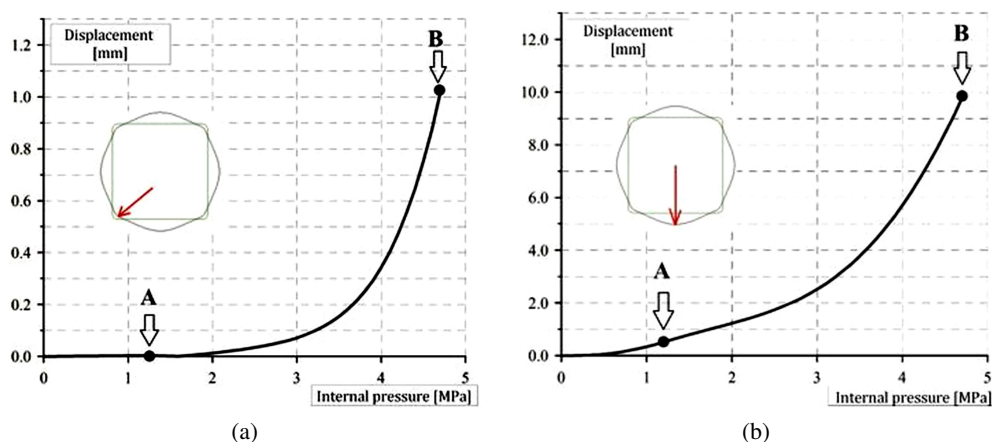
As a result of the calculations, a correlation between the wall displacement and the internal pressure obtained at the corner and at the midpoint of the wall was established, which is shown in Figure 10. It was found that stresses equal to the characteristic tensile strength of steel correlated with a wall displacement in the central part of about 10 mm. The deformation observed in situ was greater. This can be attributed to the fact that the actual corner strength could be higher (the bending effect and the characteristic strength are the 95% quantile of test results), and the mechanism could involve cyclic freezing and thawing of the water inside, changing the conditions of subsequent deformations. Freezing water after a profile rupture could lead to further deformation and crack widening.

Fig. 10. Correlation between wall displacement and internal pressure in a  $200 \times 200 \times 6$  tubular profile:  
 (a) at the corner, (b) at the midpoint of the wall
