THE INFLUENCE OF HIGHER MODES VIBRATIONS ON LOCAL CRACKS IN NODE OF LATTICE GIRDERS BRIDGES

S. PRADELOK¹

Several previous investigations on failure of a certain type lattice girders railway bridge (on so called BJD line) have not convincingly explained reasons nor have they described potential hazards. This paper attempts to provide an answer, employing static, dynamic, and fatigue analysis of the structure, focusing on previously not analyzed vibrations of elements constituting a lattice node. Detailed models of two types of such nodes – damaged and non- damaged were compared, inside carefully defined limits of applicability.

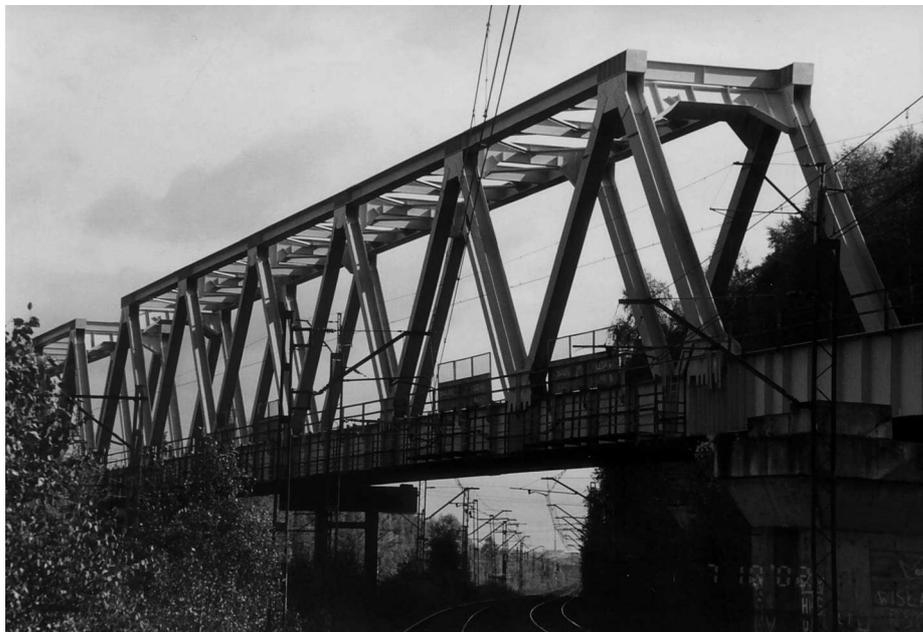
Fig. 1. Side view of the fault bay.

The cracks in the node were spotted during a routine track walk – down. A more detailed examination followed, resulting in finding further, smaller cracks near other nodes of the same bay. No cracks, however, were found in the adjacent “twin” bay. The damages were described in details (WESELI, PRADELOK [6, 7]).

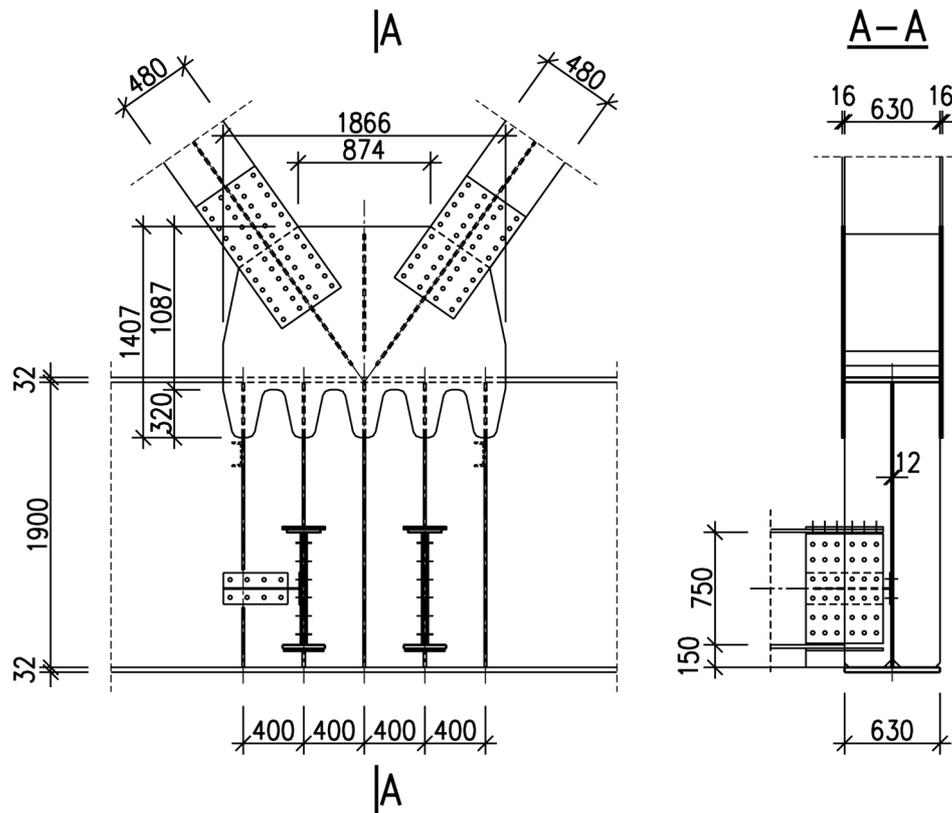
The node structure (Fig. 3) is not typical either. The gusset plates are not, as usually, connected to the top flanges only, but extended to the chord ribs.

Fig. 3. Fault bay. Node construction near expansion joint in a reinforced concrete track channel.
Rys. 3. Przęsło uszkodzone. Konstrukcja węzła przy przerwie dylatacyjnej w żelbetowym korycie balastowym

Both trusses differ also in the way the members' connections are developed. In the fault bay there are extended nodes and the diagonal member webs are cut 80 mm short of the bottom chord. In the other bay, the diagonal members have trapezoidal perforations up to 800 mm away from the bottom chord, and the gusset plates are much smaller.

Cross members in the fault bay are connected with the bottom chord in a way that allows partial transfer of the bending moment. In the other bay connection transfers only shear. Moreover the cross members near the dilatations in the non – fault bay

have ties in the middle of their spans, unlike the ones in the fault bay, which have no tie at all.

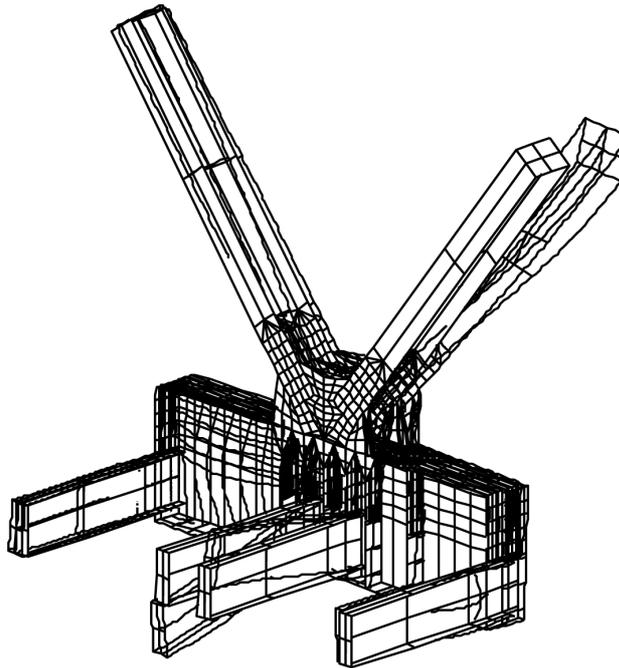
The modal analysis showed appearance on a relatively low positions modes of natural frequencies of near dilatations cross beams. In the considered set of shapes they appeared in both models, however there were more of them present at the failing node. All had the period of 0.06 s (which is an equivalent to frequency of about 17 Hz). Fig. 6 shows one of the natural frequency shapes observed in the model of the failing node.

Fig. 6. Fault bay. Period 0.06 s natural frequency shape.
 Rys. 6. Przęsło uszkodzone. Postać drgań poprzecznic o okresie 0,06 s

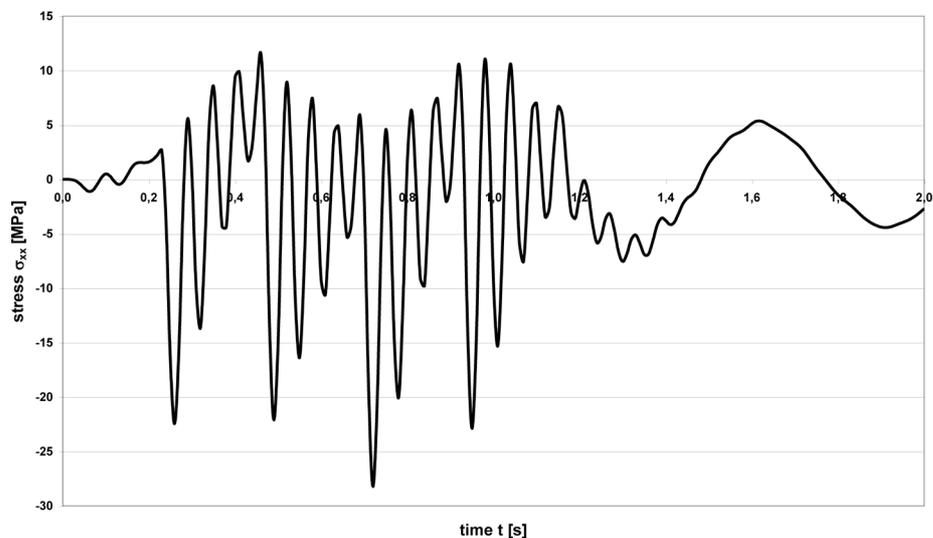
Further on, a time analysis was also conducted (integration of movement equations). Load was assumed to be exerted by travel of 4 consecutive axles of 165 tonnes ET41 locomotive. The axles are at 3.05 m distances which roughly coincides with the spacing of cross beams in the bridge (3.1 m). It was assumed further that the speed of the locomotive travel to be 0.23 s for this 3.1 m distance (equivalent of 48.5 km /h). Change in normal stress σ_{xx} of in the upper layer in the place of failure of the upper flange of the girder was shown in Fig. 7. Amplitude of stresses reaches 34 MPa. It can be also observed that there is a significant increase of normal stresses σ_{xx} at the time of the axle crossing of the cross beam, and next 4 cycles of natural frequency vibrations (with period of 0.06 s) which generate quickly fading vibrations. The approach of the next axle (after 0.46 s) initiates impulse to jump in the normal stresses, followed again by 4 cycles of fading natural frequency vibrations. All that is repeated 4 times. Approach of last, fourth axle happens after 0.92 s. Local vibrations of the cross beams of 0.06 s are damped after a few cycles and the graph shows stresses related second shape of natural vibrations of the entire structure with a period of 0.59 s.

Fig. 7. Fault bay. Time analysis of normal stresses σ_{xx} at the location of failure.

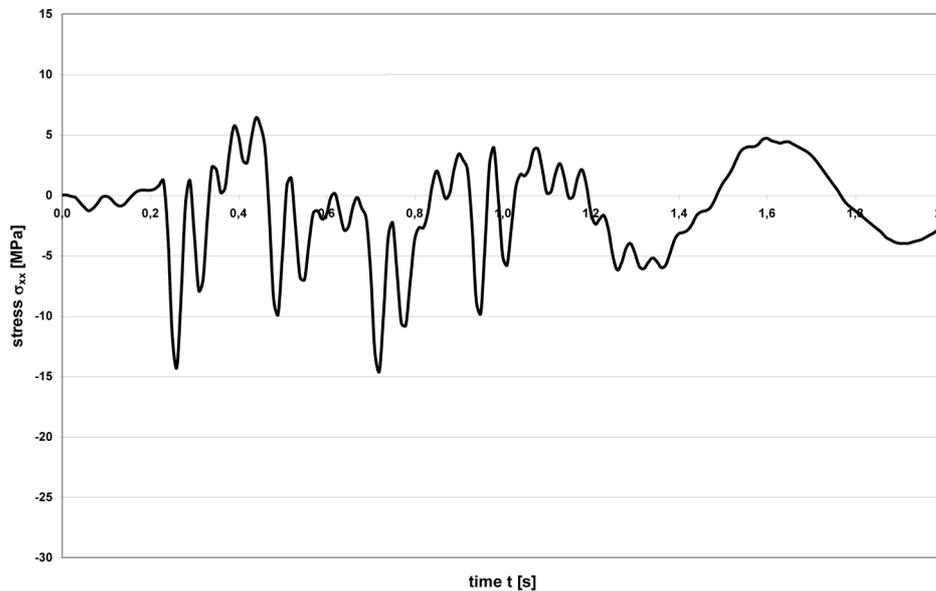
Figure 8 shows a change in the normal stresses σ_{xx} in the upper layer of a location corresponding to that displaying failure in the fault bay. The stresses amplitude is about 16 MPa. The remaining characteristics are similar to those shown in Fig. 7.

Fig. 8. Non- fault bay. Time analysis of normal stresses σ_{xx} at the corresponding location.
 Rys. 8. Przęsło nieuszkodzone. Analiza czasowa naprężeń normalnych σ_{xx} w odpowiednim miejscu

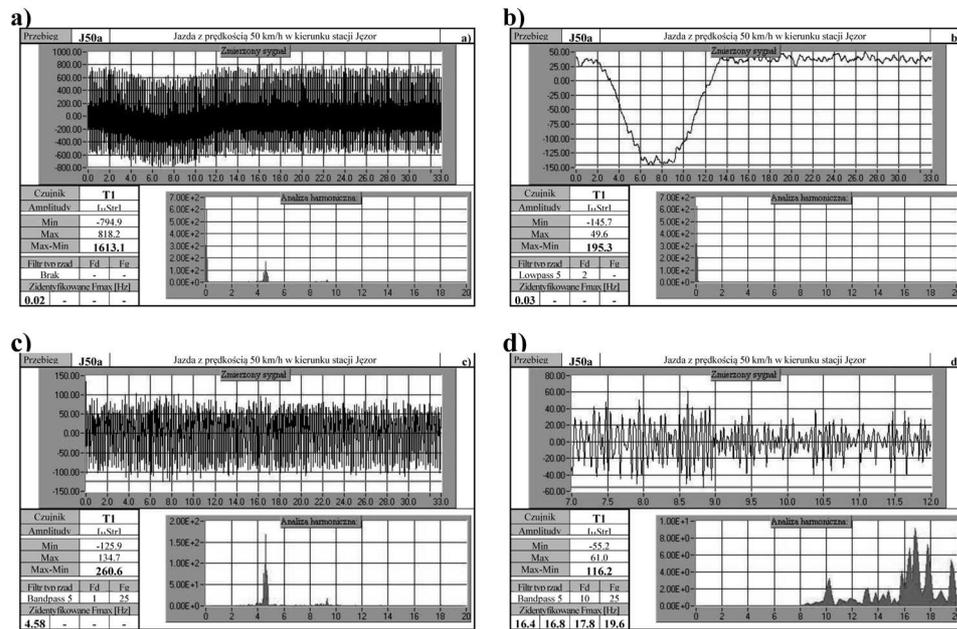
Examples of change of deflection in time "t" registered with electro-resistance tensometer T1, were obtained during passing of a load at 50 km/h speed toward Jęzor, and the arrangement is shown in Fig. 9. Both drawings are divided into 4 parts, marked a through d.

The signal shown in part a of Fig. 9 is heavily distorted to a point where it is impossible to conduct analysis of vibrations using analysis graphs of power spectral density (PSD). After filtering of the measurement signal, it is possible to run some analysis. It is evident in part b of the graph where it is already possible to see the characteristic of the signal and range of changes during the load movement. In part c a heap of spectral density can be observed at frequency $F_{max} = 4.58$ Hz. However, only at the part d, after selection of 5 s part of registered measurement signal, obtained during the loading of the structure for analysis, and with the lower threshold of the bandpass filter raised to $F_d = 10$ Hz heaps at PSD graphs at frequencies between 16.4 Hz and 19.6 Hz were observed.

Fig. 9. Tensometer T1. Drive at 50 km/h speed toward Jęzor.
Rys. 9. Tensometr T1. Jazda z prędkością 50 km/h w kierunku stacji Jęzor

This confirms correctness of the calculation model developed. The dynamic tests proved occurrence of vibrations of frequencies affecting the strain of the structures near the nodes. The way the electro resistance tensometers (T) were deployed enabled registration of local shapes of vibrations in the analysed node.
