Poznan University of Technology  
Chair of Thermal Engineering  
Poznań

## Analysis of heat load in a biomass-fired boiler

This paper discusses an exemplary cooperation between a research center, industry and technical inspection authorities. The purpose of the investigations (carried out to find the failure of a biomass-fired boiler in a heating plant) is an analysis of the effect of operating water boiler conditions on the heat load of the heating surface. The analysis concerns the reasons for failure of the membrane heat exchanger of the water-gas type being a basic heating surface of the boiler burning biomass. During the operation of the boiler some cracks perforated the bottom and smoke tube endings occurred.

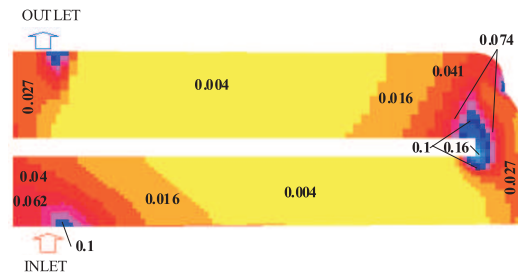
The distribution of the exhaust gases kinetic energy of turbulence changes caused by their flow through a profiled return chamber and their inflow onto the exchanger-perforated bottom has been shown in Fig. 5. The obtained results show that at points where the main direction of flow changed, some flow separations were formed on the constructional surfaces as well as a wake formed by the flowing-off swirls. This complex swirl structure has two characteristic features: it makes the exhaust gas flow across the wake difficult and significantly increases the heat transfer coefficient at the perforated bottom. The wake moved along the whole perforated bottom of the first bank of pipes. Consequently, the exhaust gas flow blockage was uniform along the whole height and did not cause any significant changes in the distribution of mass flowing through individual smoke tubes. The second effect of the wake was more important from the point of view of the failure analysis. The exhaust gas flow of high turbulence moved along the perforated bottom and intensified the heat exchange between the perforated bottom surface and exhaust gases.

Figure 5. The distribution of kinetic energy of turbulence,  $[\text{m}^2/\text{s}^2]$ .

The performed numerical calculations show that the exhaust gas flow was uniformly distributed inside the pipe bundles however, at the same time the perforated bottom surface had to carry significantly higher heat loads caused by an increase in the heat transfer coefficient due to the increased intensification of gas turbulence. This means that an increased receipt of heat flow from the exhaust gases should be guaranteed on the waterside.

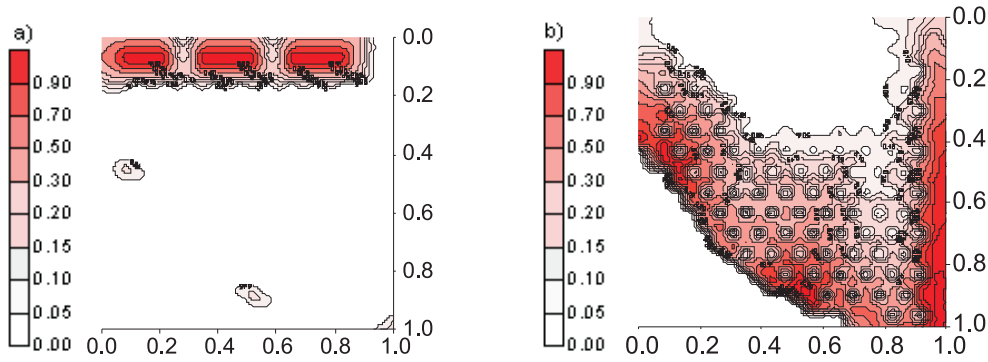
The distributions of velocity in the transverse plane showing its changes in the vicinity of the first perforated plate are presented in Figs. 7 and 8. The obtained data show that a stream flowing out from the openings located in the central part of the perforated bottom, under the plate separating the draughts of flows of the heat exchanger along the pipes, only slightly propagated in a radial direction. The openings arranged circumferentially were to provide cooling smoke tubes with water.

However, numerical calculations show that, due to the pipes packed too close, water cannot be fed to some areas of the heat exchanger and its direction of flow quickly changes into the axial one. The problem with the heat exchanger appears in situation, when axial and radial components of velocity are equal to zero. The white areas corresponding to the minimum or zero velocity of flow between the smoke tubes would not exist. The analogical solutions for the distance of 0.5 m from the perforated bottom have been shown in Fig. 8. The axial component indicates a gradual but very slow propagation of flows in a radial direction. The distribution of the radial component presented in Fig. 8b shows that at the distance of 0.5 m from the perforated bottom the maximum velocity

Figure 7. The normalized distributions of axial component (a) and radial component (b) of velocity in section  $z = 50$  mm.

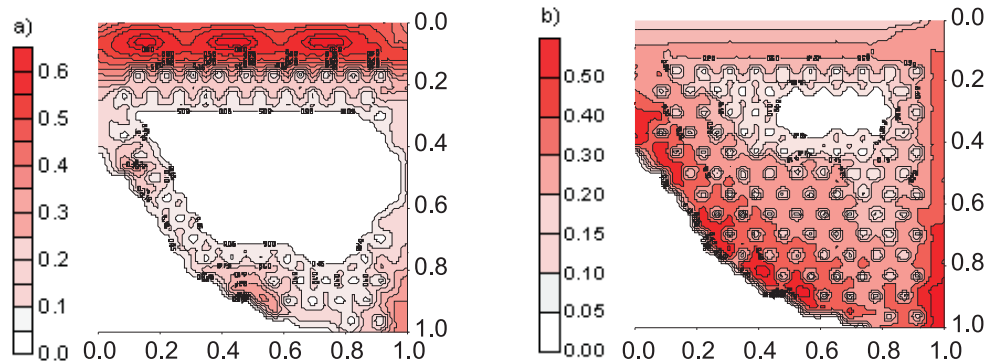
Figure 8. The normalized distributions of axial component (a) and radial component (b) of velocity in section  $z = 500$  mm.

area fades. A lack of the mass exchange, anywhere inside the heat exchanger may mean an occurrence of local overheating or even boiling water states.

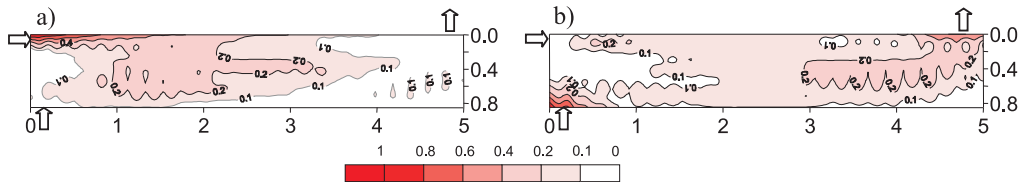
The axial and radial velocity components in the longitudinal plane distant of 500 mm from the exchanger axis have been shown in Fig. 9. The superimposed white areas in Figs. 9a and 9b show that there was a small area of a very small mass exchange close to the perforated bottom. A thermal power taken away from the perforated bottom surface and pipes was a mass function being a velocity function. Small velocities correspond to a decrease in the mass flow acting on the perforated bottom surfaces which at a constant heat flow supplied from the exhaust gas side, results in an increase in the wall temperature and, subsequently, an increase in the water temperature. The results of the numerical

calculations prove the occurrence of two superimposing effects. First, a flow of heat transferred from the exhaust gases to the wall was greater due to an increase in the turbulence of flow caused by a wake formed in the exhaust gas return area. This resulted in an increase in temperature of the perforated bottom. Second, a disturbed water flow at the perforated bottom area in the central part of the bundle resulted in a smaller heat receipt and caused an even more intensive increase in the wall temperature. Analyzing the failure causes, the technical inspection revealed the effects of such a phenomenon confirming the above hypothesis. During the visual inspection of the boiler, some boiler scale deposit was found on the surface of the perforated bottom and on the pipes at their contact with the perforated bottom. This unquestionable proof seems to verify the results of the numerical calculations, as the boiler scale deposits only in the overheating water areas or in the phase transition areas. The statement that a disturbed water flow in a certain part of the heat exchanger caused a sudden increase in water temperature (resulting in the boiler scale deposition) seems to be right. Next, the growing boiler scale layer reduced additionally the receipt of the wall heat by water, thus leading to an even greater increase in the wall temperature.

Figure 9. The normalized distributions of axial component (a) and radial component (b) of velocity in section  $r = 500$  mm.

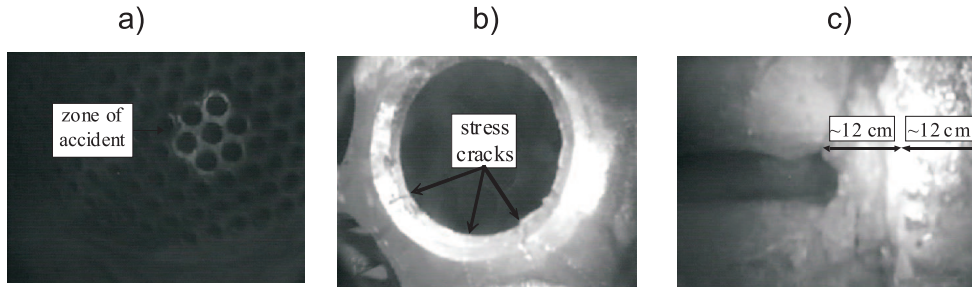
The heat exchanger failure was caused by numerous cracks of the smoke tubes at their connections with the exchanger draught perforated bottom. The cracks that were propagating in the pipe joined the perforated wall and propagated in the wall material. The relevant photos presented in Fig. 10 show the places where the cracks of the smoke tubes and the perforated bottom material occurred. The cause of failure can be determined based on those photos and information on the boiler operating conditions, which, in general, may concern many factors responsible for the failure acting at that time. Among them, an effect of the high temperature exhaust gas flow on the perforated wall combined with the periodic pressure changes caused by the automatics controlling the pump mixing units, and a lack of the mass change on the water side should be mentioned. The point

Figure 10. Small break loss of coolant accident (a), stress crack of smoke tube and perforated bottom (b) thickness of boiler scale and perforated bottom (c).

of attachment of the smoke tube and perforated bottom is the weakest link in all heat exchanger.

The deposit thickness was of 5 to 15 mm. The analysis of a water sample taken from the heating system showed that the total water hardness of  $0.065 \text{ mval/dm}^3$  was almost twice as high as the standard value  $0.035 \text{ mval/dm}^3$ . The consecutive water tests showed  $\text{pH} = 7.61$  which was too low ( $\text{pH} = 9\text{--}10$ ). The chemical analysis of the boiler scale showed the following results: the calcium compounds in the form of  $\text{CaO} - 44.0\%$ ; magnesium content in the form of  $\text{MgO} - 5.02\%$ ; carbonate content  $\text{CO}_2 - 11.4\%$ ; sulphite content  $\text{SO}_3 - 5.1\%$ ; silicate content  $\text{SiO}_2 - 7.52\%$ . The boiler scale was characterized by a small thermal conductivity in relation to steel. An additional layer on the steel increased its temperature and consequently decreased its strength.
