Research paper

Long-term SHM (Structural Health Monitoring) of continuous rigid frame bridge reinforced by external prestressing

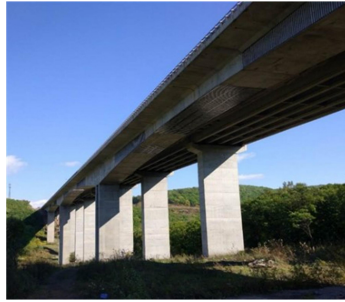
The rehabilitated highway bridge located in the northeast region of China, first opened to traffic in December 2010. The bridge has a total length of 549356 mm, and a total width of 24.5 m. The bridge is 12 m in width with 2 traffic lanes. The span arrangement is 75 m + 3 × 130 m + 75 m, as shown in Fig. 1 and Fig. 2.

Fig. 1. General view of the rehabilitated highway bridge

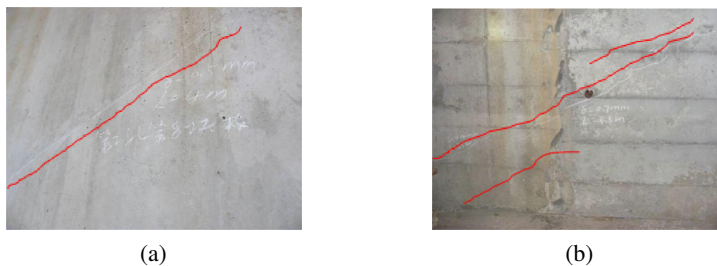
In 2013 and 2015, the routine inspection was conducted again, cracks distribution was similar compared to the inspection in 2012. However, cracks on the web gradually developed into transverse cracks at the chamfering angle of the top slab. As a result, a total of 156 oblique cracks were detected on the web of the box girder, with a total length of 38.6 m, among which 72 cracks on the right side with a total length of 19.3 m and 84 cracks on the left side with a total length of 19.3 m. Crack distribution on the web of the box girder is shown in Fig. 4.

Fig. 4. Cracks distribution on the web: (a) Crack on the No. 8 block exterior surface ($L = 4$ m, $\delta = 0.5$ mm, $\alpha = 45^\circ$); (b) Interior surface oblique crack ($L = 8$ m, $\delta = 0.5$ mm, $\alpha = 35^\circ$)

The web of the bridge is seriously cracked, and the distribution range of the inner cracks of the web is from 6 # block to 14 # block. The lateral cracks of the web were mainly concentrated in blocks 7 # to 9 #, while no cracks appeared in blocks 0 # to 5 #. After checking the bridge design drawings, the thickness of the web of blocks 0 # ~ 5 # is 60 cm, and prestressed steel bundles are arranged, while the thickness of the web of blocks 6 # ~ 14 # is 40 cm, and there is no prestressed steel bundles, and the diameter of the web stirrings is 10 mm. Through calculation and analysis, the web size of 7 # ~ 9 # blocks does not meet the requirements of minimum shear size. It can be seen that the inclined crack of the web is caused by the joint action of bending moment and shear force, and is caused by excessive main tensile stress.

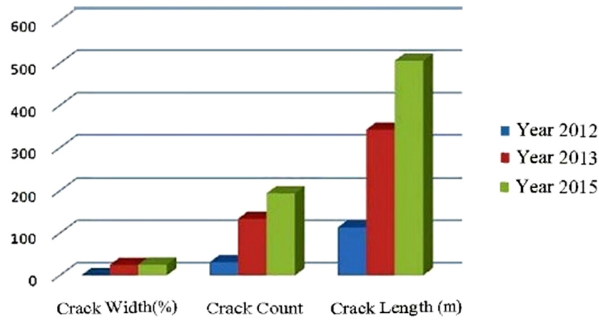
The number, length, and width of cracks increase with the number of years of operation as shown in Fig. 6. From 2012 to 2013, the width of cracks on the web increased by 24.77%, and the number of cracks increased by 103, and the length increased by 229.37 m. From 2013 to 2015, the width of cracks increased by 11.26%, the number of cracks increased by 60, and the length increased by 163.03 m.

Fig. 6. Cracks profile over 3 inspection periods

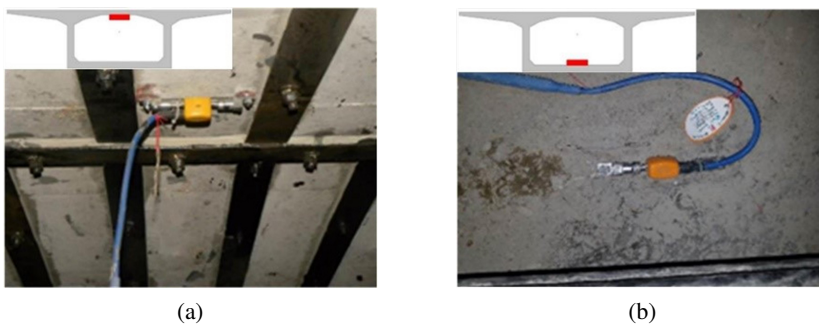
On-site installation of JMZX-212HAT Surface Strain Gauge and an illustration of the box-girder instrumentation cross-section is shown in Fig. 14.

Fig. 14. On-site installation of surface strain gauges: (a) Top slab; (b) Bottom slab

JMZX-212HAT vibrating wire strain gauges, which are a component of the JMZX-21A general data acquisition module, are used to measure strain response and it is also equipped with temperature sensors. The vibrating wire strain gauge consists of a vibrating tensioned wire, base, strain gauge, and protecting cover, suitable for steel structure and concrete structure surface strain measurements. The base of the strain gauge is welded onto the steel structure or nailed by high-strength bolt into the surface of the concrete, and is commonly used for long-term and automated measurement. The strain is calculated by measuring the resonant frequency of the wire (an increase in tension increases the resonant frequency).

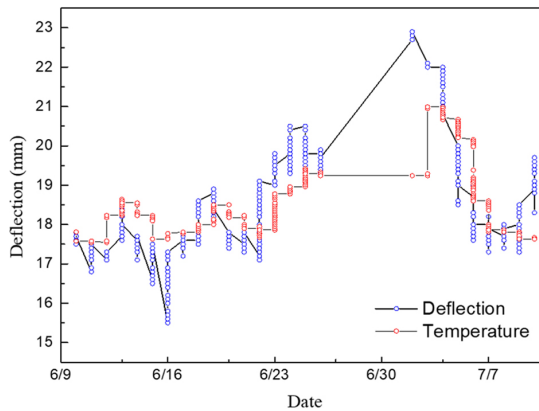
The portion of the data from June 10th to July 10th, as shown in Fig. 19, was extracted for demonstration analysis. In order to remove the temperature effect, temperature is used as an independent variable to simulate deflection caused by temperature, as shown in Fig. 20. Linear regression has an R^2 of 0.54. To verify using F value, $F = 2257.11 > F_{0.05}$, and its corresponding $p > 0$, which satisfies $p < 0.05$. Therefore, there is indeed a high correlation between temperature and deflection. It makes sense to use this method for temperature effect simulation.

Fig. 19. Temperature and deflection from June 10th to July 10th

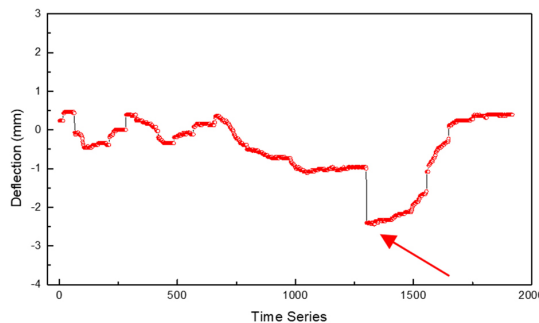
Total deflection subtracts linear regression simulated data would be the result. The resulting deflection calculated from the linear regression model and temperature data is shown in Fig. 21. The change in deflection can now be seen as the deflection caused by vehicle load alone.

Fig. 21. Deflection after the removal of temperature effect

As shown by the arrow, continuous heavy traffic flow was observed at the range of [1302, 1509] for a total of 207 minutes or 34.5 hours. However, there should be unloading during this period which was not observed. This leads to two explanations to this phenomenon, one is that there was indeed continuous heavy traffic flow during that period or there were intervals of traffic flow. To verify this, strain responses during the same time series range will be analyzed for consistency.

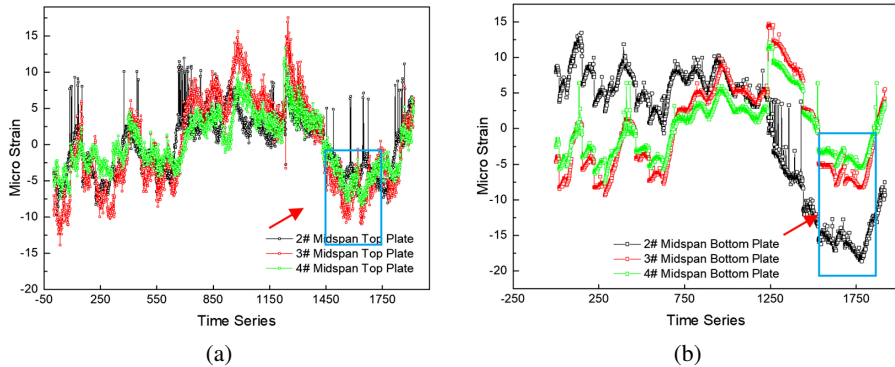
Used the same algorithm as the treatment of deflection data, the temperature effect of strain data from June 10th to July 10th, were treated. Results are shown in Fig. 23.

Time series data in the range of [1302, 1509] for both top and bottom slab showed dramatic change in strain. This corresponds to the change detected in deflection, indicating the presence of vehicle load. The strain change for the data range of [1302, 1509] is $16.20 \mu\epsilon$ for span 2 midspan bottom slab, $10.60 \mu\epsilon$ for span 3 midspan bottom slab, and $8.70 \mu\epsilon$ for span 4 midspan bottom slab. The strain change for the data range of [1302, 1509] is $10.58 \mu\epsilon$ for span 2 midspan top slab, $18.39 \mu\epsilon$ for span 3 midspan top slab, and $12.42 \mu\epsilon$ for span 4 midspan top slab.

Fig. 23. Resulting temperature removed strains: (a) Top slabs and (b) Bottom slabs

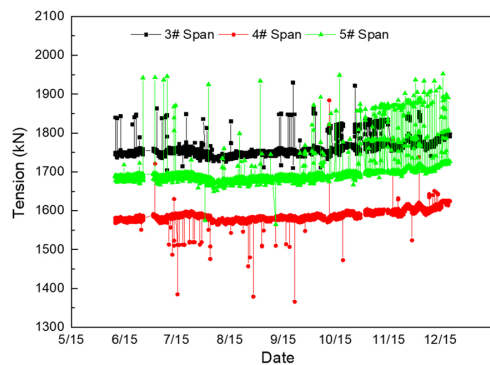
Tension forces of external prestressing tendon has been temperature corrected automatically by pressure cells, data collected for the last 6 months of 2018 is shown in Fig. 24. The maximum change of external prestressed steel strand tensile force of the 3rd span, 4th span and 5th span is

226 kN, 518 kN and 387 kN, respectively. The peak tensile forces of the 3rd, 4th and 5th span are 1930 kN, 1884 kN and 1952 kN, respectively. Through the evaluation of tension force data, no over-limit data was observed. The rehabilitated bridge has not experienced tension loss.

Fig. 24. Tension force data for the last 6 months of 2018

3. The maximum change of external prestressed steel strand tensile force of the 3rd span, 4th span and 5th span is 226 kN, 518 kN and 387 kN, respectively. The peak tensile forces of the 3rd, 4th and 5th span are 1930 kN, 1884 kN and 1952 kN, respectively. Through the evaluation of tension force data, no over-limit data was observed. The rehabilitated bridge has not experienced tension loss.
4. Deformation data and strain data in the time series range of [1302, 1509] has shown related responses, which may help in determining the vehicle load in the future.
