ARCHIVES
of
FOUNDRY ENGINEERING

Issue 2/2017

Microstructure of Archaeological 17th Century Cast Copper Alloys

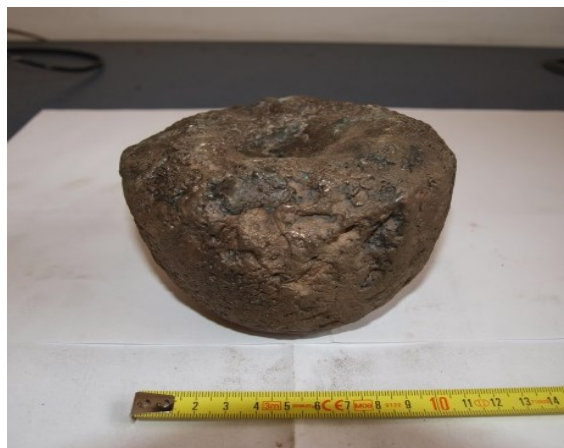
The study involved an archaeological artefact in the shape of a lump. During preliminary studies, the outer layer burst, revealing the casting itself in a shape resembling, or similar to, a bell. It was named a "kettlebell" by the authors (Fig. 1). As a result of a break in the surface layer, several fragments were obtained (Fig. 2).

The base of the weight has a nearly circular shape with a diameter of 130 mm. In its geometric centre, there is a cavity with a diameter of 40 mm and a depth of 10 mm. The cross-section is an ellipsoid shape with a clearly clipped, blunt tip at a height of 90 mm. In the middle, a small recess and character (like a number 4, probably a craft sign of ownership) are visible.

On the surface of the weight, the presence of a large number of small craters was revealed (Fig. 1). They are most likely a result of the release of air bubbles during casting. This is a casting defect that results from the inability of the foundrymen (craftsmen) to dispose of the gases from the molten metal.

Fig. 1. The kettlebell excavated on the market place in the city of Czestochowa in summer 2009

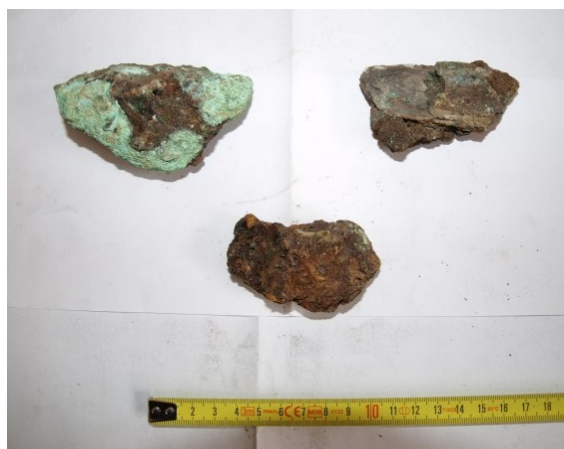
Fig. 2. Fragments derived from the mould surrounding the bell-like part

Three parts of the investigated weight shell, are presented in Fig. 2. The first of them, called “part No. 1” during the observations in order to distinguish triangle-shaped and elongated parts, is covered by a patina, which raises the hypothesis of a high copper content. Patina consists basic of copper carbonate and has a characteristic green colour. It is also the product of atmospheric copper corrosion in a sufficiently moist environment. In a clean atmosphere, the main component is the main hydroxy copper carbonate (II), $[\text{Cu}(\text{OH})_2\text{CO}_3]$. This type of coating is very durable and is a result of the last stage of the corrosion process, which ensures its passivity. In an atmosphere that contains sulphur dioxide, the patina also includes sulphite (VI) of hydroxy copper (II), $[\text{Cu}(\text{OH})_2\text{SO}_4]$, but the film has no protection against further corrosion. The covering of the surface of metal with patina

Part No. 1 has a length of 90 mm, a width of 50 mm measured at the widest point, and a height of 45 mm. Part No. 2 reveals embedded ceramic fragments and charcoal residue as well as a small amount of patina. Its length is 75 mm, the width measured at the widest point is equal to 45 mm, and its height is 25 mm. Part No. 3 is in the form of a tetrahedral block and is of an elongated shape with visible areas affected by corrosion products derived from its iron impurities and compounds as well as small areas covered with patina.

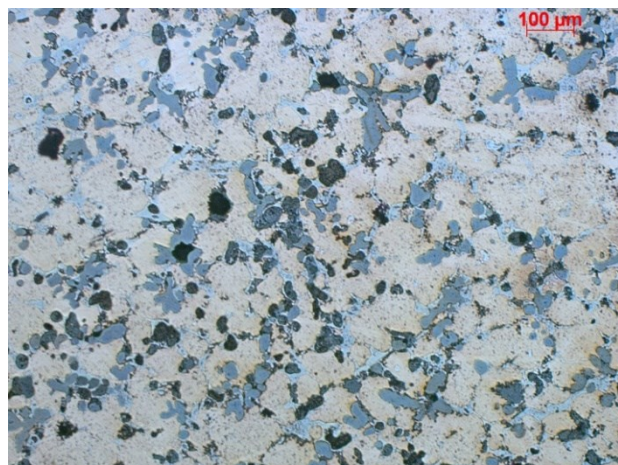
Observations of metallographic specimens of the weight material revealed that the structure consists of a matrix (Fig. 4), which is probably the copper and three other phases. Moreover, numerous voids arising from the foundry process are present in the structure.

Fig. 4. Microstructure of the weight alloy, LM

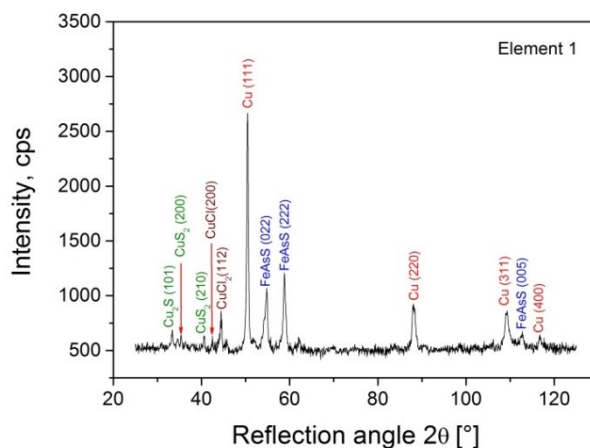
The metallic nature of the material was confirmed in one cross-section of part No. 1. The qualitative X-ray phase analysis results presented in Fig. 7 confirm that copper (Cu) is the dominant element in the material of part No. 1, crystallizing in the face-centred cubic (FCC) crystallographic system. In addition to copper, the phase FeAsS (arsenopyrite), which crystallizes in the monoclinic system with d-spacing values of $a = 5.741 \text{ \AA}$, $b = 5.668 \text{ \AA}$, $c = 5.770 \text{ \AA}$, and $\beta = 111.93$, was also confirmed in the material. Other phases like copper sulphide (Cu_2S and CuS_2) and copper chloride (CuCl and CuCl_2) were also present. Both arsenopyrite (FeAsS) and copper sulphide are assumed to be the remains of the ore used for production of this alloy.

Fig. 7. X-Ray diffraction for phase analysis of the investigated material of part No. 1
