NATURAL AND ANTHROPOGENIC TRANSFORMATIONS OF THE NATURAL ENVIRONMENT IN THE “KĘPA REDŁOWSKA” RESERVE

Aneta Marek^{1*}, Ireneusz J. Olszak²

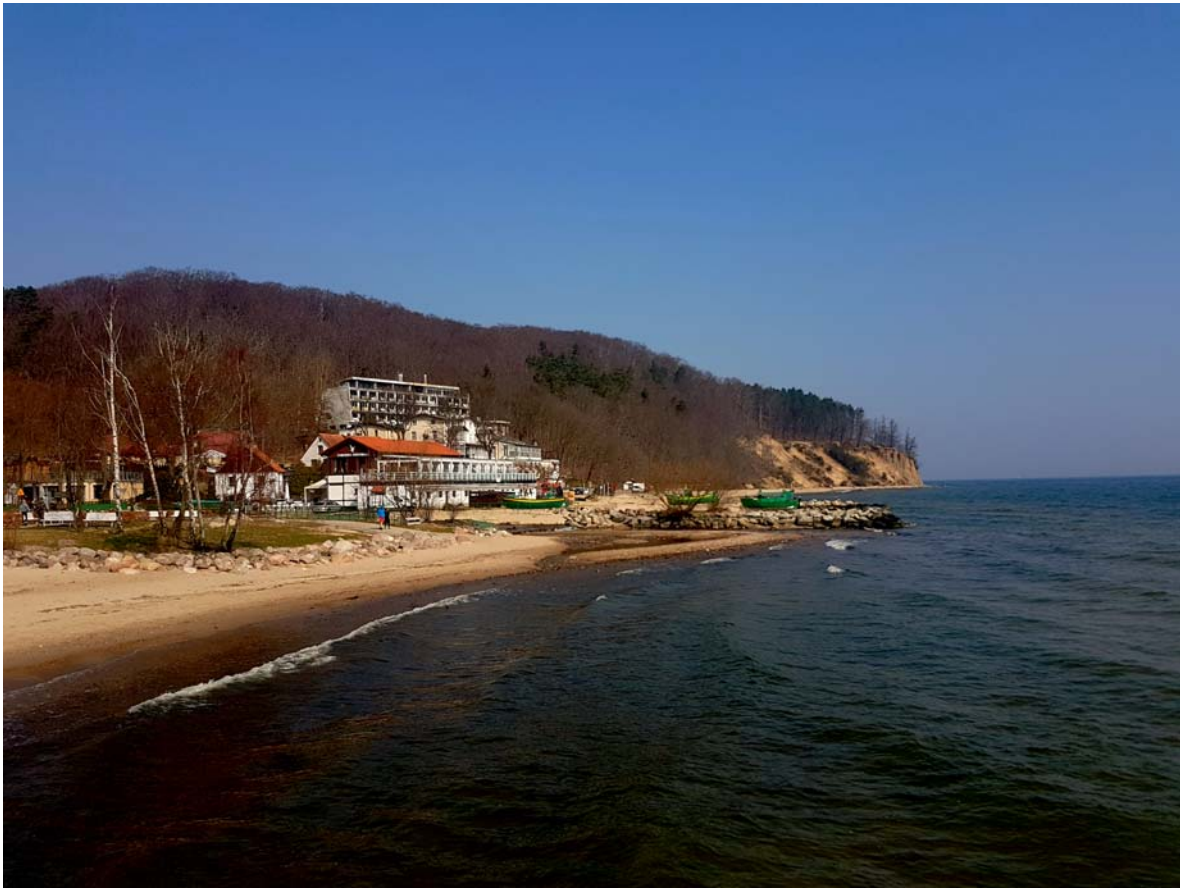
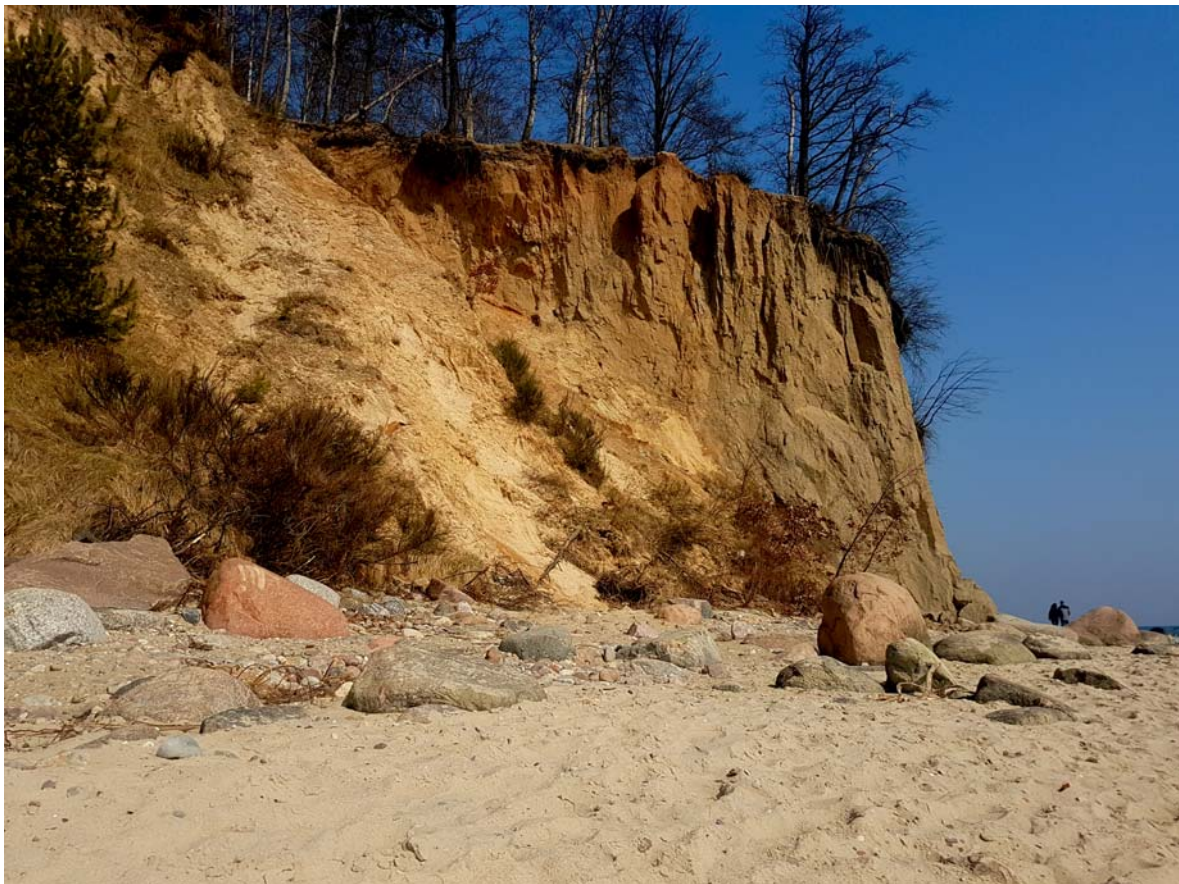
Fig. 2. Orłowo Cape (photo by A. Marek).

The geological outcrops located in the Orłowo and Gdynia cliffs provide a full insight into the geological structure of the reserve area. In these cliffs, the oldest exposed sediments are the Miocene grey and grey-brown silt and fine-grained sand. Within these sediments there are lignite insertions in the Orłowo cliff. However, they do not constitute a continuous bed (Pazdro, 1960; Bohdziewicz, 1961; Musielak, 1971; Pępek and Olszak, 1995). In the Orłowo cliff, the Miocene sediments are exposed only in its central part, where their roof is covered with moraine pavement. In both, the southern and northern part of the cliff, the Miocene roof has been strongly eroded. The whole wall of the cliff is made of glaciectonically disturbed Quaternary sediments. These are glaciofluvial vari-grained sands and, in the southern part of the cliff, a vertically-piled brown till. This till builds up the Orłowo Cape, which is one of the most characteristic sites of the Polish Baltic coast (Fig. 2).

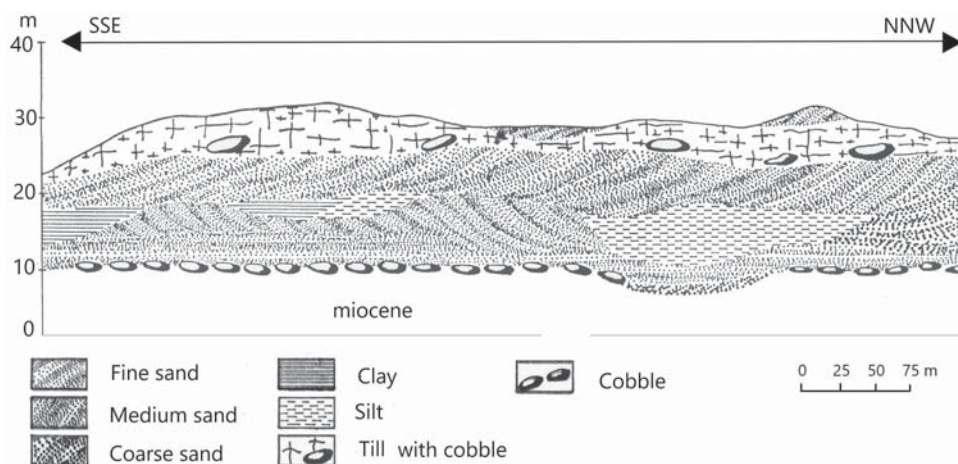
Fig. 3. Geological structure of the Orłowo Cliff. Source: Pepek, Olszak (1995).

The Gdynia cliff has a geological structure very similar to that of the Orłowo cliff (Figs 3, 4). However, there are some differences. Firstly, the roof of the Miocene sediments does not indicate major changes in its altitude. Secondly, the Quaternary sediments lying above are undisturbed. Thirdly, there are basins filled with clays within the Quaternary deposits. They are remnants of small reservoirs that were found in glaciofluvial sediments (Pępek and Olszak, 1995).

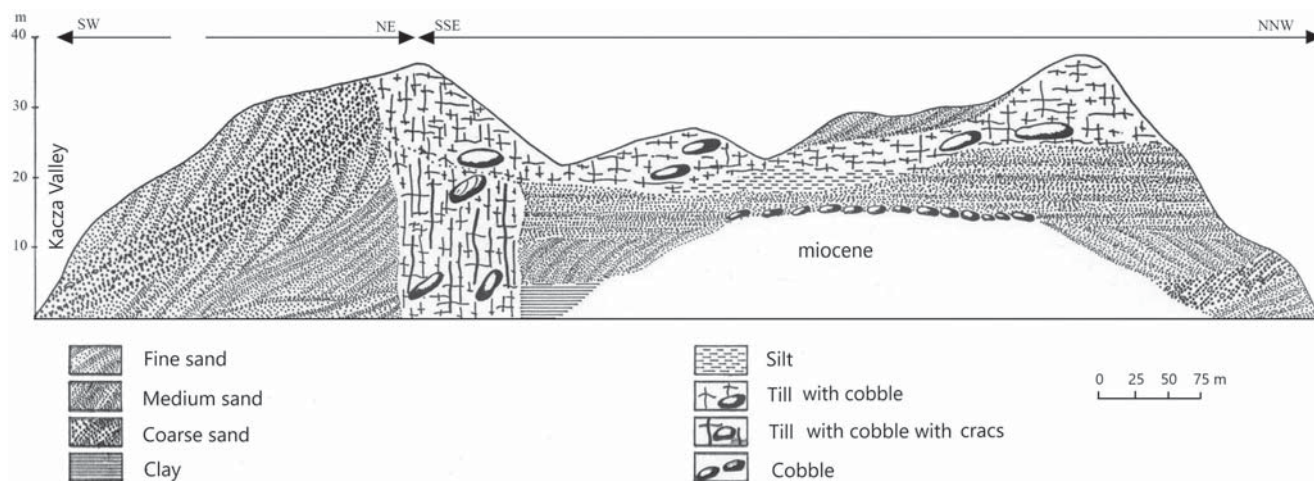
Fig. 4. Geological structure of the Gdynia Cliff. Source: Pepek and Olszak, 1995.

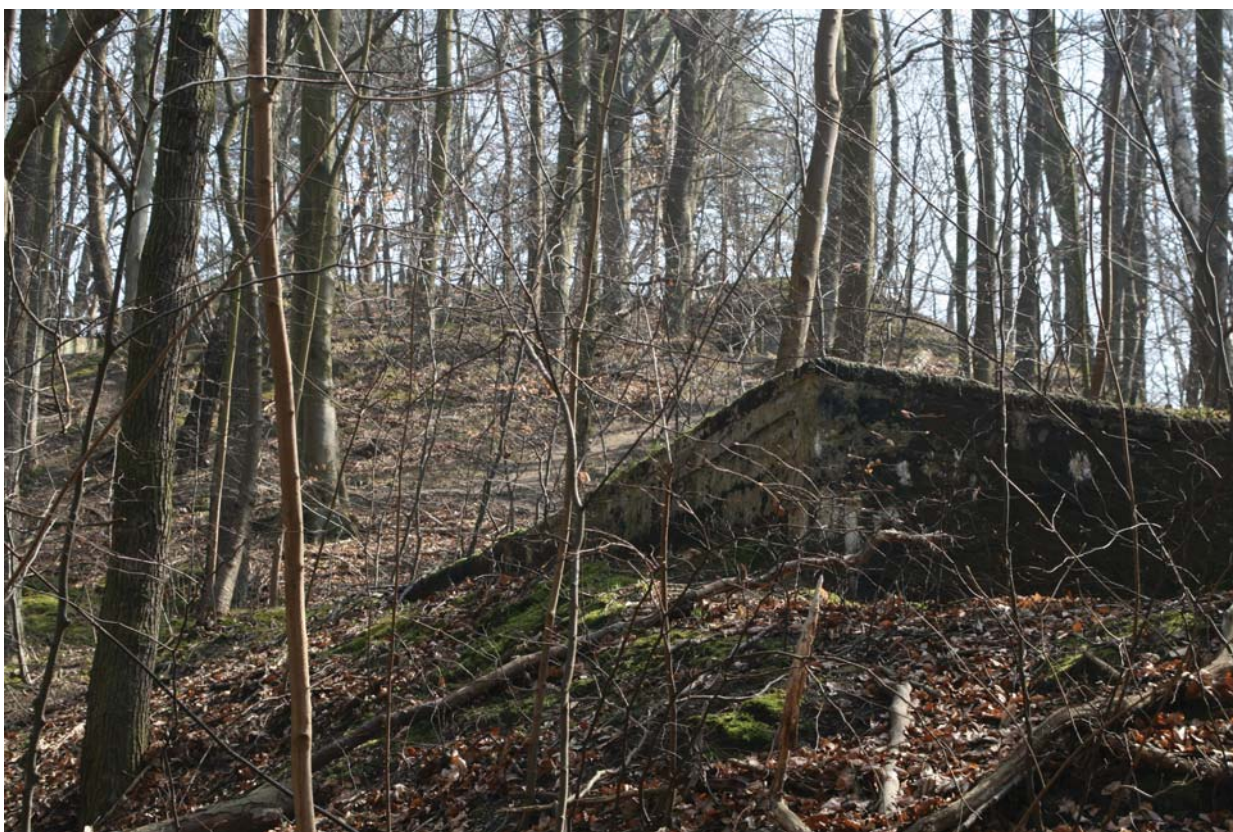
Fig. 5. Fragment of the command post of 32nd Squadron of Coastal Artillery (photo by I.J. Olszak).

The largest number of military facilities was created in this area after the Second World War. These are various types of bunkers, command posts (Fig. 5) and numerous trench stretches (Fig. 6; Woźniakowski, 2017).

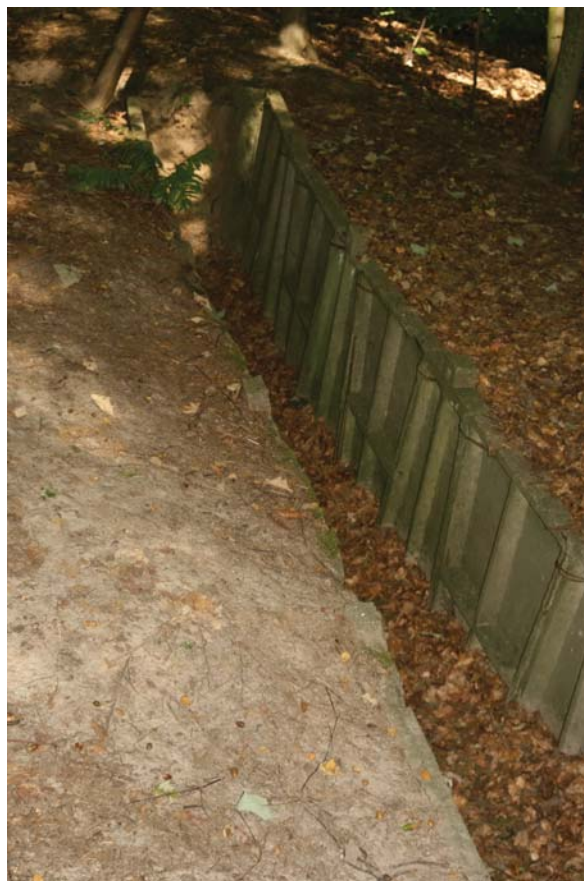
Fig. 6. Trench intersecting the reserve area (photo by I.J. Olszak).

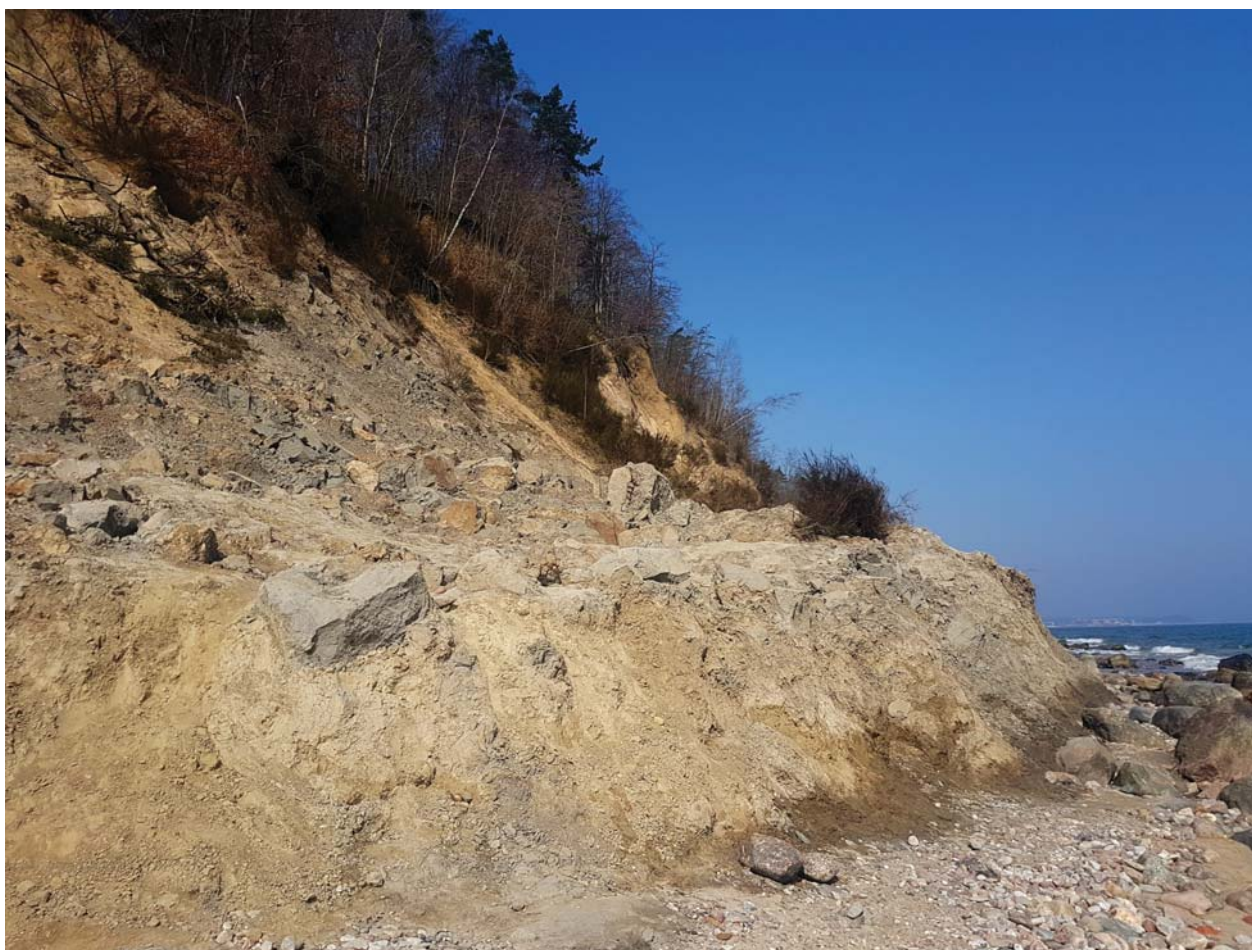
Fig. 7. Landslide in the Orłowo cliff which occurred on February 15, 2018 (photo I.J. Olszak).

The transgression itself, being relatively slow, does not pose a serious threat to the coastal zone. Much greater damage to cliffs occurs as a result of rapid wind surges and the accompanying waving (Zawadzka-Kahlau, 1999). Storm surges, with prolonged exposure to north-easterly winds, may reach about 3 m. Waves in the coastal zone reach a height of up to 4–5 m. Such rapid hydrodynamic changes in the coastal zone cause landslides in cliffs. In particular, this applies to winter periods, when due to air temperatures of over 0°C, there is no ice cover in this zone that would otherwise protect the shore against abrasion. The result of such a situation is the occurrence of a large landslide (Fig. 7) in the Orłowo cliff on February 15, 2018 when about 700–1200 m³ of deposits moved down (Nowak, 2018).

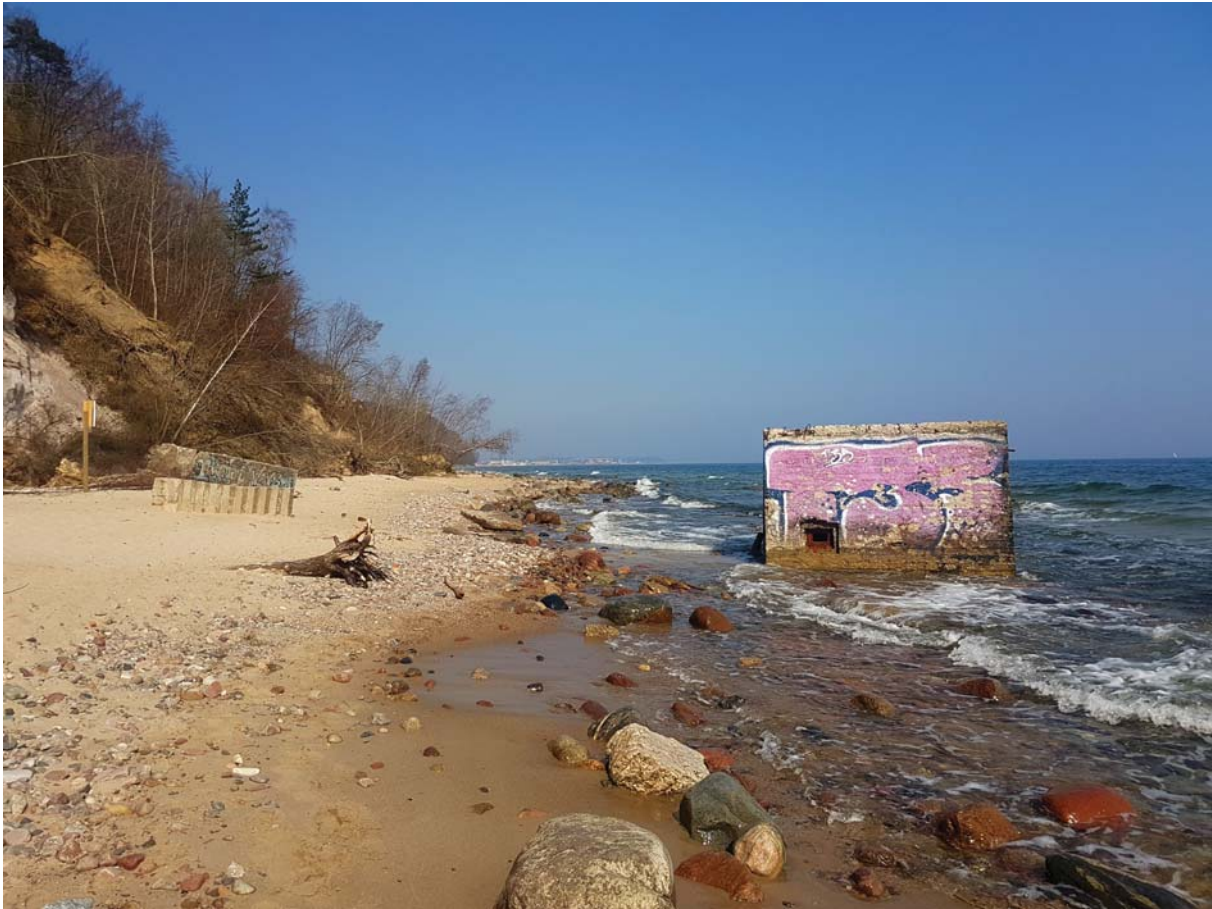
Fig. 8. Two-sided observation bunker after its fall from the Orłowo Cliff (photo by A. Marek).

Also the bunkers, remnants of the 11th Permanent Artillery Battery in Gdynia Redłowo, built at the turn of the 1940s and 1950s are noteworthy. One of them slid to the beach in the 1980s. The second example is a bunker, which served as a two-sided observation point (Mielczarski, 1999). This bunker was located several meters from the edge of the cliff crown. In 2012, a controlled fall of the object from the edge of the cliff to the beach was performed. Currently, it is located in the waters of the Gulf of Gdańsk (Fig. 8).

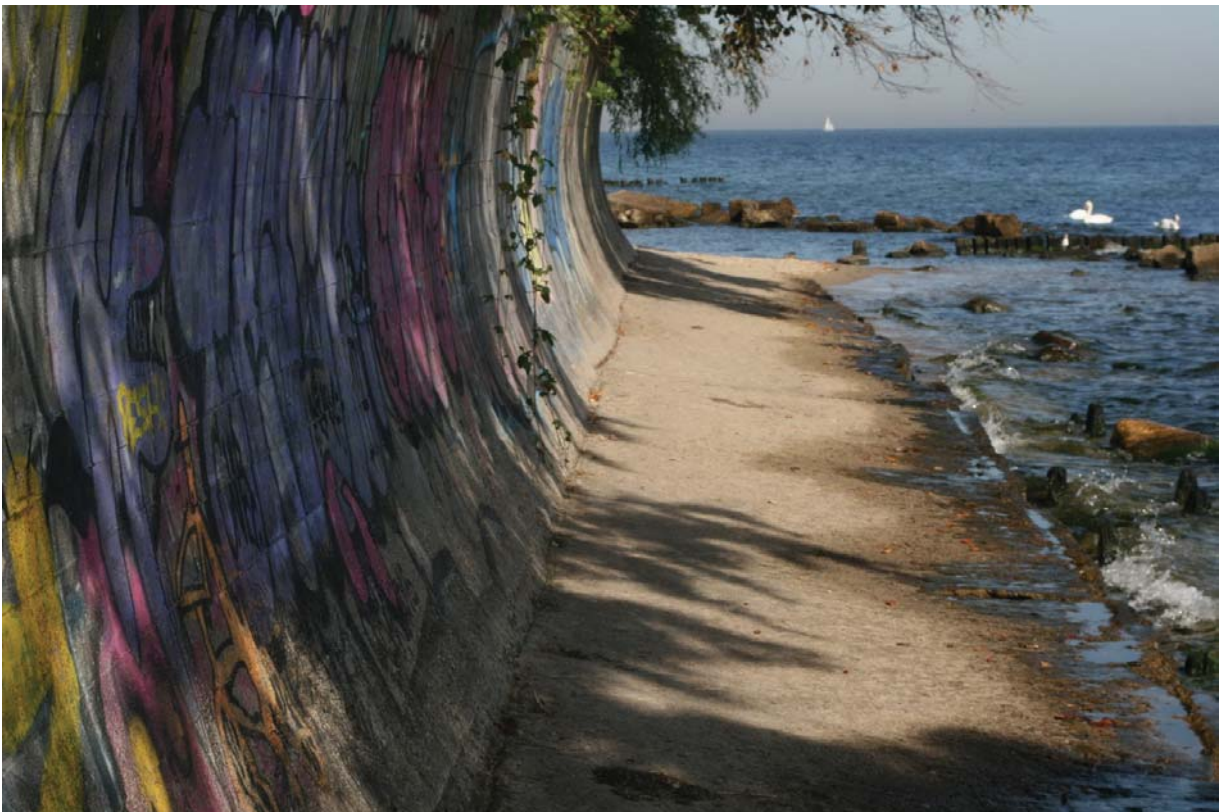
Fig. 9. Gdynia Cliff. Concrete band and groynes (photo by I.J. Olszak).

The Gdynia Cliff retreats definitely more slowly. This is due to the fact that part of this cliff was secured with a fascine band and groynes already in 1905. In 1936 this band was exchanged with the existing concrete band, additionally reinforced in 1957 (Basiński, 1963). This band was made to secure the cliff, in the back of which a military unit was located (Fig. 9). In addition to the threat from the Baltic Sea, the reserve area is also threatened from land. During heavy rainfall and rapid thaws, water flowing through ero-

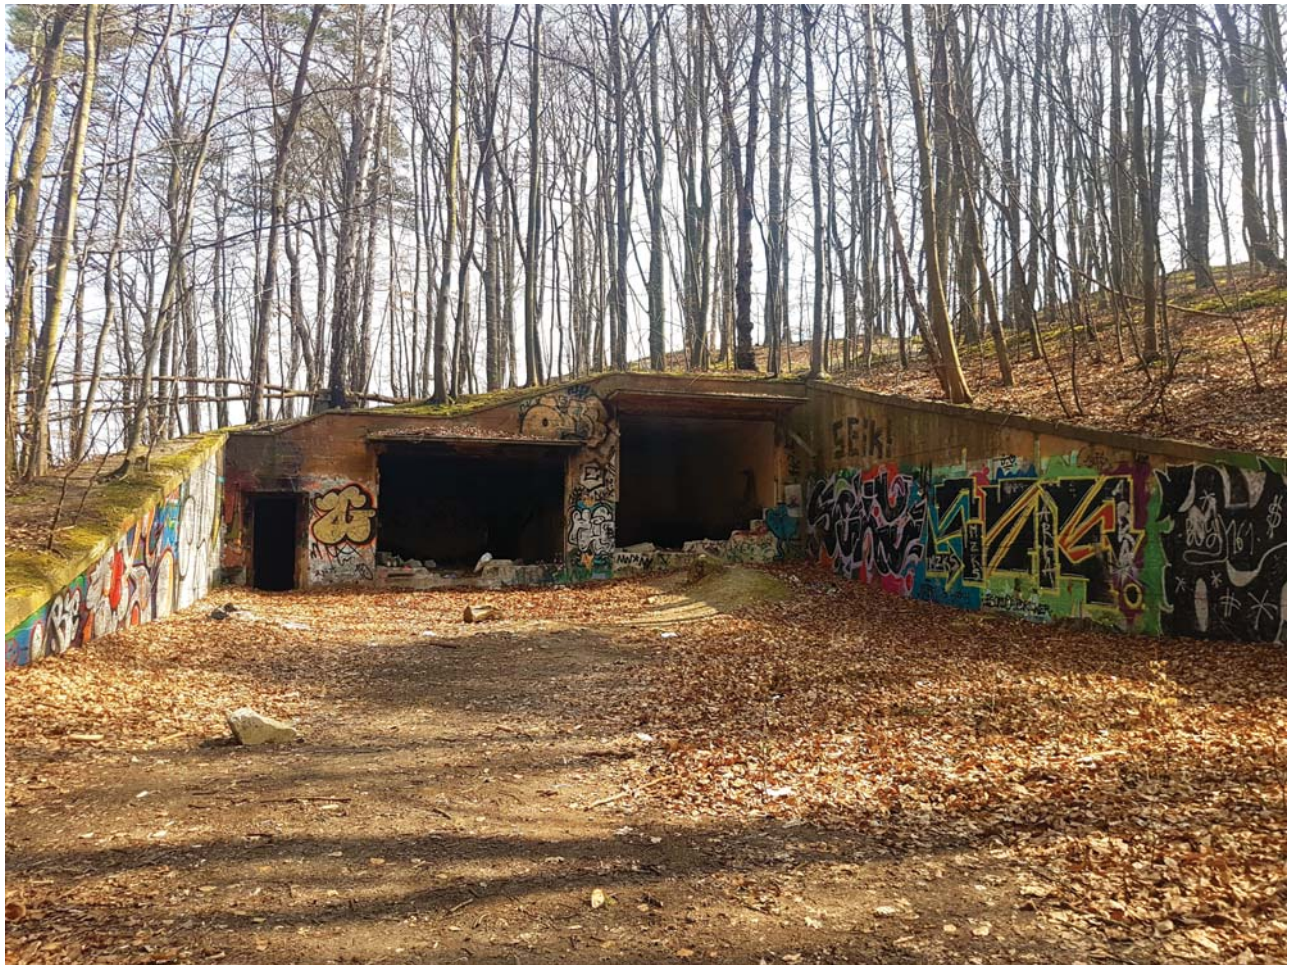
Fig. 10. Remnants of military objects in Kępa Redłowska (photo by A. Marek).

Negative manifestations of anthropogenic activity can also be observed on military facilities located within the reserve. These include graffiti, illegal landfills and littering. Acts of major vandalism, such as devastation of objects (Fig. 10), in order to obtain metal parts from the fixings are also noted.
