MICHAŁ WOJENKA

**THE OCTAGONAL TOWER AT CASTLE OJCÓW –
A COMMEMORATIVE REALISATION OF KING
KASIMIR III THE GREAT?**

Key words: castle Ojców, tower, Kasimir III the Great, architectural detail, commemorative realisations

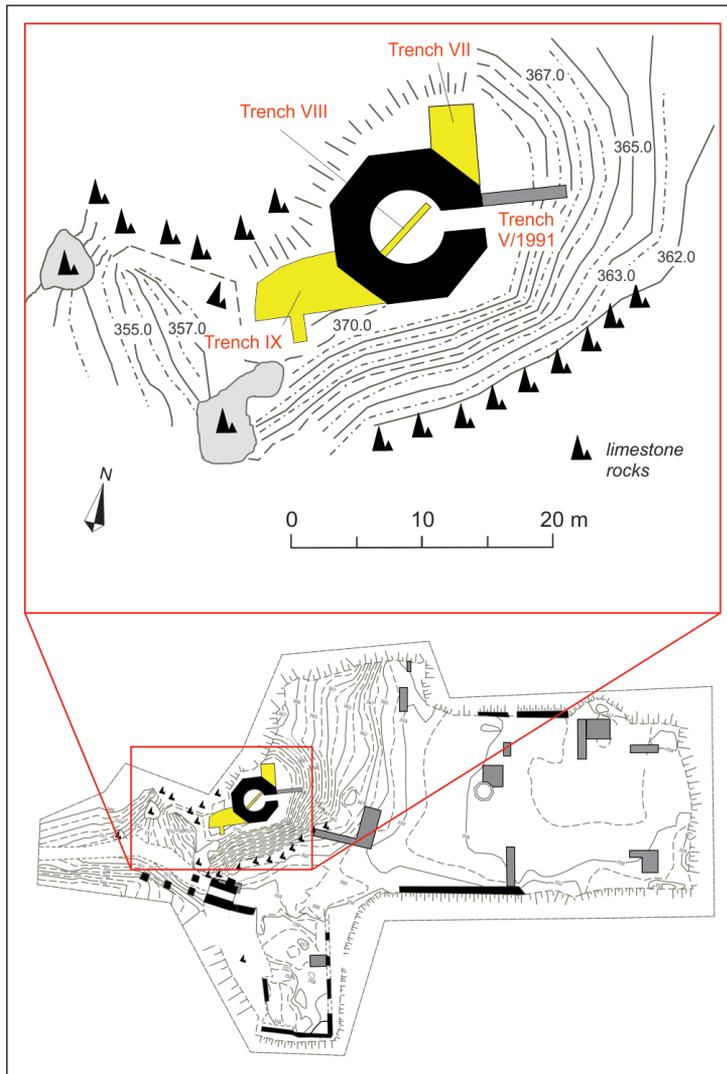
Fig. 2. The castle Ojców. Location of the tower area (archaeological trenches V/1991 and VII-IX marked with grey and yellow colour). Drawn by M Wojenka

The trench VII, localised north-east from the tower (see Fig. 2) was set out to examine the stratigraphic evidence and to confront it with the results achieved by Krystyna Kruczek in 1991. The goals have been completed, but apart from these the trench VII brought new evidence for the castle planning.

The trench VIII which was localised inside the tower (Fig. 2) has not produced data of major significance in its development. The meticulously levelled bedrock was covered by a thin (10-15 cm) sequence of dusty mixed layers, which provided with few pottery sherds of medieval and post-medieval origin. This makes it

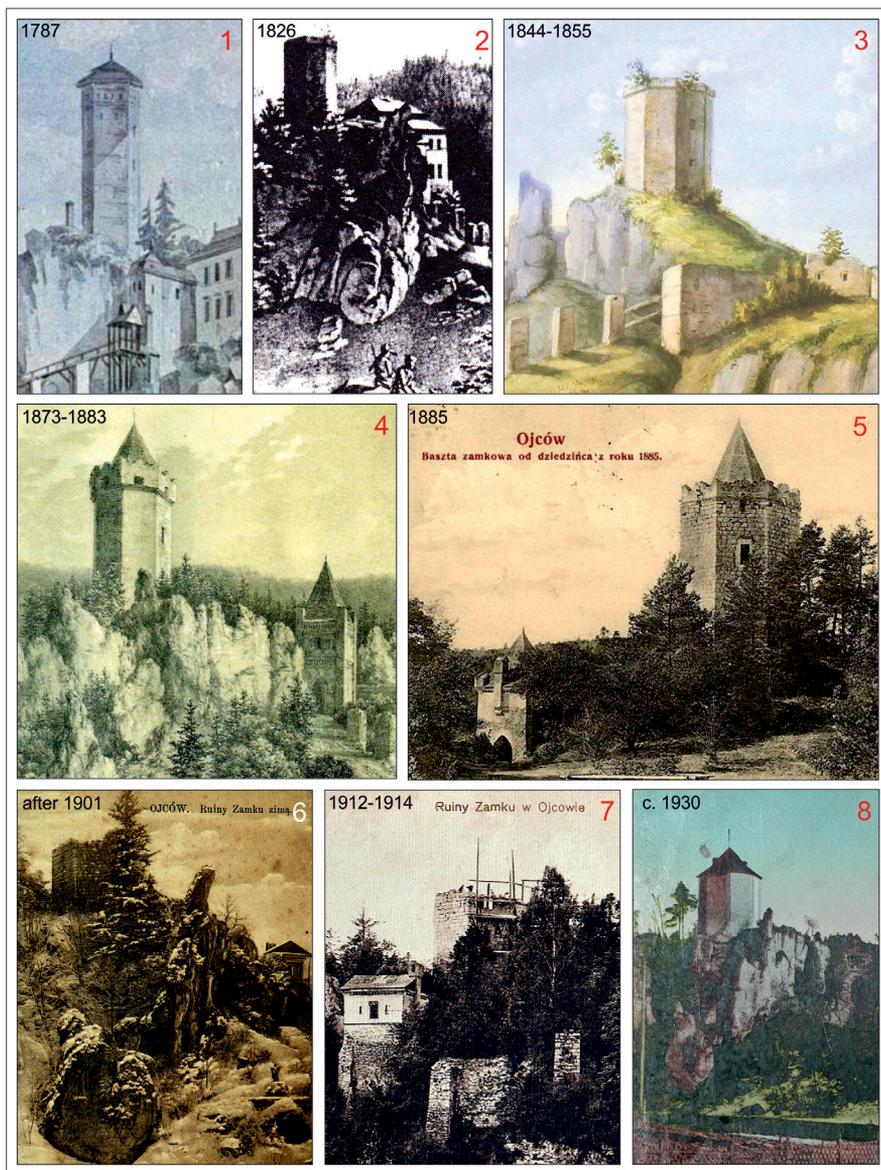
Fig. 3. The octagonal tower at castle Ojców in the iconographic material. 1 – a watercolour of Z. Vogel, 1787; 2 – a watercolour of J.N. Głowacki, 1826; 3 – a litography of K. Stronczyński, 1844-1855; 4 – a litography of N. Orda, 1873-1883; 5 – the octagonal tower in 1885, a postcard; 6 – the tower in the early 20th c., a postcard; 7 – the tower during restoration works in 1912-1914, a postcard; 8 – the tower in the early 1930s, a postcard.

As we can see, in the written accounts of the early 1800s the tower is only marginally described, and the scarce available data does not allow for a precise determination of its appearance and internal design. To some extent this disadvantage is compensated for by the iconographic sources dated to the late 18th c., which demonstrate the tower as a high landscape-dominant building, with a couple of windows and an octagonal gable roof of „Polish” type. Below the roof line there was a row of rectangular window-like openings (Fig. 3:1; Nowacki 1958, 14).

Soon after the castle is abandoned, the original elements of the tower begin to blur (Fig. 3:2). Due to the state of repair, its upper section was dismantled by Ludwik Krasiński between 1893 and 1895. His ambitious plan was to rebuild it, ended with his early death in 1895 (Fig. 3:6; see Ziarkowski 2015). The look of the tower as can be seen at present (Fig. 3:8) results from extensive restoration work carried out by his daughter Maria Ludwika, in 1912-1914 (Fig. 3:7; Ziarkowski 2015, 235; Falniowska-Gradowska 1999, 81). It is most likely that around the same time a new door and window framings were placed (Frazik 1966, 31). A bit earlier it might have looked quite different. Thanks to Kazimierz Wróblewski, the author of a guidebook for the Prądnik river valley travellers’ from the turn of the 20th c., we are able to get a glimpse into the tower’s inside before it was partially dismantled by Krasiński. As he reports, yet in 1893 the entrance to the tower was narrow³ and vaulted. The passage led to the inside of a ground level, without any window, and next to the doorway there were remains of a chimney and two smaller niches – the right yet with shelves, which suggests its storage function, and the left one, which was regarded by Wróblewski as a bouldered passage to a dungeon (this is a significant point to which we will return later). As of today, a stairway on

the left, yet at the end of the 19th c. concealed by a thin wall, led to the first floor of the tower, which had one window (facing south; see Fig. 3:3-4) and included a finely decorated fireplace (Fig. 6.2). The second floor had two windows (facing south and east; Fig. 3:3-5), while the third was equipped with eight T-shaped openings (Fig. 3:4-5), doubtlessly loop-holes (Wróblewski 1907, 132-136). As regards window openings, in light of iconographic sources it is likely that it was only the third floor which originated from the restoration works of Przewdziecki; the number of windows seen at the first and the second level probably resembles the original pattern from the times of the tower's residual function.

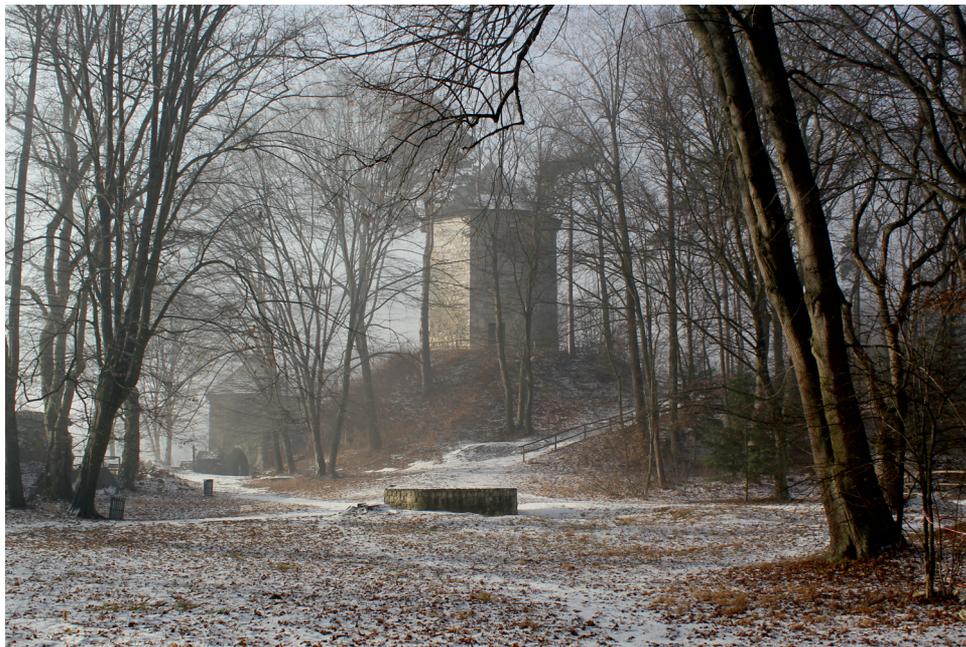
Fig. 4. The octagonal tower at castle Ojców. View from the east. Photo by M. Wojenka

The tower (Fig. 4, 5) is an octagon in plan, has 11.55 m in diameter, and walls that are ca. 2.7-2.8 m thick. On the inside it is round, has 6.2 m in diameter (Fig. 6:1). At the moment the structure is around 13 m high, but since it was extensively

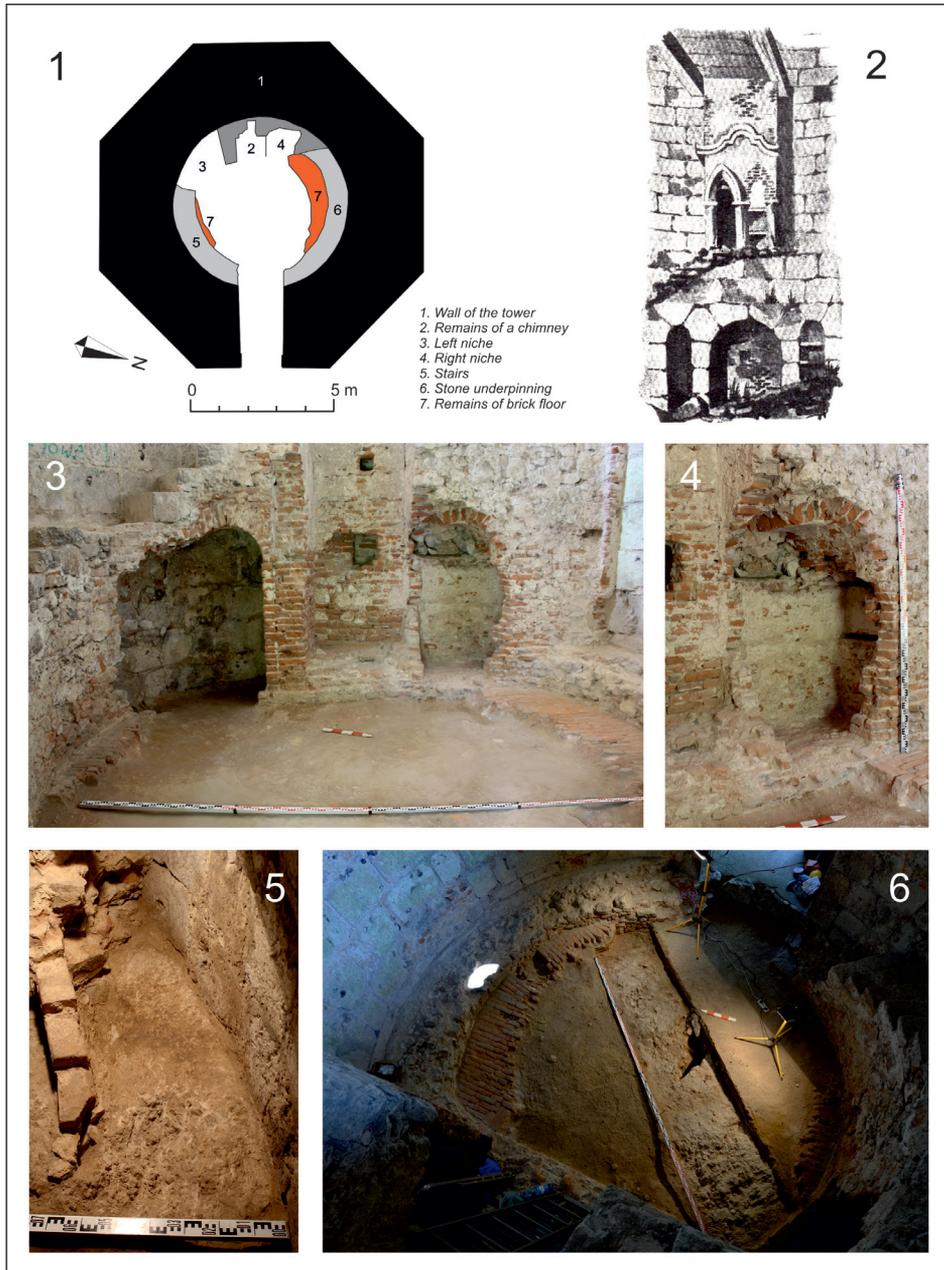
Fig. 6. 1 – Plan of the tower; 2 – the inner furnishings in 1893; 3-4 – modern state of repair of the inner furnishings; 5 – bedrock in the left vaulted niche; 6 – bedrock in the trench VIII.

Nowadays, the only furnishings seen inside of the tower consist of stone stairway relics (preserved up to the first floor; Fig. 6:1, 6:3), remains of a chimney (Fig. 6:1-3), the two niches previously commented by Wróblewski (Fig. 6:1, 6:3-4) and a flat stone underpinning in the north part of the tower, supplemented by bricks (headers ca. 6 × 12-13 cm), which was likely related to the stairway (Fig. 6:1, 6:6). The niches and chimney are built of brick. On the ground there are still remains of paving (Fig. 6:1, 6:3, 6:6) which survived by the northern and southern parts of the wall, built of bricks of 6 × 12-13 × 27 cm. As the size of bricks indicates, the furnishings largely, if not entirely, correspond with the 18th c. (Nowacki 1958, 9-10).

impossible to agree with Kazimierz Wróblewski, who visited the tower in the very late 19th c. and reported that *in front of the entrance there were three vaulted hollows* [brick-made; see Fig. 6:3]. *The right one was still attached with shelves, so it likely served as a medicine cabinet or a handy storage. The middle hollow, twice roomy as the right one, was a fireplace, while the left, the same size as the right one, housed an entrance to the dungeons; than bouldered* (Wróblewski 1907, 133; transl. MW). Inside the left vaulted niche, as well as in the middle part of the tower, the levelled bedrock was reached right after the fieldwork has begun (Fig. 6:5-6).

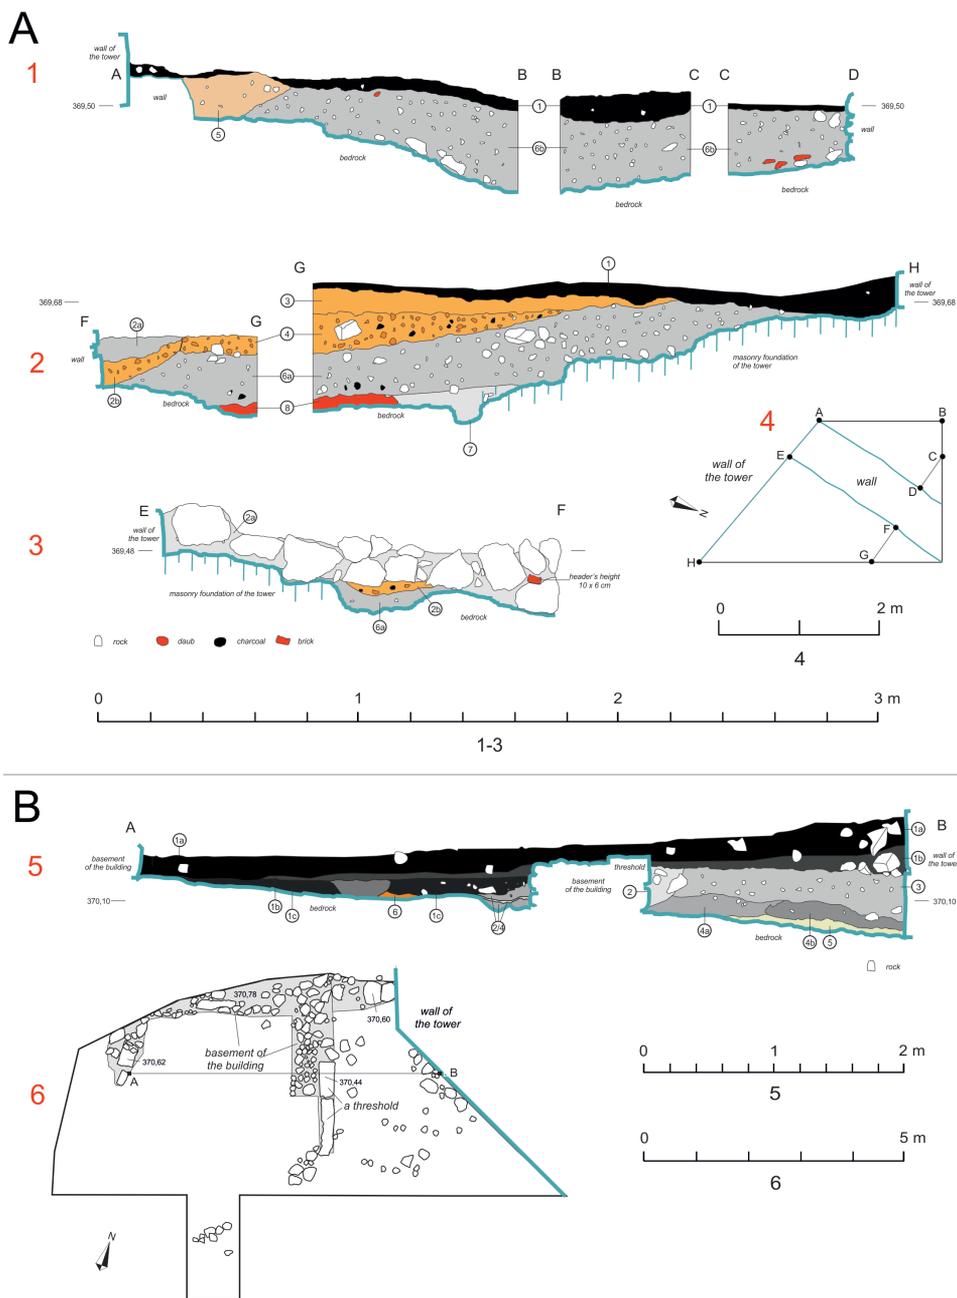
Fig. 7. Stratigraphic sequence in the trench VII (A.1-3) and IX (B.1), a plan of a building localised west from the tower (B.6). Drawn by M. Wojenka

The 2016 excavations took place in three trenches (VII-IX). Trench VII, situated on the northern side of the tower was orientated NS and measured 3.5 × 6.5 × 3 m. Trench VIII was set out inside of the tower; it was orientated ca. NE-SW and measured 5.1 × 1 m. Trench IX was situated to the west from the tower; it was orientated WE and measured ca. 10 × 3-5 m (Fig. 2). In all trenches the recorded stratigraphic evidence was relatively simple and all of them were completely excavated down to the top of bedrock or to the architectural remains. In trench VII the bedrock was recorded at a depth of 100 cm max., in trench VIII – only 10-15 cm, and in trench IX 60-80 cm; see Fig. 7:A-B).

In the trench VII the recorded stratigraphic evidence may be characterized as follows (Fig. 7:A.1-3): **layer 1** – modern-date humic layer with small admixture of limestone rubble; **layer 2** – filling of a foundation ditch for the wall adjacent to the tower (2a: upper layer of mortar, 2b: lower layer of redeposited elements of layer 4); **layer 3** – yellow clayey loess, ca. 20-10 cm thick; **layer 4** – yellow clayey loess, ca. 20-30 cm thick, with charcoal, small pieces of daub and pieces of heavily eroded bricks in large quantities; **layer 5** – humic layer mixed with large quantities of mortar, all grey-yellowish in colour, occurring close to the tower's gable in the south-west part of the trench; **layer 6a** – dark grey mortar layer with sparse humic inclusions on the east side of the limestone wall, ca. 50-60 cm thick; **layer 6b** – dark grey mortar and humic layer fused together on the west side of the limestone wall; **layer 7** – light grey mortar lying on the bedrock, ca. 10-20 cm thick; **layer 8** – dark red layer of daub with charcoal, ca. 10 cm thick, in the east part of the trench lying directly on the bedrock.

In the trench IX the recorded stratigraphic evidence (Fig. 7:B.5) may be characterized as follows: **layer 1a-d** – modern-date humic layers with a small admixture of limestone rubble, ca. 20-50 cm thick; **layer 2** – filling of a foundation ditch for the building placed west from the tower; **layer 3** – light grey mortar layer with a small admixture of limestone rubble, ca. 30 cm thick; **layer 4a** – light grey mortar layer with a small admixture of limestone rubble, ca. 20 cm thick; **layer 4b** – dark grey mortar layer with a small admixture of limestone rubble, of similar thickness to the layer 4b; **layer 5** – yellowish mortar layer covering the bedrock in the east part of the trench, ca. 10 cm thick; **layer 6** – reddish orange residual clay in a fissure in the middle part of the trench, ca. 5 cm thick.

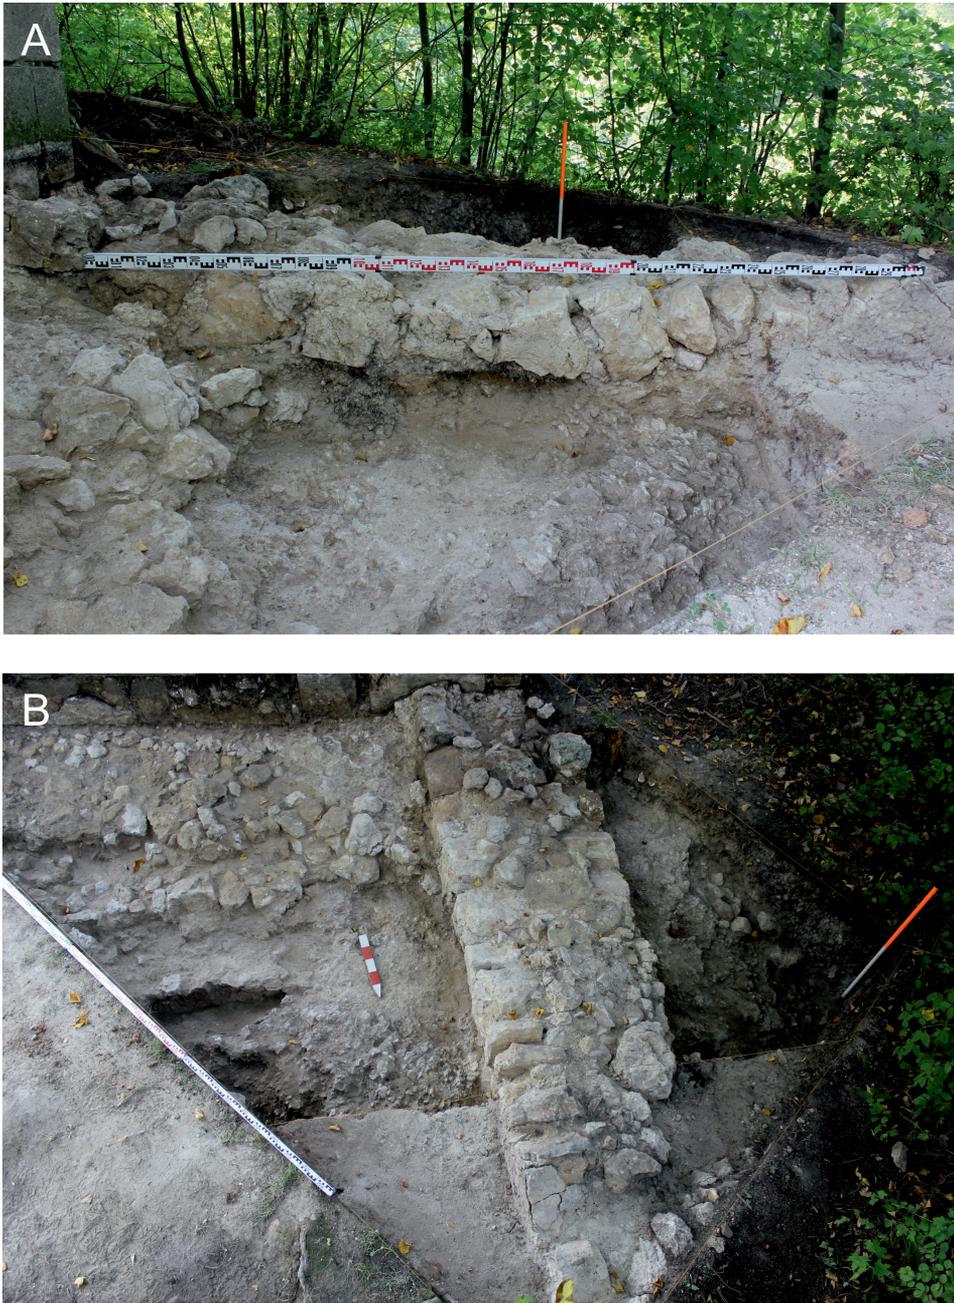
Fig. 8. Trench VII. Remains of limestone wall. A – view from the east; B – view from the north.
Photo by M. Wojenka

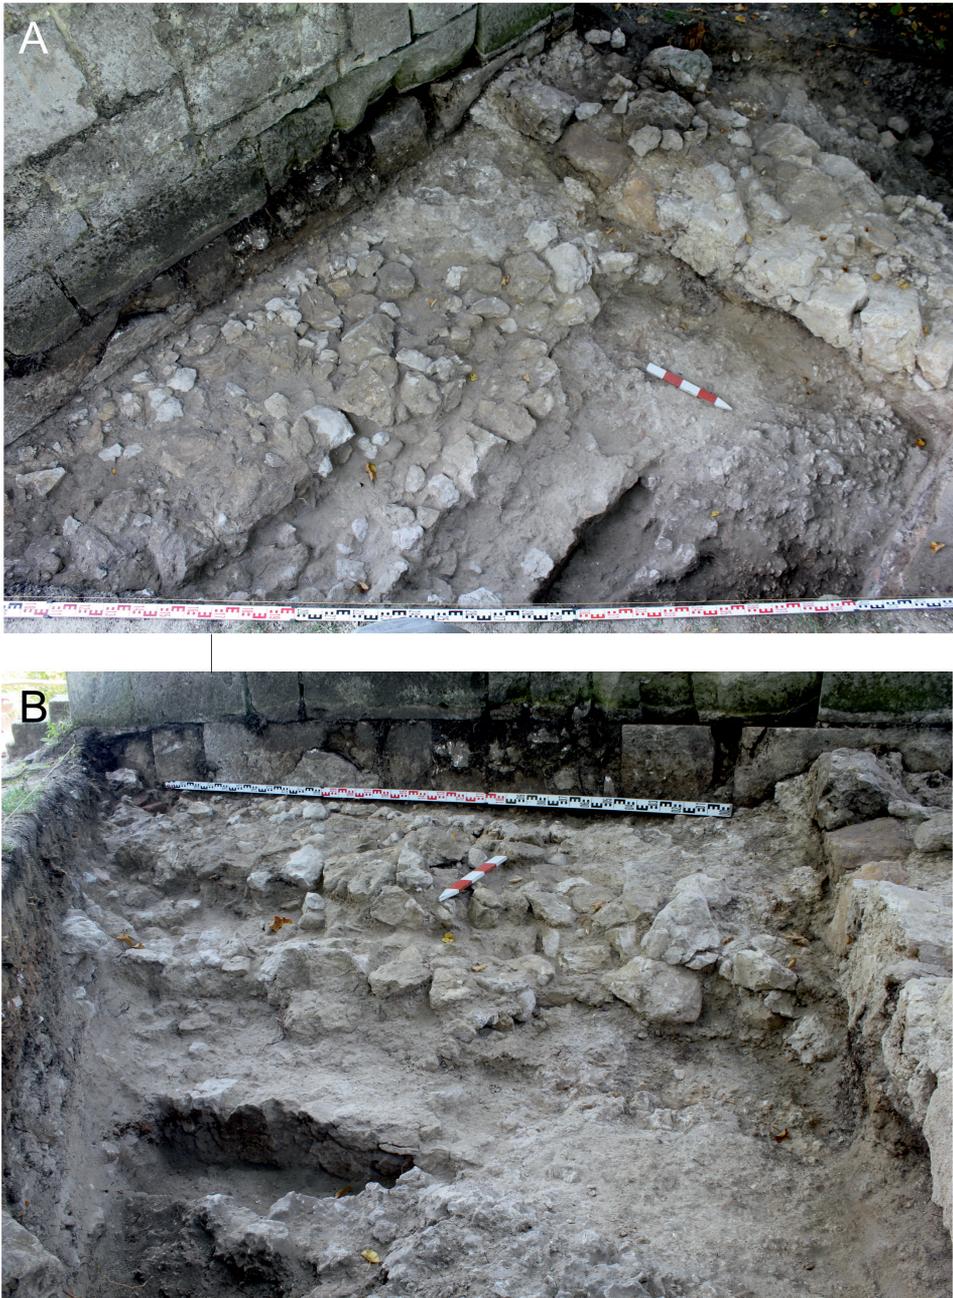
Fig. 9. Trench VII. Remains of a stair-like limestone construction. A – view from the east;
B – view from the north. Photo by M. Wojenka

Both layer 7 and 8 were lying directly on the bedrock or were covering the another masonry structure, which deserves special attention. These were the remains build up by small limestone rocks (ca. 10-15 cm), set in lime mortar. The structure was unearthed below mortar layers 6 and 7 at the bottom part of trench, practically at the level of bedrock. It took a stair-like form with the height of each single "step" ca. 20 cm (Fig. 9:A-B). It is difficult to draw conclusion on its function. Obviously, it is tempting to regard this structure as remains of medieval stairway leading to the entrance of the tower. On the other side, the stair-like form of the structure may have been seen in context of natural form of the bedrock, which in many places of the hill is characterized by an irregular course with frequently occurring natural fissures (*cf.* Fig. 6:6 and Fig. 10). Thus, it may as well be presumed that the stair-like structure resulted from necessity to fill the natural fissure in order to keep the tower's basement firm and even. In light of observations made in the trench VII it would also appear that the stone wall which was seen by Krystyna Kruczek in 1991, forms part of the same construction (see Kruczek 2001, 398).

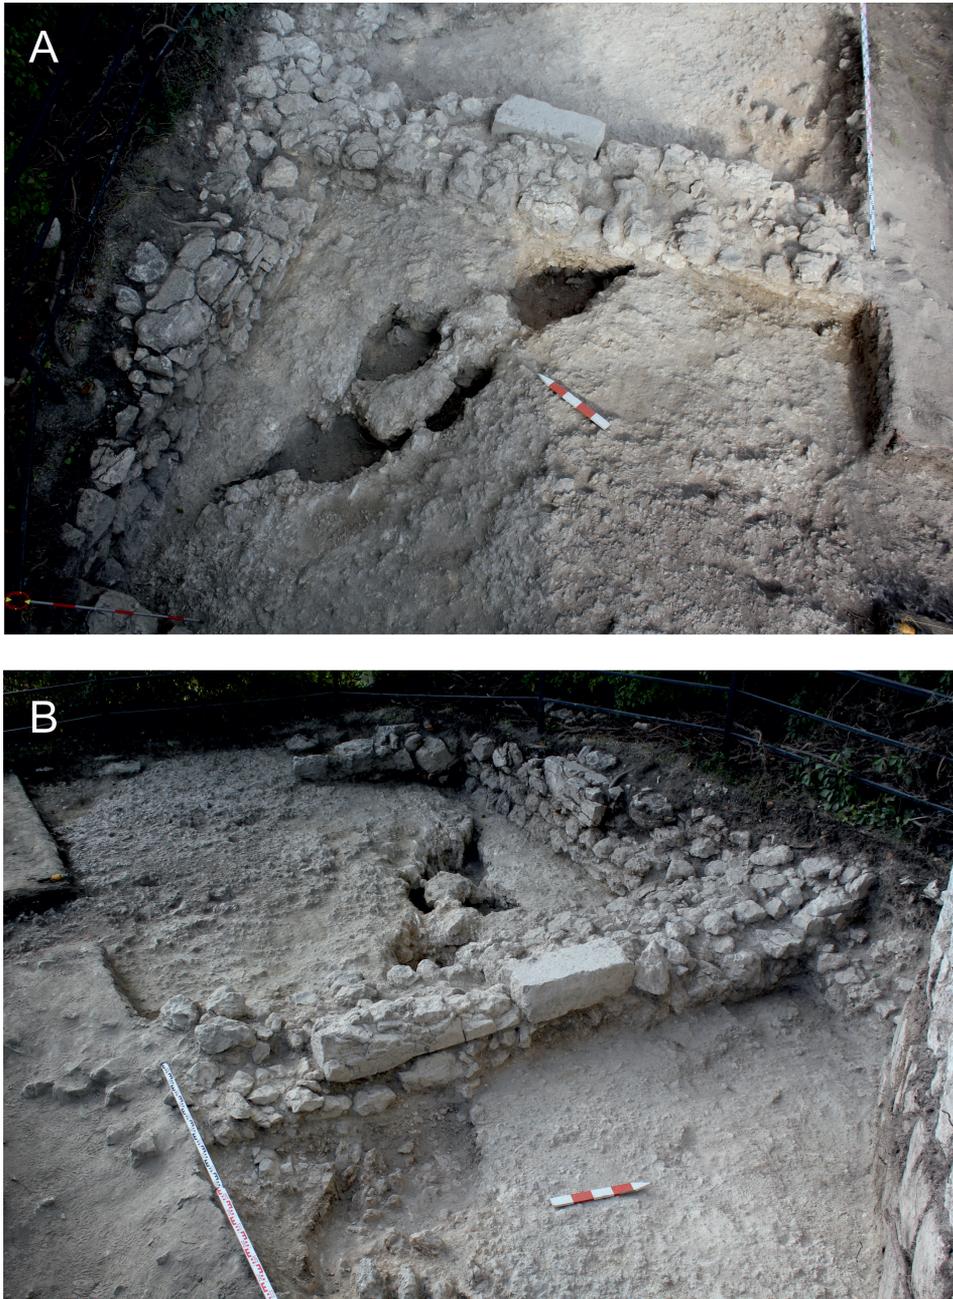
Fig. 10. Trench IX. A limestone base of the building localised west from the tower. A – view from the west; B – view from the east. Photo by M. Wojenka

appears that it is a structure younger than a base for a building with threshold. Both the building and adjacent wall were built directly on a bedrock.

It is fair to say that the discovery of a building west from the tower was quite unexpected, as it has never been mentioned in the written sources. Its function must therefore remain unclear. Thankfully, the archaeological finds from the **layer 2** allow its dating to the late 15th – mid 16th century. This is evidenced by rim fragments of a white kaolinite clay vessel decorated with painted dark orange lines (Fig. 11:4; see Bis 2014, 130-133) and a rim part of a pot made of iron-rich clays (Fig. 11:5). Both finds were well-fired and had one-coloured thin sections. As regards chronology of the building, a mention should also be made of its threshold, which was a piece of limestone architectural detail – it likely came from a Gothic portal (Fig. 13:6).

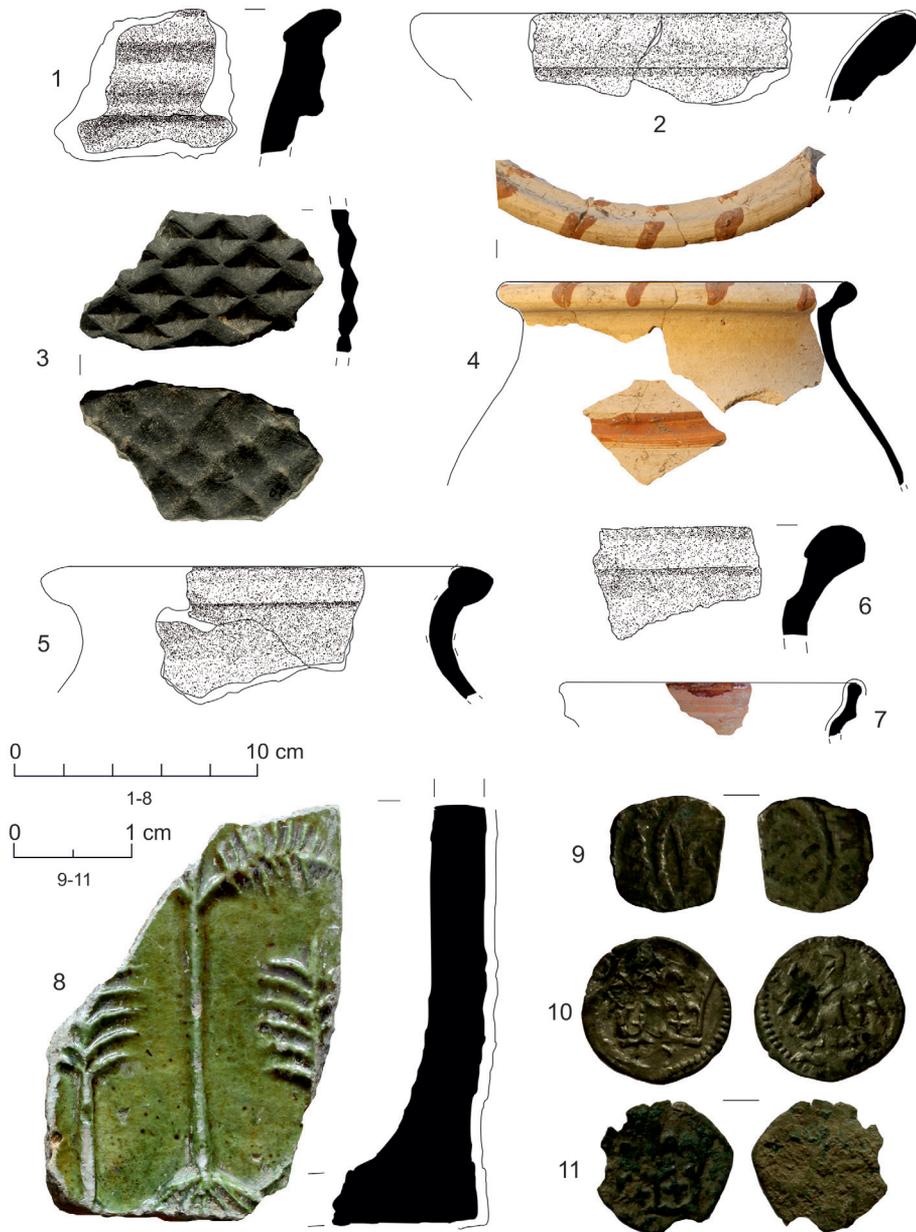
Fig. 11. Finds assemblage from trenches VII (1, 6), IX (2, 4-5, 7-11) and V/1991 (3). 1 – trench VII, layer 6a; 2 – trench IX, layer 4a/4b; 3 – trench V/1991; 4, 5 – trench IX, layer 2; 6 – trench VII, layer 4; 7 – trench IX, layer 4a/4b; 8 – trench IX, layer 1; 9, 11 – trench IX, layer 4a/4b; 10 – trench IX; layer 3/4a/4b/5. 1-8: clay; 9-11: silver. Photo and drawings by M. Wojenka

⁴ The most characteristic finds from the 2016 fieldwork are depicted in Figure 11.

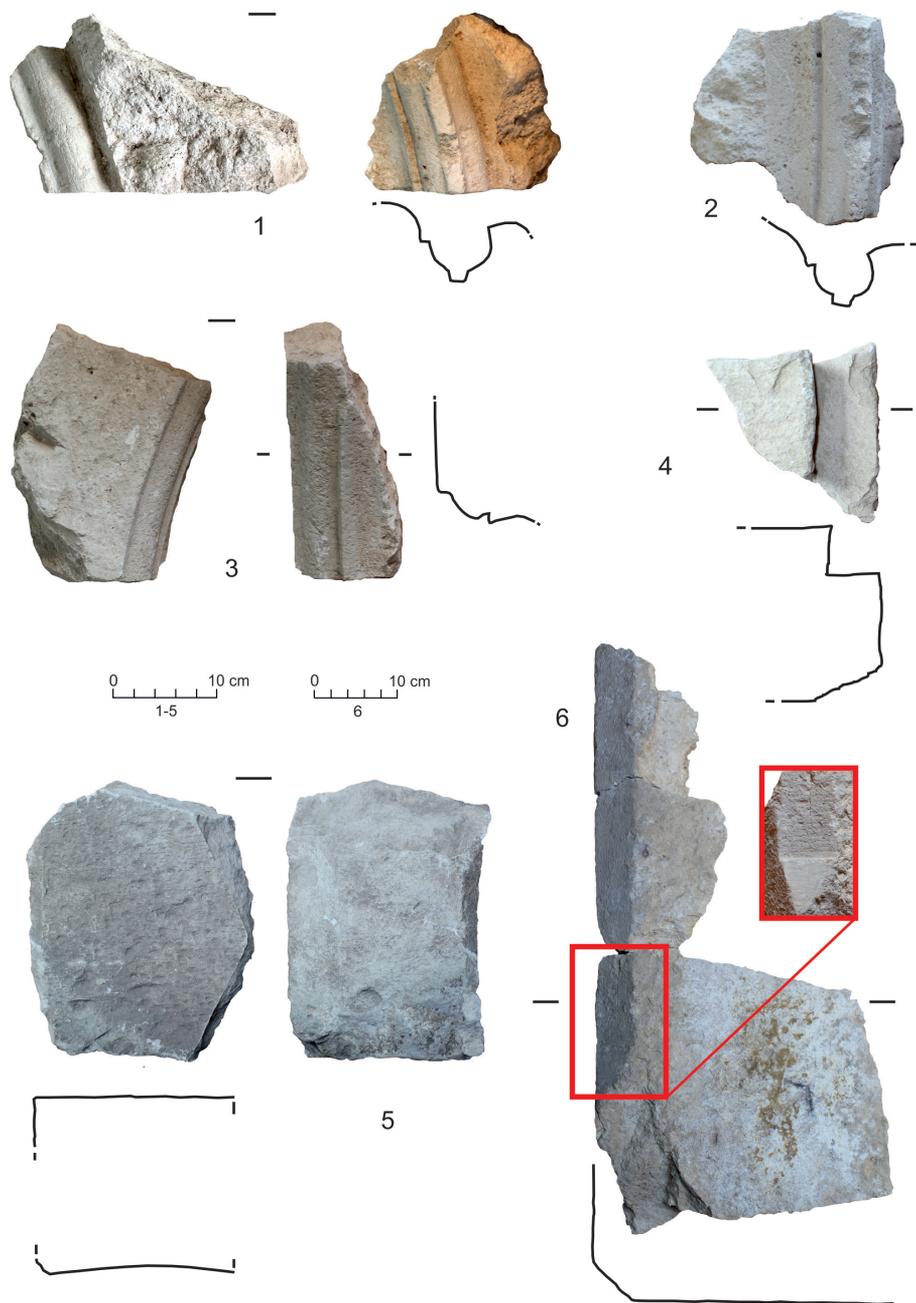
Fig. 13. The architectural details from the trench IX. 1-5 – layer 1b/3; 6 – a detail used as threshold in the building placed west from the tower. Photo and drawings by M. Wojenka

The aforementioned part of stratigraphic sequence, right next to the tower's gable, unexpectedly revealed 18 fragments of limestone architectural details (Fig. 13:1-5). Apart from possible elements of a door framing (?) (Fig. 13:4-5) this assemblage provided a series of stylistically homogenous window or portal framings, with characteristic pear-shaped mouldings and hollow-chamfered profiles (Fig. 13:1-3). There is a high degree of confidence that these elements were originally placed in the tower, and, if so, they determined rich and representative design of the whole structure.

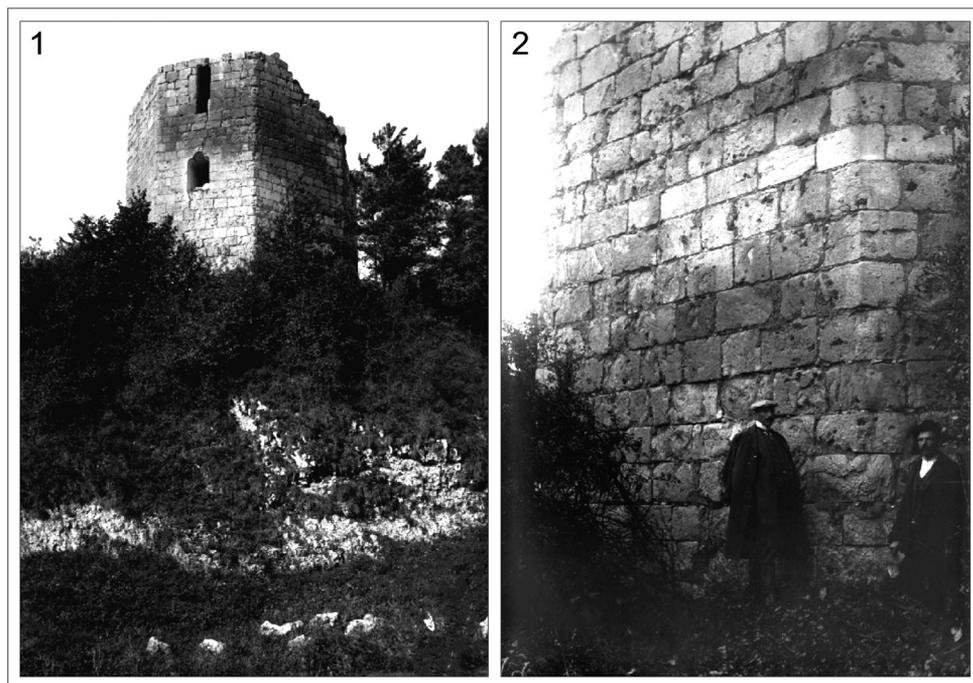
Fig. 15. The octagonal tower before restoration works carried out in 1912-1914.
