# EXPERIMENTAL TESTS OF STEEL UNSTIFFENED DOUBLE SIDE JOINTS WITH FLUSH AND EXTENDED END PLATE

KOZŁOWSKI ALEKSANDER<sup>1</sup>, KUKLA DAMIAN<sup>2</sup>

Experimental tests of steel unstiffened double side bolted end-plate joints have been presented. The main aim of the conducted tests was to check the behavior of joints in an accidental situation and possibility of creating secondary mechanism, i.e. catenary action in the scenario of column loss. Two types of end plate joints were tested: flush end-plate (FP) and extended end-plate (EP) with different thickness and different number of bolt rows in each. The tests were carried out on an isolated cross beam-column-beam type system until joint failure. During tests the available moment resistance and rotation capacity of bending joints and also values of tension forces in the beam were determined. The joints with extended end-plate have demonstrated higher bending and rotational capacity than flush end-plate. Significant deformation of column flanges, web and end plate were observed. The fracture of bolts was the failure mode of joints. Obtained results of axial force values in beam exceeded standard requirement what confirmed that

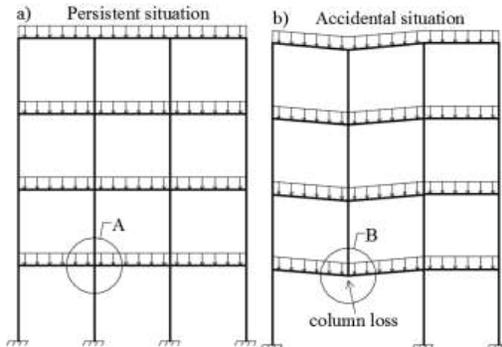
Fig. 1. Design situations of frame structures: a) persistent, b) accidental

Two basic design situations: persistent and accidental should be considered during designing of frame structure. In a persistent situation (Fig. 1a) the frame loading is transferred through the entire system of appropriately connected columns and beam. In accidental situations (Fig. 1b), the column removal scenario may take place as a result of an explosion in the building, fire or impact of the vehicle. During a sudden change in the design situation from persistent to accidental, there is a significant change in the internal forces distribution in the system. This transformation is particularly noticeable in the area of direct column removal.

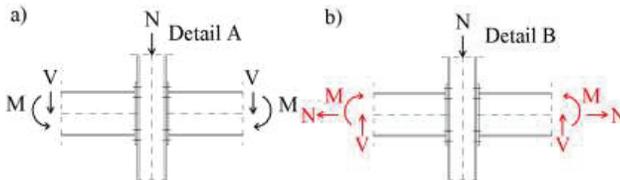
Fig. 2. Configuration of force in connection: a) at persistent situation, b) at accidental situation of column loss

Distribution of forces in the internal connection (Fig. 2) is as follows: in persistent situation (Fig. 2a), the column is mainly subjected to the axial compression force, beams and joints are subjected to bending moment and shear forces. In accidental situation (Fig. 2b), the distribution of these forces changed significantly. The column in an accidental situation ceases to be support for the beam. In this case, the beams are forced to take over these additional vertical forces.

The values, the sign of the bending moment and the shear force in the joint changed. Additional horizontal force in the beam axis also appeared. In accidental situation, the load value may significantly exceed the design elastic bearing capacity of the joint. This can lead to major deformations of connections or/and even to joint damage.

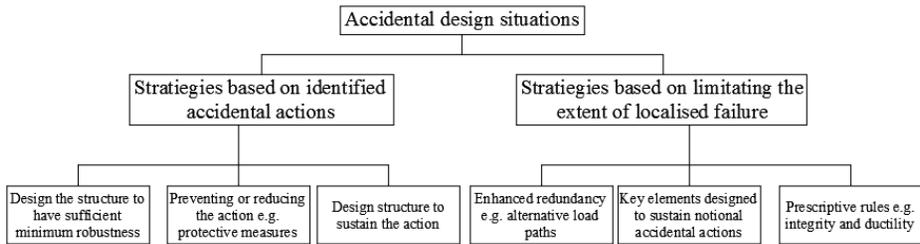
Fig.3.Strategies for accidental design situations [12]

The standard [12] considers two design strategies in accidental design situations presented in Fig. 3.

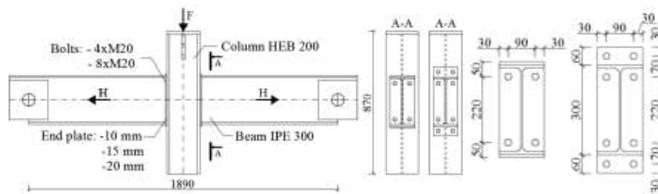
Fig. 4. Specimen scheme and details of connections (dimensions are in mm)

The tested specimen (Fig. 4) is an isolated part of a frame structure in a cross beam-column-beam arrangement. The beams are designed of IPE 300 profile with a total length of 965 mm, a HEB 200 column with a total length of 870 mm. The beams elements were made using remaining parts of beams used in the tests [24]. The length of the beam corresponded to the place of zeroing of bending moments in a frame with a length of 6.0 m spans in a combination of gravitational loads. The total length in the support axes is 1890 mm. The connection were designed as end-plate joints with flush or extended end plate. The end plate was designed with three variants of thickness: 10, 15 and 20 mm for both types of plate. The connection was made by M20 bolts 10.9 HV with two bolts in a row.

A different number of bolt rows were also used (Fig. 4): two rows of bolts for a flush end-plate, four rows of bolts for the extended end-plate joints. At the end of the beams there are additionally two-sided plates strengthening the beam web with dimensions 240x240 mm and a thickness of 20 mm. The purpose of these plate was to avoid deformation of the web under the influence of high vertical and horizontal forces, which could lead to the ovalization of the hole. In order to connect the specimen to the test stand, round holes 80 mm in diameter were designed at the ends of the beams. In the upper part of the column, a 200x200 mm rectangular plate 20 mm thick was designed to distribute the linear load from the oil jack to the entire cross-sectional area of the column. Under the plate in the axis of the column, 20 mm thick stiffener was designed to strengthen the web at the point of application of the load. Table 2 presents the geometrical parameters of the specimen tested.

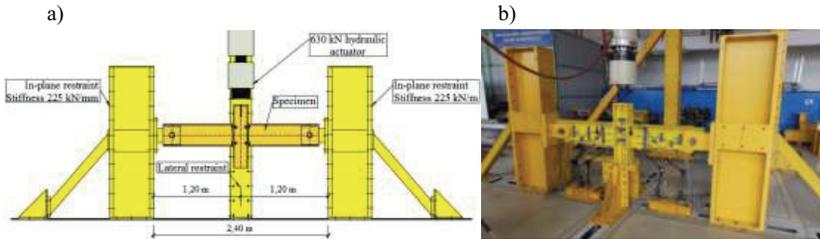
Fig. 5. Test setup: a) scheme, b) view

Figure 5 shows the view of the test setup. The test stand consisted of two columns bolted to the laboratory floor with the additional use of diagonal braces on the outside. Connection of the stand column with a beam specimen was designed as pinned with 78 mm diameter of pin, with full rotation capability in the specimen plane. The lower part of the column specimen was supported laterally to protect the column of inclination from the plane of the specimen. The horizontal stiffness in the plain of tested specimen of the test stand shown in Fig. 5 obtained from the tests was equal to 225 kN/mm.

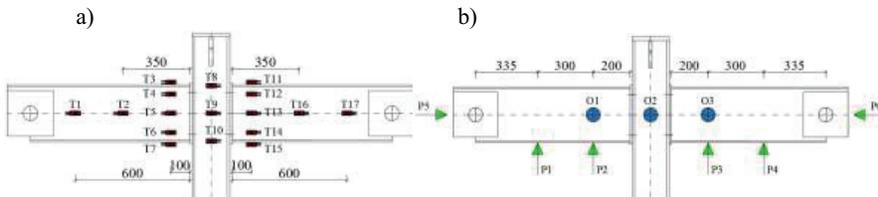
Fig. 6. Layout: a) strain gauges, b) displacement transducers and inclinometers

Load was applied to the upper surface of column by the INSTRON 630 kN hydraulic jack through a round roller in the column axis. A teflon foil spacer was additionally applied to the top surface of the end plate of the column. Two steps of each specimen loading were executed: the initial one consisting in a small load on the specimen in order to check the operation of the instrumentation and the proper fitting of the connection parts, the second step is the basic loading. The basic loading was divided into two stages: the first used a constant displacement increase of 0.5 mm per minute during 60 minutes, then a displacement of 2.0 mm per minute was established till the end of the test. Seventeen strain gauges with 120 Ω resistance with temperature compensation were instrumented in order to measure strains at selected locations on the surface of the specimen. Seven strain gauges were fixed on each side of the beams, three of them are located in the main axis of the beam, the other four in the vicinity of the joint at the height of the flange. Three strain gauges were fixed to the column web in the main axis of the column at the height of the flange and beam axes. The test also involved six displacement transducers LVDT in two arrangement. Four transducers were used to measure deflection at selected places in the specimen in the vertical direction. Two transducers were used to measure horizontal displacements of supports during the test. Moreover, two inclinometers to measure directly the rotation angle of beams and one to the column were applied. The layout of arrangement of stain gauges, displacement transducers and inclinometers is presented in Fig. 6.

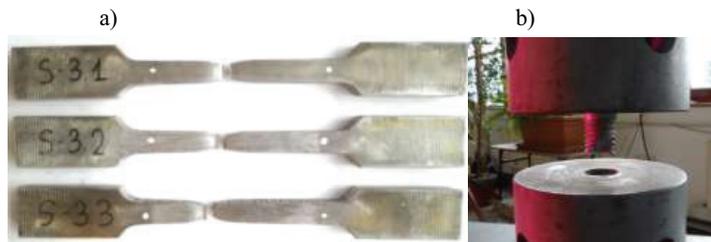
Fig. 7. View: a) material coupon after test, b) bolt after test

In order to evaluate the material parameters of each of the steel used to make the specimens, three material coupon were cut out (Fig. 7).

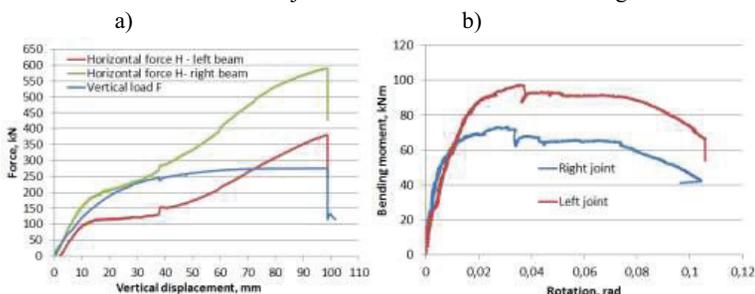
Fig. 8.P-1 specimen: a) vertical load and horizontal force vs. vertical displacement, b) bending moment vs. joint rotation

The force-deflection relationship of the specimen P-1 is shown in Figure 8a. The vertical F load (Fig. 4) is the loading applied to the top surface of the column by a hydraulic jack and measured during tests in the form of a digital reading. In the initial phase of the study, a linear increase of vertical F load to a value of approximately 150 kN was observed. After exceeding this value, the load increment began to decrease, where in the final phase the vertical displacements increased

significantly without any visible change in loading. The graph (Fig.8a) also shows the development of horizontal axial H force in beams which have been obtained on the basis of measurements of the strain gauges. For the left beam, the value of H force has been determined from the strain reading of the T5 strain gauge, for the right beam with the T13 strain gauge. From the beginning of the loading, significant increases in the horizontal H force were observed. Up to value of vertical displacement of 10 mm, the increase in H force for left and right beam was almost the same. After exceeding 10 mm of deflection in the beams a difference in the value of H force started to arise, nevertheless the axial force in both beams shows a continuous increase from the beginning to the end of the test. Catenary action in the beams was developed. The basic characteristic of connection behavior, namely the M bending moment -  $\phi$  rotation diagram was shown Fig. 8b. In the initial phase of the loading, a constant linear increase in the bending capacity of the joint was observed, which is identical with the constant initial stiffness of the joint. After obtaining the bending moment of 67 kNm by the right connection and bending moment of 85 kNm by the left connection the bending moment in the connections began to decrease. In the final phase of the test, there was a significant increase in the rotation of the joint with a decrease in the bending moment of the joints.

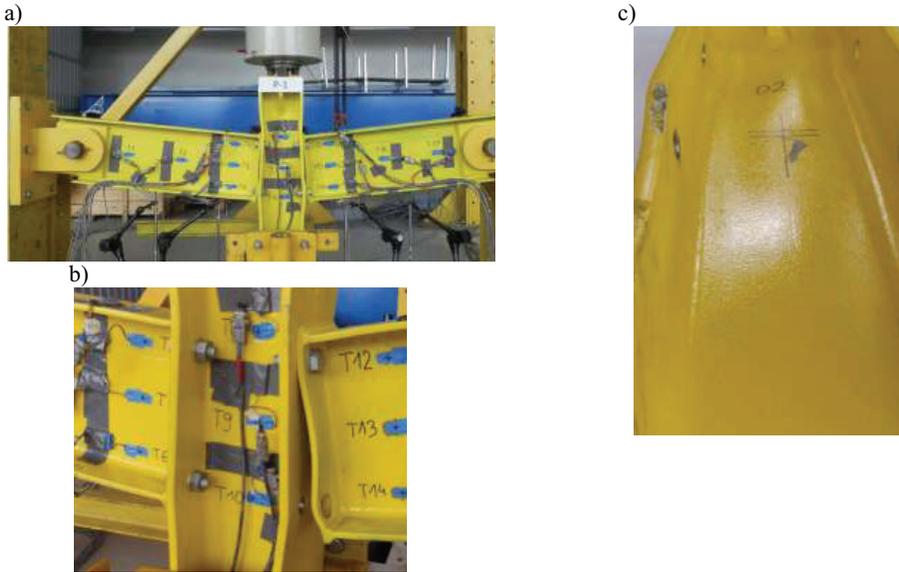
Fig. 9. P-1 specimen: a) view before failure, b) failure mode of specimen, c) column view after test

During the test, noticeable deformations of part of the joint were observed. The end plates near the bottom row of bolts, i.e. in the tensile zone have been the first elements that were deformed. With the increase of the loading, the deformation of the end plate increased. There were also deformations of the flanges and column web at the height of the beam flange (Fig.9a). Further increase in loading caused the development of further deformations. The specimen was failed by violent bolts' fracture in the bottom row (Fig. 9b). After the test, one could notice a clear buckling of the column's web from its surface. This phenomenon is caused by the action of compressive forces in connection at the height of the upper beam flange (Fig.9c). In the tensile zone, bends of the column flange was visible due to the tensile forces transmitted by the bolts of the lower row of the connection. During the test, it was possible to notice the opening of the contact at the height of the beam's axis.

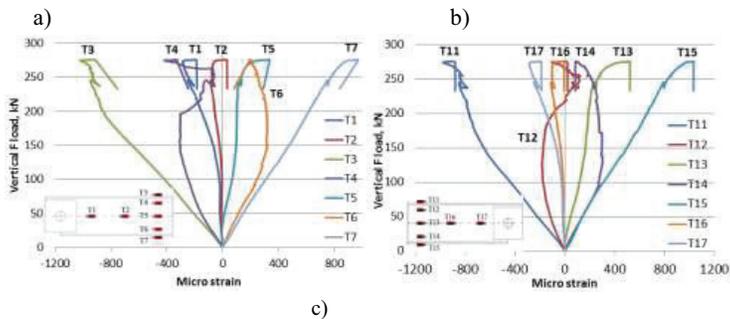
Fig. 10. Strain distribution of P-1 specimen: a) left beam, b) right beam, c) column

The distribution of strains in the P-1 specimen were shown in Fig. 10a-c. The strain gauges located on the beam flanges (T3, T7 and T11, T15) showed a linear increase in strain during the whole test. Strain gauges set in the horizontal axis of the beam (T1, T2 and T5 as well as T13, T16 and T17) showed different values. The T1, T2 and T16 and T17 strain gauges have been compressed, while the T5 and T13 strain gauges near the joint were tensioned.

The column strain (Fig. 10c) show different values. The strain gauge set at the height of the upper beam flange T8 to the value of 220 kN showed a linear increase. After exceeding this value, there was a significant increase until it was broken. The middle of the T9 column strain gauges had a negligible deformation value up to the force of 230 kN. Then it was compressed, while in the final phase the mark changed to tension. The T10 strain gauge till a force of 250 kN showed a constant increase in strain, where in the final phase there was a significant increase in value. All three strain gauges represent the respective web zones in the connection: T8 is the compression zone, T9 is the neutral zone and T10 is the tensile zone.

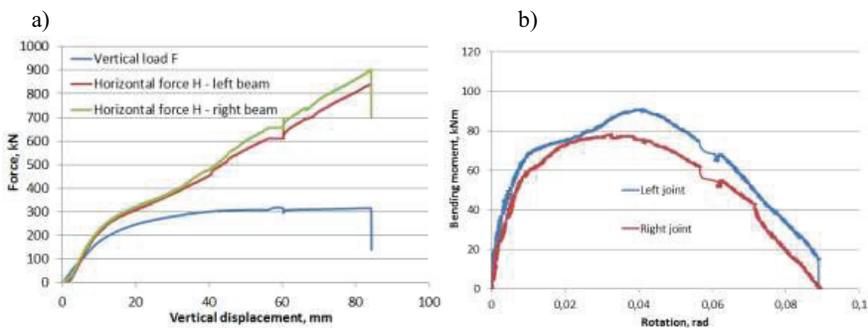
Fig. 11. P-2 specimen: a) vertical load and horizontal force vs. vertical displacement, b) bending moment vs. joint rotation

From the beginning of the P-2 specimen test, there was a constant vertical load increase to the value of about 200 kN (Fig. 11a). A further increase in vertical displacement followed a decrease in the increment of vertical force. At a deflection of 40 mm, a further increase of F force was lost until the moment of destruction. The development of the horizontal axial force in the beams was almost constant during the study. The axial H force was the same in both beams. Connection behavior is shown in Fig. 11b. In the initial phase, the increase in the load capacity of the joint was linear. After exceeding 60 kNm, the rotation of the connection started to increase. After exceeding the rotation of connections 0,04 radian, the moment in the connections started to drop until the end of the test.

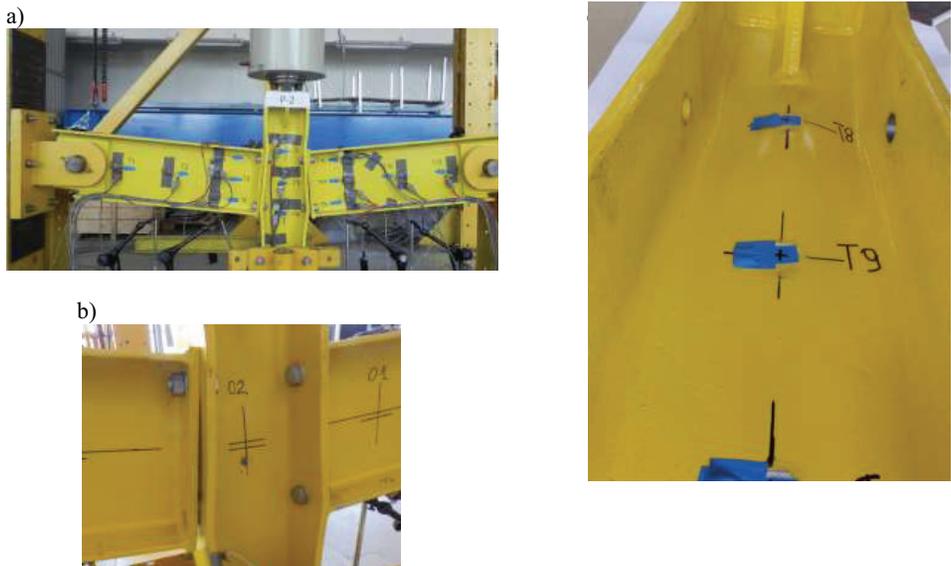
Fig.12. P-2 specimen: a) view before failure, b) failure mode of specimen, c) column view after test  
 Strains of the P-2 specimen are shown in Fig. 13. As in the P-1 specimen, the largest strains occurred in the beam flanges (T3, T7 and T11 and T15) (Fig. 13a and b). A significant increase in strain in the upper part of the beam web T4 and T12 is visible after reaching F force of 200 kN. This indicates the appearance of considerable compressive forces in this zone of the beam.

In the initial phase of the test, no signs of deformation of the specimen were noticed. After reaching loading around 200 kN, deformation of the column flanges started to appear. The column flanges at the height of the upper bolt rows began to move towards the main axis of the column. The column flanges at the level of the lower row of bolts moved in the opposite direction. The increase in loading caused further development of deformation of the column section (Fig. 12a). The end plate (Fig. 12b), despite the same thickness as the column flanges, has been not deformed. After the test (fig. 12c), buckling of the column web at the level of the upper row of the bolts was also noticed. Failure mode of the specimen was the rupture of the bolts in the bottom row.

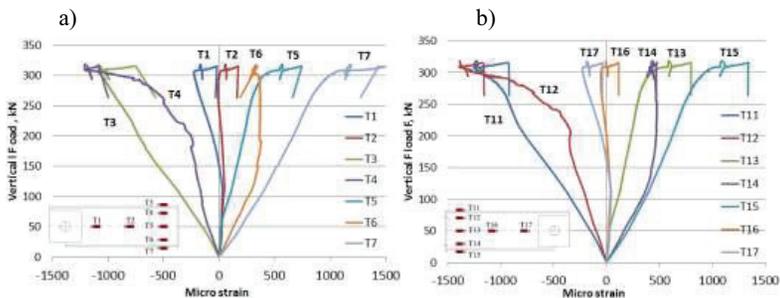
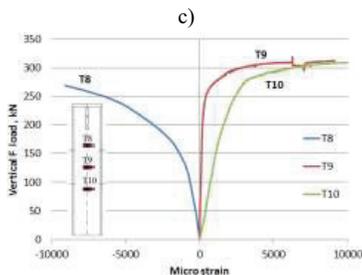
Fig.13. Strain distribution of P-2 specimen: a) left beam, b) right beam, c) column

The web column behavior during the test can be divided into several phases. In the initial phase of the test, three zones can be clearly seen: the compression zone represented by the T8 strain gauge, the neutral zone represented by T9 and the tensile zone by T10. After exceeding the force of 250 kN, there was a change from three to two zones: compression represented by T8 strain gauges and tensioned by T9 and T10.

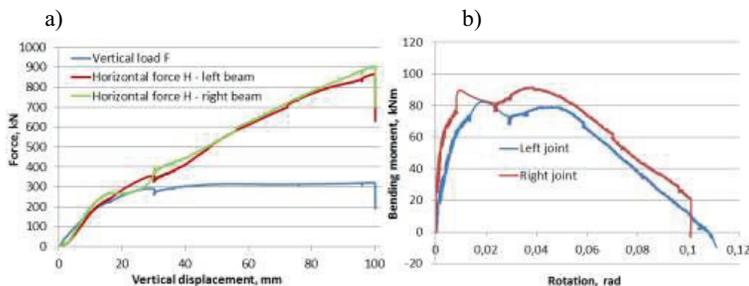
Fig.14. P-3 specimen: a) vertical load and horizontal force vs. vertical displacement, b) bending moment vs. joint rotation

From the beginning of the test (Fig. 14a) to about 200 kN F vertical loading, the specimen showed a linear loading increase. After exceeding 200 kN there was a decrease in the growth of the vertical F load, where it was almost invisible after reaching the F value of 300 kN. In the final phase of the test, only a large increase in displacements was observed. The jump at the curve of vertical load at the value of 300 kN was caused by operator error. The development of horizontal H axial force in beams is shown in Figure 14a. From the beginning of the study, the tensile H force in both beams was developed. During the study connection behavior (Figure 14b) was variable. In the initial phase of the loading a linear increase of bending moment was observed. Then, after exceeding 60 kNm, there was a decrease in stiffness caused by the plasticization of the connection elements. After exceeding the rotation of connections equal to 0.05 radians there was a significant linear decrease in of the moment in the connections.

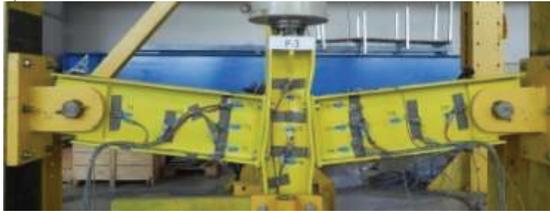
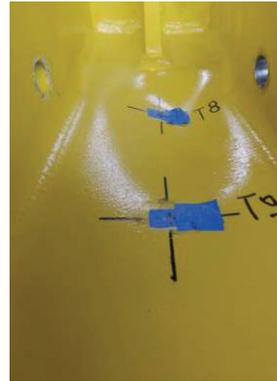
Fig.15. P-3 specimen: a) view before failure, b) failure mode of specimen, c) column view after test

From the beginning of the test, no visible deformation were observed till achieving a loading equal to 185 kN. After exceeding the load of 185 kN, the opening of the contact was observed at the bottom of the connection, which increased along with the loading increase. During the test, the largest deformation (Fig. 15a) was observed in column flanges in the zone of the lower row of bolts as well as the column and web flanges at the height of the upper beam flange. After the test, a significant deformation (buckling) of the column web was observed (Fig. 15c). This phenomenon arose as a result of the action of large compressive forces near the upper row of bolts. The specimen was damaged by fracture of the bolts in the bottom row. The bolts' fracture in the bottom row caused the damage of the joints.

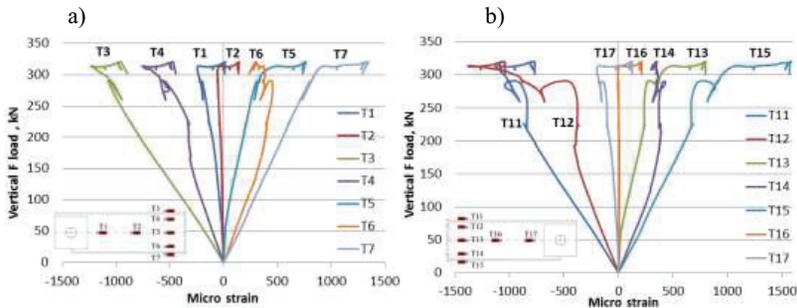
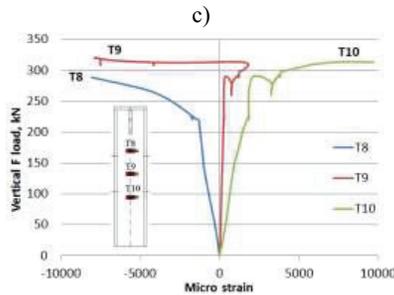
Fig.16. Strain distribution of P-3 specimen: a) left beam, b) right beam, c) column

The strains distribution of the P-3 specimen beams are shown in Fig. 16a and b. Practically all of the measurement points showed a linear increase in strain up to 310 kN loading. After exceeding the loading of 310 kN, the tension strain increased and the strains in compression zones decreased. Interestingly, each of the strain gauges set in the main axis of the beam (T1, T2 and T5 as well as T13, T16 and T17) showed different values.

In the initial phase of the loading the strain distribution in the column web (Fig.16c) can be divided into three zones. The compression zone is represented by a T8 strain gauge, tensioned over T10 and neutral by T9. However, after exceeding the 310 kN loading, there was a reduction from three to two zones as it was in the P-2 specimen.

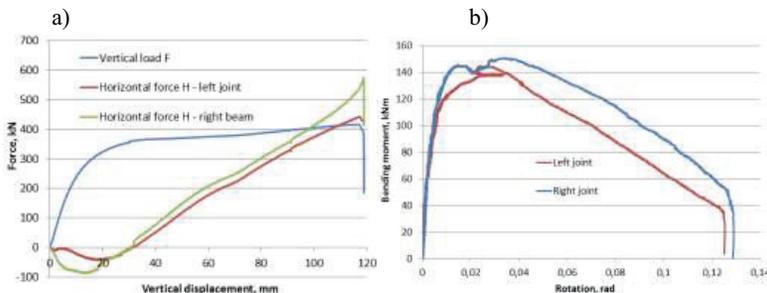
Fig.17. P-4 specimen: a) vertical load and horizontal force vs. vertical displacement, b) bending moment vs. joint rotation

From the beginning of the test (Fig. 17a) to F load of about 200 kN a constant linear increase of loading was observed. After exceeding 200 kN, non-linearity began and specimen deformations started to be visible. After reaching approximately 30 mm of specimen deflection, the load F increase was small. The horizontal axial force H in the beams showed different values during the test. Up to 20 mm vertical displacement of the specimen, the forces were compression. Then, the tensile force developed with a linear increase until the end of the test. The behavior of connections were shown at the M-Φ curve (Fig. 17b). The initial phase shows a linear increase of bending moment in the joint. After reaching 120 kNm, there was an increase in rotation with a smaller increase in bending moment. After obtaining the rotation of connections, 0.03 radians in joints there was a linear decrease of the bending moment until the end of the test.

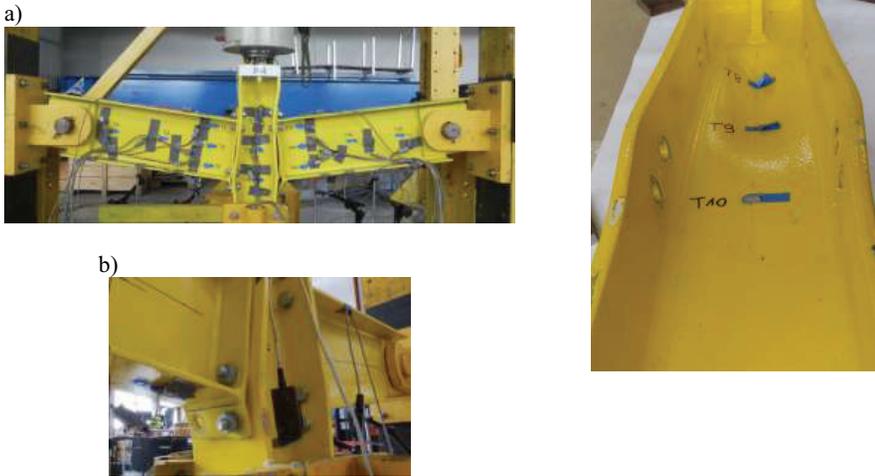
Fig.18. P-4 specimen: a) view after failure, b) failure mode of specimen, c) column view after test

In the initial phase of the test, up to approximately 200 kN no visible changes in the specimen geometry were observed. After exceeding 200 kN, the deformations of the column flanges in the tensile zone started to appear. At about 330 kN, deformations of the column flanges in the compression zone of the joint started to develop (Figure 18a). After exceeding 350 kN, fracture of the weld (Fig.18b) connecting the end plate in the bottom flange of the beam appeared. The P-4 specimen was failure because of the fracture of the two bolts in low row. The web of column (Fig. 18c) was deformed significantly (buckled at the height of the upper row of bolts).

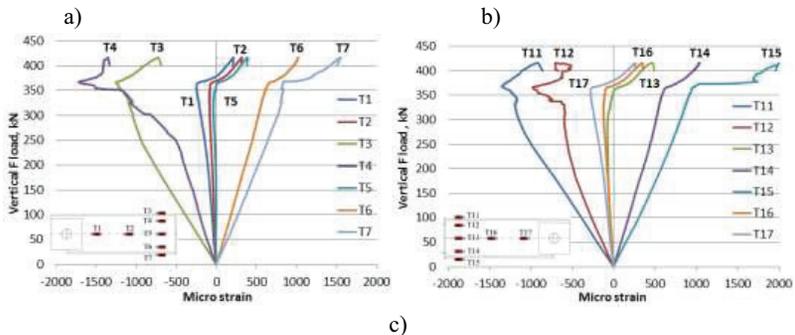
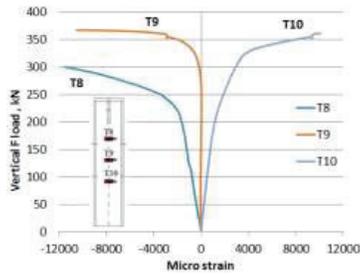
Fig.19. Strain distribution of P-4 specimen: a) left beam, b) right beam, c) column

The strains of the P-4 specimen in selected locations were shown in Fig. 19. In the beams (Fig.18a, 19b), a linear increase in strain occurred till a load of 350 kN. Only differences can be seen in the T4 strain gauge. Then, the further increase in the loading caused a decrease in deformation in the compression zone and its increase in the tensile zone. The strain values in the strain gauges set in the beam axis were similar.

The strains distribution in the column is shown in Fig. 19c. Up to 200 kN, one can notice a linear increase in the strains T8 and T10 followed by non-linear increase. The T9 strain gauge remained without deformation up to the loading of 300 kN, afterthat there was an increase in compression strains observed.

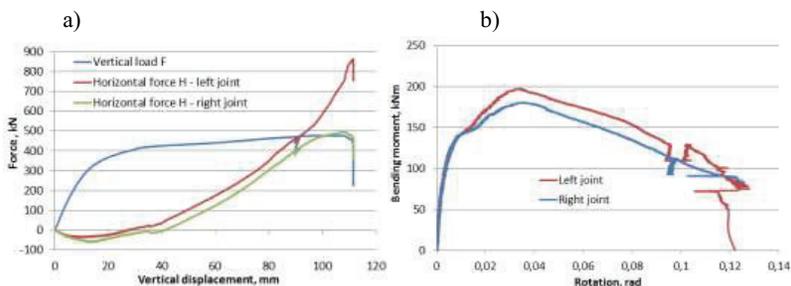
Fig.20. P-5 specimen: a) vertical load and horizontal force vs. vertical displacement, b) bending moment vs. joint rotation

From the beginning of the test there was a constant increase in the F loading of the specimen up to about 250 kN (Fig. 20a). After exceeding the value of 250 kN, the specimen deflection increased. The specimen showed slowly increase in load-bearing capacity until the end of the test. The development of the horizontal axial H force in the beams varied during the test. From the beginning to 30 mm of deflection, horizontal H force caused compression. After exceeding 30 mm of deflection, the catenary action developed until the specimen was destroyed. The connection behavior (Fig. 20b) can be divided into two phases: elastic and plastic. In the elastic phase, there was a constant increase of moment from the beginning of the test to a bending moment equal to 130 kNm. Then further increase of the load caused an increase in the rotation of the connection. After obtaining a rotation of 0.03 radians, the bending moment in connections started to decrease linearly.

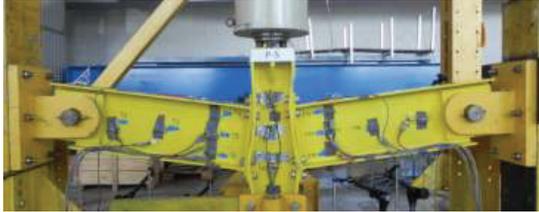
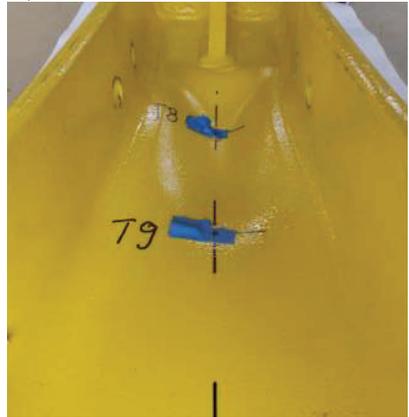
Fig.21. P-5 specimen: a) view after failure, b) failure mode of specimen, c) column view after test

Until a load of 250 kN was achieved, no visible changes in the specimen were observed. After exceeding this value, the column flanges were compressed at the level of the upper beam flange.

Then, at 420 kN, there was a gap between the surface plate and the column flanges at the height of the lower beam (Fig. 21a). Then there was a fracture in the weld (Fig. 21b) connecting the bottom flange of the beam with the end plate. Because of the fracture of the two bolts in low row the P-5 specimen was damaged. After the test, significant deformation of the column web (Fig. 21c) can be noted at the height of the top rows of bolts. This buckling was caused by high compressive forces from the top flange beam.

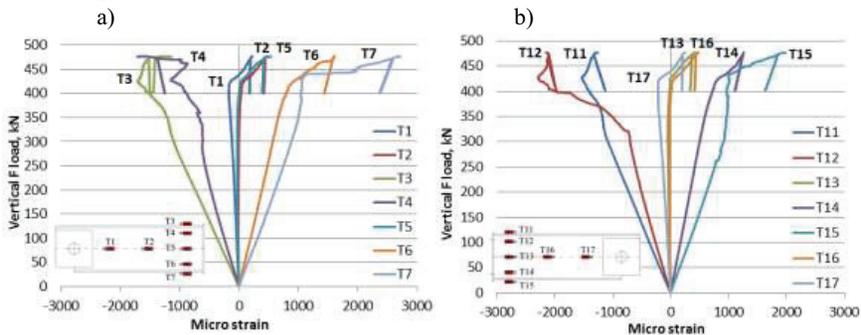
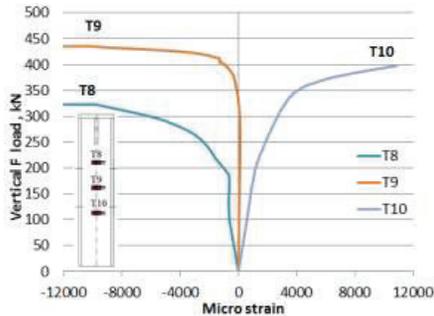
Fig.22. Strain distribution of P-5 specimen: a) left beam, b) right beam, c) column

The linear increase in beam strains in the initial phase of the test is presented in Figs. 22a and 22b. As in the previous results of the P-4 specimen, after linear increments, a significant change in the strains values occurred. The strain gauges in the beam axis up to 420 kN showed negligible values. After exceeding 420 kN, the tensile strain increased.

The development of the column strains in the joint zone is presented in Figure 23c. Strain gauges T8 and T10 show the linear increment of deformations up to 150 kN of the load and then the strain values increased rapidly. Furthermore, the test range in strain gauge was exceeded and they were damaged with a load of 325 kN for T8 and 400 kN for T10. Up to the force of 350 kN, the T9 strain gauge remained in the range of very small strains, where after reaching 350 kN there was an increase in compressive strain.

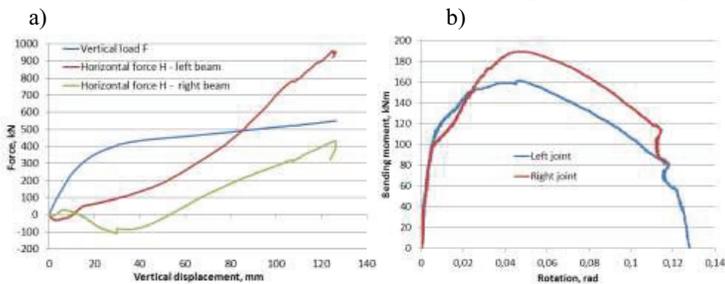
Fig.23. P-6 specimen: a) vertical load and horizontal force vs. vertical displacement, b) bending moment vs. joint rotation

The constant increase of load  $F$  from the beginning of the test to about 250 kN can be observed in Fig. 23a. Then there was an increase in the vertical displacement with a smaller increase of loading. The horizontal axial  $H$  force in the beams from the beginning of the test up to 13 mm of deflection was approximately zero. After reaching a deflection of 13 mm, the compressive  $H$  force in the right beam was developed until the 53 mm deflection. After that a linear development of the tensile action took place in the right beam. On the other hand, the left beam has shown the development of a tensile action. The behavior of the P-6 specimen connections is shown at the Fig. 23b. It can be noticed that the connection exhibited linear behavior up to approximately 100 kNm. After exceeding this value, the rotation increase non-linearly. After exceeding the rotation of connections equal to 0.05 radians there was a continuous decrease of the bending moment in the joints.

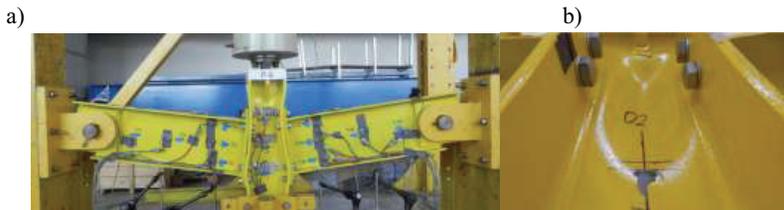
Fig.24. P-5 specimen: a) view before ending test, b) column view after test

In the initial phase of loading up to 220 kN no changes were observed in the specimen. Then, small deformation of the column flanges in the connection zone began to appear at the height of the lower beam flange. At the force of 425 kN, deformations of the web and the column flanges in the level of the upper rows of bolts began to emerge. Before the end of the test (Fig. 24a), it was possible to notice the torsion of a part of the column above the level of the upper beam flange. This was caused by large deformations of the column's web. Interestingly, the specimen was not damaged because the maximum load generated by the actuator of 550 kN was reached and the actuator started to fall into dynamic resonance. The buckling of the column's web from the main plane of the specimen can be observed in Fig. 24b.

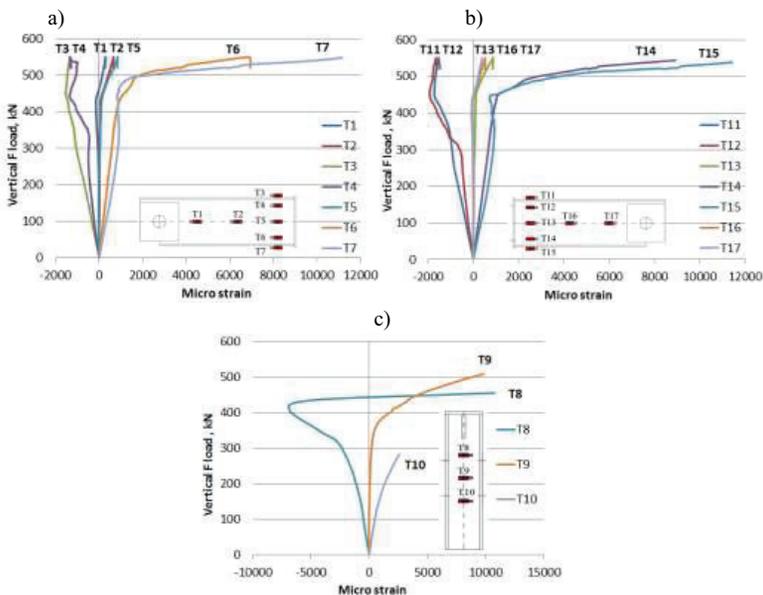
Fig.25. Strain distribution of P-6 specimen: a) left beam, b) right beam, c) column

The strains pattern of the P-6 specimen (Fig. 25a, b) can be divided into two zones. The first zone is the linear increment of deformations from the beginning of the tests to the value of 440 kN. The second zone is characterized by a distinct increase in strains in the lower flange beam for T6, T7 and T14 and T15 strain gauges.

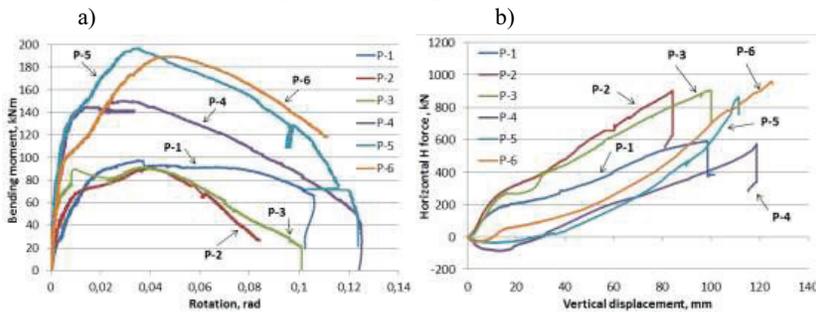
Fig. 26. Comparison: a) bending moment vs. rotation, b) horizontal force vs. vertical displacement

The connection tested as P-5 specimen has the highest bending capacity as shown in Fig. 26a. A clear division into two groups can be noticed: joints with flush and extended end-plate. Specimens with four rows of bolts gained greater load capacity than with two rows. Comparing the specimen P-1 and P-4, the bending capacity of the P-4 specimen is almost twice as high. The larger number of bolts and the thicker the plate, the higher the bending moment resistance was reached.

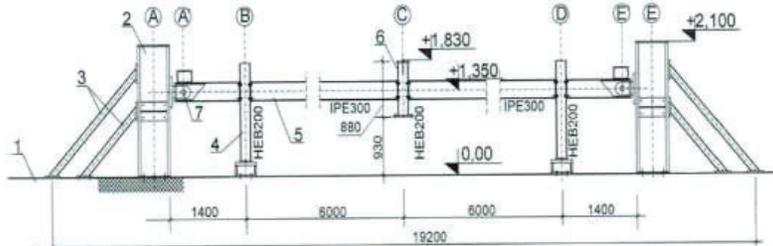
Fig. 27. Test setup: 1 – laboratory floor, 2- resistance stand element, 3- stand stability elements, 4- frame column, 5- frame beam, 6-middle frame column, 7- pin stand-to-side stand joint by [24]

The tests of the steel frame subsystem [15,19,24] were made on the specimen shown in Figure 27.

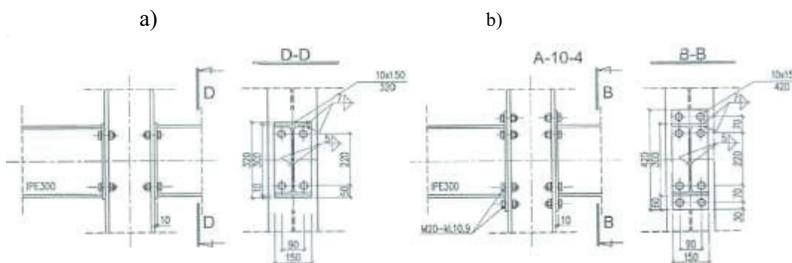
Fig. 28. Connection details: a) flush end-plate, b) extended end-plate by [24]

Flush end-plate joints (fig. 28a) and extended end-plate (fig. 28b) with end plate 10 mm were used. Two or four rows of M20 bolts 10.9 were used.

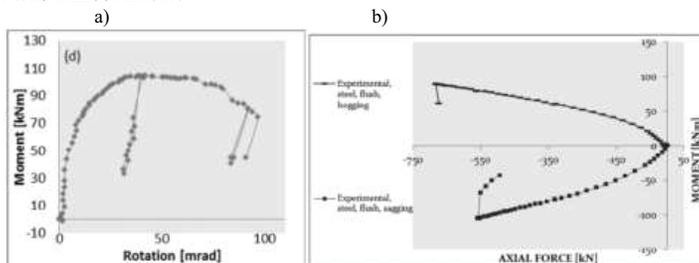
Fig. 29. Specimen with flush end connection: a) local characteristics moment-rotation of inner column joint under sagging bending, b) moment-force relationship of the flexural-membrane state at the inner and outer flush end plate joints (sign minus of the axial force refers to tension) by [24]

The results of testing the specimen with flush end-plates were shown in Fig. 29. The bending moment growth was constant to the loading creating a bending moment in the joint equal to 70 kNm. After exceeding 70 kNm, there was a non-linear increase, while after 0,050 rad of rotation there was a decrease in bending moment until destruction. The development of axial force in beams was shown in Figure 29b. Along with the increase of the bending moment in the joint, the axial force growth was almost linear.

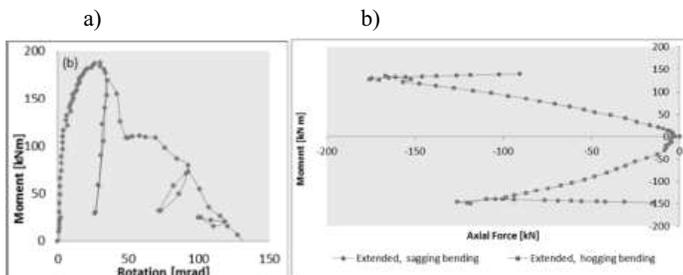
Fig. 30. Specimen with extended end connection: a) local characteristics moment-rotation of inner column joint under sagging bending, b) moment-force relationship of the flexural-membrane state at the inner and outer flush end plate joints (sign minus of the axial force refers to tension) by [24]

The results of the test of the sub-system with extended end-plate joints are shown in Fig. 30. The increase in the bending moment was constant till the value of the moment of 120 kNm in the joint (Fig. 30a). After exceeding 120 kNm, the connection behavior was non-linear. From the beginning of the test (Fig. 25b) a linear increase in value of axial force in the beams was shown. The failure mode of both subsystems was the tearing of the end plate in the lower zone of the flange beam.

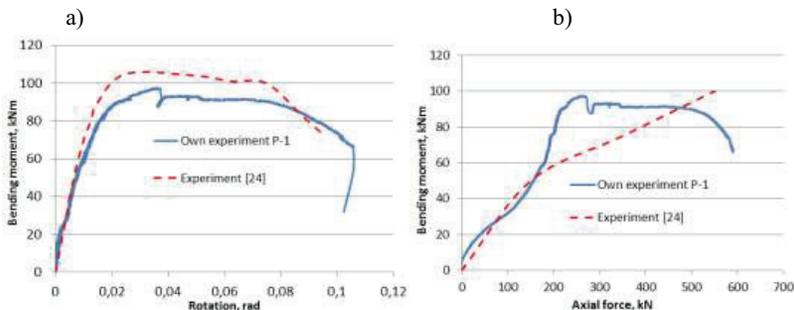
Fig. 31. Comparison results of flush end-plate connection: a) moment – rotation, b) moment—axial force in beam

The comparison of the own test results of isolated joints with results of tests conducted on the subframe [24] was presented in Fig. 31 and 32. The results of the P-1 specimen (flush plate 10 mm thick) were compared with the results of the subsystem with flush end-plate joints (end plate thickness 10 mm). The first graph (Fig. 31a) shows the moment-rotation characteristics of the inner connection. As can be seen, the behavior of both connections was the same at the initial stage. After exceeding the bending moment of 60 kNm there were slight changes in the behavior of the connections. Both joints obtained a similar angle of rotation of the joint in case of failure. The development of axial force in both tests is shown in Fig. 31b. From the beginning of own experiment of the P-1 specimen, there was a tensile axial force with non-linear behavior. During the whole range of loading in tests presented in studies [24], there was a linear increase of tension force in the joints.

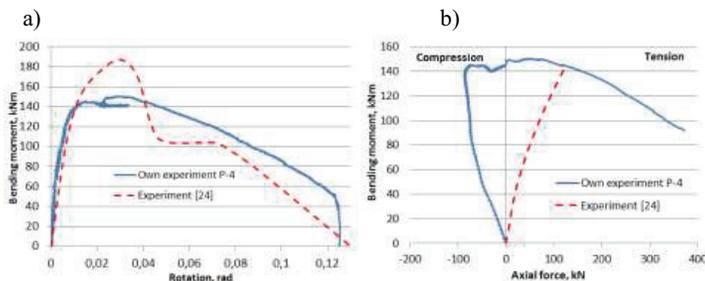
Fig. 32. Comparison results of extended end plate connection: a) moment – rotation, b) moment—axial force

The second comparison, of the P-4 specimen (extended plate 10 mm thick) with a sub-system with extended end-plate joints with a plate of a thickness of 10 mm [24] was presented in Fig. 32. In the range from 0 to 140 kNm of bending moment in the joint, the behavior of both connections was the same. From 150 kNm, the difference in the behavior of connections began to clearly differ. The P-4 specimen (own research) shows further development of the joint rotation with a decrease of the moment in the joint. The connection tested in [24] reached the peak of load capacity at the rotation of 0.03 rad, and then showed a significant decrease of bending moment. The connection of the P-4 specimen was subjected to sudden failure (fracture of bolts) while the connection from the tests [24] of gradual degradation by end-plate tearing. At the initial stage of the test of the P-4 specimen, there was a compressive axial H force up to a value of 140 kNm, followed by an intensive development of the catenary action (Fig. 32b). In test [24] the development of the tensile force took place throughout the loading. Differences in the behavior of joints in own test and test [24] may result from the different stiffness of the horizontal test setup. In own test (Figure 5), horizontal stiffness, in the specimen plane, for a column with one brace was 225 kN/mm. In test [24], however, in the external support of the end columns (Fig. 27), two braces were applied per side, which significantly increased the stiffness of the supports.

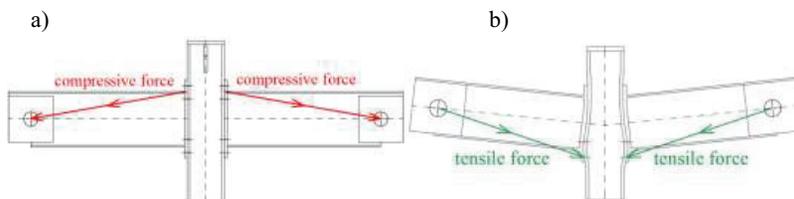
Fig. 33. Horizontal force development phases in the beam axis a) arch action, b) catenary action

- the working phase of end plate joints can be divided into three stages: elastic, plastic and plastic with the development of horizontal forces in beams,
- in the initial phase of the loading, the small horizontal compression force is generated due to the arc action in the beams with extended plate (Fig. 33a). From the beginning of the loading, the connections with flush plate show the ability to create a catenary action (fig. 33b).
- an important aspect of the development of horizontal force in the beam axis is the possibility of deformation of the connection parts,
