DOI: 10.24425/ace.2021.136468

# ADVANTAGES OF USING 3D SCANNING IN THE SURVEY OF ARCHITECTURAL MONUMENTS ON EXAMPLE OF ARCHEOLOGICAL SITES IN EGYPT AND RUSSIA

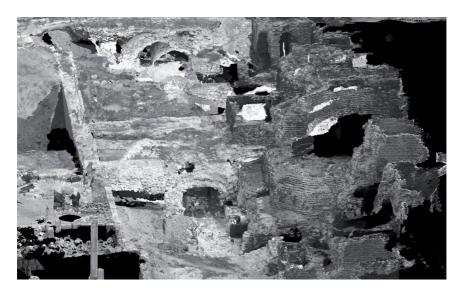
Rys 1. Obraz przekroju wykopu otrzymany za pomocną skaningu laserowego
