Determination of the extent of damage and calculation of the indemnity in case of natural disaster – tornado in South Moravia

Michal Mikulík¹, Tomáš Hanák², Patrik Sokol³,
Miloslav Výskala⁴

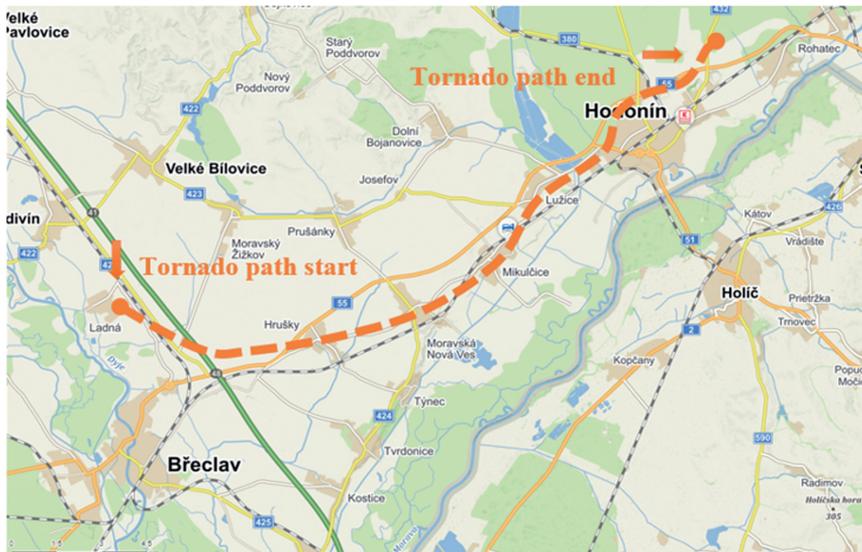
As documented by aerial photography, the damaged area was 26 kilometres long and 500 meters wide (Fig. 1). It started at the eastern outskirts of the town of Břeclav, extending roughly to the village of Ratíškovice. The most affected municipalities were Týnec, Moravská Nová Ves, Mikulčice, Lužice, Hodonín, Hrušky and Břeclav; some damage was caused to practically all buildings and monuments in Valtice, including the castle listed as a UNESCO cultural heritage site [3].

Fig. 1. The approximate path of the tornado, source: annotated base map [4]

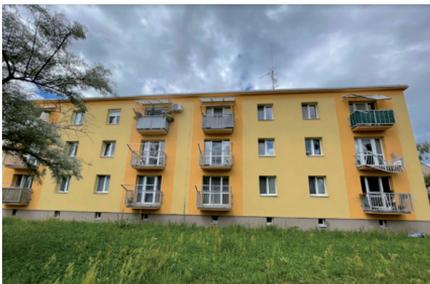
Fig. 2. Building A, source: author

On Building A, we addressed the extent of damage to the external thermal insulation composite system. The on-site investigation and the attached photographic documentation revealed only minor damage (Figure 4). To repair the damage, the construction company proposed to recoat the façade with a fibreglass reinforcement mesh and sealant covering the area of approx. 100 m². Subsequently, it proposed to apply a silicone plaster to the façade.

During the on-site investigation, it was found that the scope of repairs actually needed in square metres did not correspond to the scope according to the price quotation sent by the construction company (Table 1). In fact, only localised patching of areas of up to 1 m² was needed. There was no need to recoat the whole façade to carry out the repair.

Adjusting the budget for the extent of the necessary repairs established according to the findings of the on-site investigation, it was found that adequate repair costs corresponded to only 5% of the total amount according to the construction company's price quotation (Table 2). In this case, therefore, the acceptance of the price offered by the relevant construction company cannot be recommended.

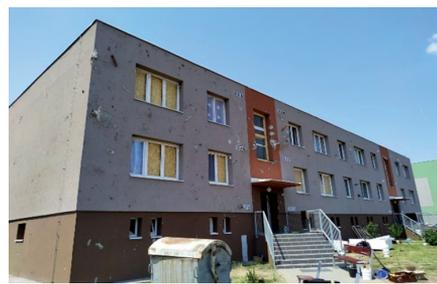
Fig. 3. Building B, source: author

Figure 5 shows building B according to photo documentation and on-site investigation; a much larger extent of damage than on the previous building can be seen. Foreign objects such as pieces of wood and construction waste were lodged in the façade.

The construction company proposed to remove the external thermal insulation composite system from the front side and then reapply it, including the surface treatment, while maintaining the existing parameters. It proposed to recoat the other sides of the façade with a second layer of fibreglass reinforcement fabric including sealant and final surface treatment.

According to the on-site investigation, the indicated extent corresponded to the actual damage on the apartment building (Table 3). Looking at Table 4 we can see comparable repair costs. The construction company's price offer was adequate and in line with the price

In this particular case, the price offered corresponded to the budget and could be accepted.

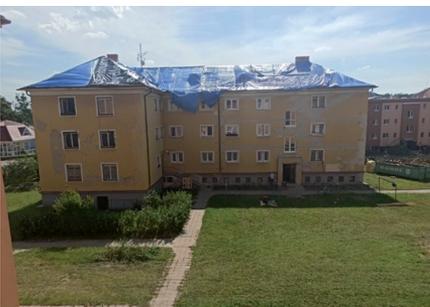
Fig. 4. Building C, source: author

In the case of Building C, we did not assess the façade, but only the damage to the roof structure. The on-site investigation and the attached photographic documentation revealed major damage. The tornado carried away most of the ceramic roofing tiles and part of the lathing. There was also some water damage inside the building.

The construction company priced the removal of the remaining roofing and lathing. It then designed a new roof structure including waterproofing and counter-battens to provide for sufficient air circulation. However, this composition did not correspond to the original structure, which lacked any waterproofing. Roofing system elements were also priced, such as the penetration tiles for the drainage, the penetration for the antenna and the ventilation and roofing tiles.

Table 6 shows the price offer comparison and the correction according to the applicable price system. The construction company significantly underestimated the cost of the entire contract. In fact, it came well below the price according to the actual scope of damage according to the on-site investigation. Another reason for the low price (Table 5) was the supply of construction materials directly from local construction supply companies who tried to provide the materials at the best price, so the construction companies could not make any profit on the construction materials. In this particular case, we did not dispute the claimed price despite the roof structure modifications. It could have been an act of kindness on the part of the construction company towards people harmed by the disaster. The construction company has certainly improved its reputation in the area where it operates.

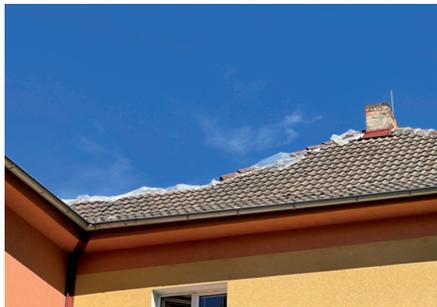
Fig. 5. Building D, source: author

We assessed damage to the roof on building D as well. In this case, the damage to the roof cladding was minimal, mainly the ridge and corner tiles were blown off. The roof covering and roof structure itself was almost undamaged.

In this case, the construction company proposed a complete removal of the roof covering, including the lathing. It proposed a new roofing composition including waterproofing and counter-battens that improved on the original composition.

The price offer (Tables 7 and 8) was underestimated relative to the applicable price system, which was mainly due to the supply of building materials directly from construction

supply contractors, but the scope of work was significantly overestimated. Compared to the previous case, this scope of work would certainly not have fit into the budget price. In this particular case, approval of the price offer could not be recommended. Subsequently, the price offer provided by the construction company was also rejected by the insurance company.
