Research paper

Research on construction monitoring of curvilinear continuous beam bridge jacking and horizontal moving construction

Abstract: This article investigates the issue of beam misalignment in continuous curved beam bridges. Taking the D0–D6 spans of the Gongbin Road elevated bridge as a basis, real-time monitoring of the stress and displacement of the beams is carried out during the jacking and shifting construction process. At the same time, the reaction forces of each support are monitored. The jacking force of the hydraulic jacks is controlled to ensure the stability and safety of the beam during the construction process. Finally, the jacking and shifting monitoring data is organized and compared with theoretical values. It is found that the stress values generated during the jacking phase of the bridge are below the stress control standard. No uplift phenomenon occurs at the supports, and the jacking height is controlled within a reasonable range. The construction process does not cause damage to the beams, and it is safe and reliable. During the shifting construction, the whole bridge was displaced using the jacking method, and the three working conditions were mon

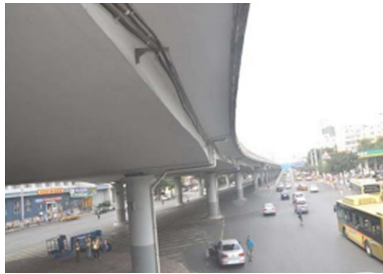
Fig. 1. Actual view of the elevated bridge

while pier D6 is a prestressed concrete inverted T-shaped cap beam pile and column-type bridge pier. The abutment adopts a reinforced concrete rectangular abutment. The actual view of the elevated structure is shown in Fig. 1, while the elevation, plan, and cross-section drawings of the bridge are shown in Fig. 2 to Fig. 4.

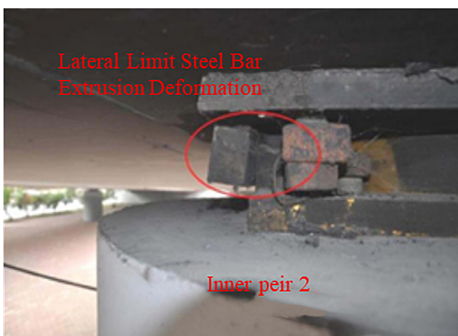
Fig. 6. Lateral limiting steel bar under compression deformation

The lateral creep of the curved beam bridge causes the steel plates on the bearings to move together. Inspection revealed a common occurrence of lateral displacement of the upper steel plate in bidirectional movable supports. In certain cases, there is a significant 40 mm offset between the upper steel shim plate and the steel pot, as shown in Fig. 6 and Fig. 7.

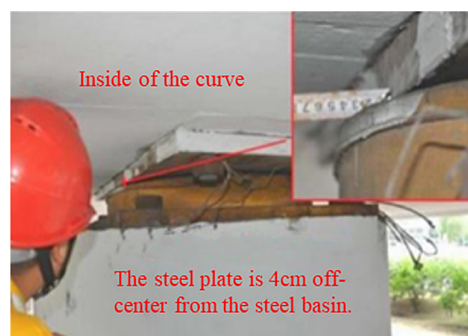
Fig. 7. Slippage of steel plate out of steel pan by 40 mm on bi-directional support

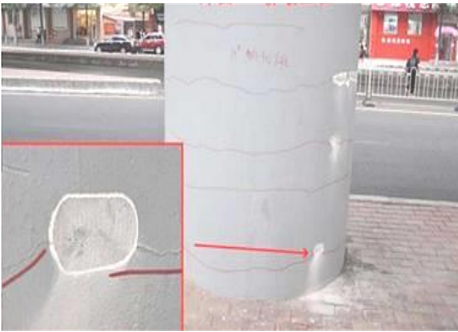
Fig. 8. Semi-circular cracking in the concrete at the base of column

There are multiple semi-circular cracks on the outer side of the lower part of the bridge pier column, as shown in Fig. 8. The maximum width of the cracks is 0.26 mm. The schematic diagram of crack distribution is shown in Fig. 9. The analysis indicates that the presence of fixed bowl-type bearings on top of the pier is the likely cause. The tendency of the main beam to move outward is constrained by the fixed bearings. According to the principle of force interaction, the main beam exerts a radial force on the bearings in the direction of creep. This results in a transition of the pier column from an axially compressed state to an eccentrically compressed state, and even induces tensile stress on the outer side of the concrete.

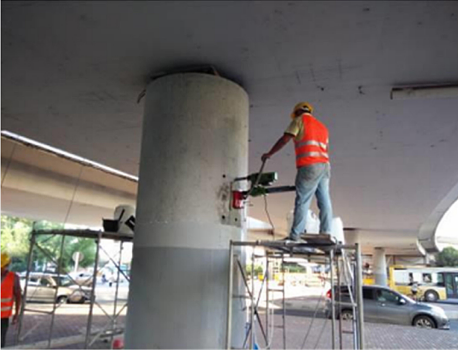
Fig. 10. Pier column drilling

Transport the prefabricated steel clamps to the side of the pier, then embed the reinforcement in the pier body and establish alignment and hole layout for the pier. The hole diameter is 300 mm with a depth of 330 mm. Before drilling, a rebar detector should be used to determine the position of the main reinforcement for adjusting the hole position as required by the drawings. Install the steel clamps and tighten the side connecting bolts before embedding the reinforcement to ensure a tight fit between the steel clamps and the pier. Before embedding the reinforcement, inspect the installation of the steel clamps and check if the welding work has been completed. The on-site construction is shown in Fig. 10 and Fig. 11.

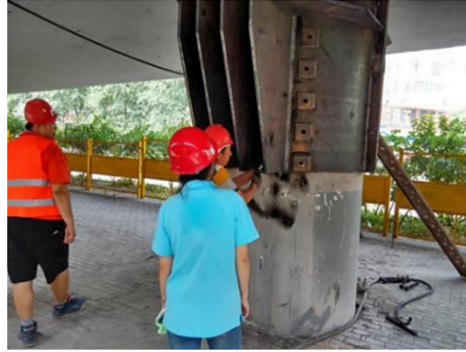
Fig. 11. Reinforcement with hoop bars

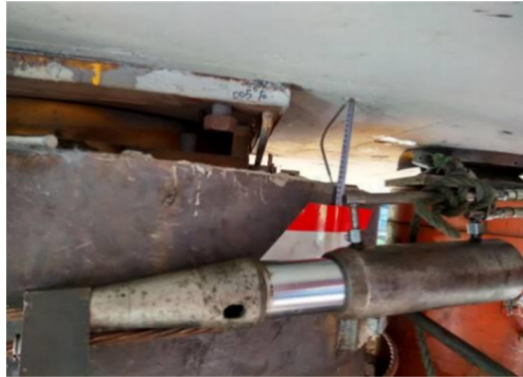
Fig. 12. Prestressing of hoop bars

Due to the large tensile force on the upper anchor bolts caused by eccentric moment, the spacing between the anchor bolt groups does not meet the code requirements. Therefore, pre-stressing is applied to the steel hoop bars to reduce the tensile force on the upper anchor bolts and ensure that the concrete will not be subjected to tension and damaged. The specific construction method is shown in Fig. 12.

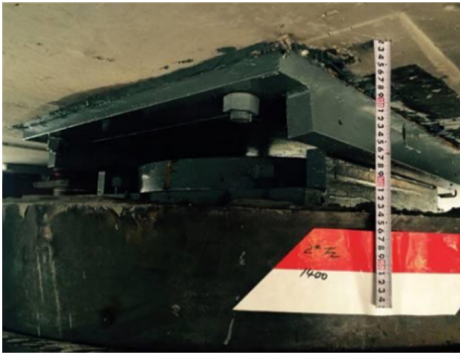
Fig. 13. Construction drawing for jacking operation (1)

Position and pad the temporary steel shims and jacks, and carry out a trial jacking of the approach bridge to inspect the performance of the jacking and sliding devices, and to verify if the steel leg or steel hoop can meet the requirements. Proceed with the formal jacking of the beam, employing a step-by-step approach, with each increment controlled within 5–10 mm, until a total lifting height of 80 mm is reached. After lifting the beam to the predetermined height, remove the existing bearings and carry out treatment on the bearing pad stones, as shown in Fig. 13 and Fig. 14.

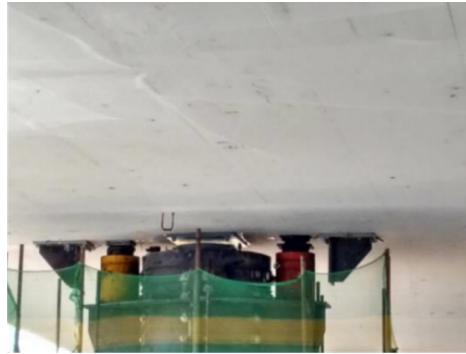
Fig. 14. Construction drawing for jacking operation (2)

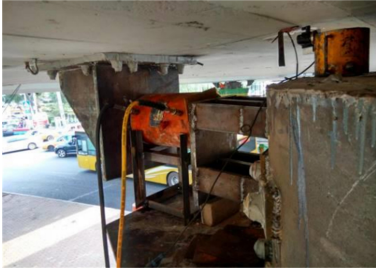
Fig. 18. Beam translation (a)

7. After the main bridge body is laterally shifted and the lateral shifting device is installed, the horizontal jacking restart construction is carried out with a jacking speed of less than 1mm/min. After the jacking restart, the horizontal jacks and horizontal steel supports will be removed, as shown in Fig. 18 and Fig. 19.

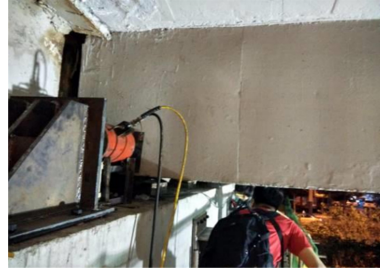
Fig. 19. Beam translation (b)

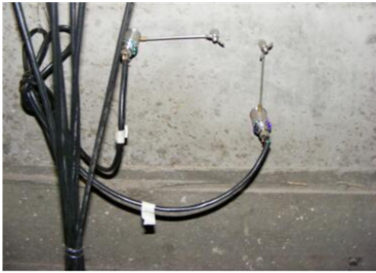
Fig. 23. Strain monitoring measurement points

Bridge lifting and horizontal displacement construction monitoring mainly involve stress monitoring and displacement monitoring. The schematic diagram in Fig. 20 illustrates the cross-sectional view for stress and displacement monitoring during the lifting process. During the lifting operation, 3 stress measurement points equipped with strain gauges are installed at the bottom of each cross-sectional beam, as shown in Fig. 21. Additionally, 3 vertical displacement control points equipped with dial gauges are arranged at the bottom of each cross-sectional beam, as shown in Fig. 22. The strain monitoring measurement points and displacement monitoring measurement points are shown in Fig. 23 and Fig. 24.

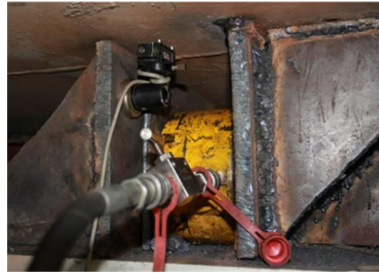
Fig. 24. Displacement monitoring measurement points

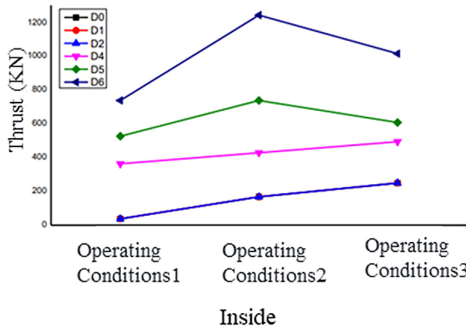
Fig. 44. Top pushing force diagram of repositioning on the inner side of the curve

2. Top pushing force results of beam translation repositioning as shown in Fig. 44 and Fig. 45.

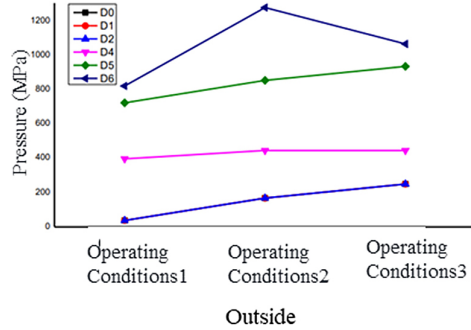
Fig. 45. Top pushing force diagram of repositioning on the outer side of the curve
