# Causes and analysis of position offset of curvilinear continuous beam bridge

**Abstract:** This study investigates the problem of beam deflection in curved continuous beam bridges. Taking the D0–D6 spans of the Gongbin Road viaduct as a basis, the main factors influencing the deflection of curved beam bridges are analyzed. The Midas/Civil finite element simulation software is used to calculate and analyze the causes of transverse and longitudinal deflection in curved beam bridges. The results show that the main influencing factor for beam deflection during operation is the system temperature, which causes a displacement greater than the combined displacement caused by self-weight, construction stage, gradient load, vehicle load, and bearing settlement. Damages to expansion joints during operation change the boundary conditions of the beam, preventing longitudinal free expansion under temperature load, and increasing the transverse displacement to 2–3 times the normal working state of the expansion joint, resulting in beam deflection. In the design phase, the selection of curvature radius and fixed support displacement is also a major factor affecting deflection. The smaller the

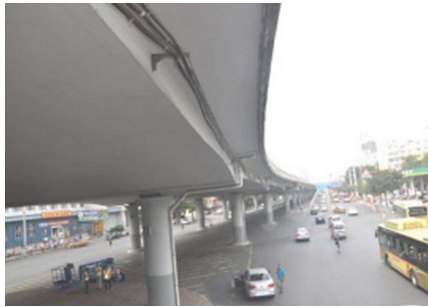
Fig. 1. Aerial view of the elevated bridge

The Gongbin Road elevated bridge system is located in Harbin, Heilongjiang Province, China, and is designed for City-A class load rating [12]. The mainline section of the Gongbin Road elevated bridge system consists of 119 spans. This study focuses on the analysis of displacements in spans D0–D6. The superstructure of spans D0–D6 is a continuous reinforced concrete curved-box beam with six spans. The span combination is  $20 + 4 \times 25 + 20 = 140$  m, and the box beam consists of two boxes with six chambers. The height of the box beam is 1.4 m. The total width of the D0–D6 span bridge deck is 28 m, and the bridge width is arranged as follows: 0.5 m crash barrier + 12.0 m roadway + 2.0 m median divider + 12.0 m roadway + 0.5 m crash barrier. The substructure of pier D1–D5# consists of column-type piers, while pier D6 adopts a prestressed concrete inverted T-shaped cap beam pile-pier structure, and the abutment is a reinforced concrete rectangular abutment. The actual scene of the elevated bridge is shown in Fig. 1. The elevation, plan, and cross-sectional views of the bridge are shown in Fig. 2 to Fig. 4.

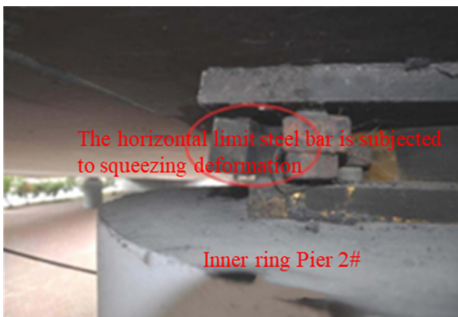
2. In some cases, there is a displacement of 40 mm between the upper steel plates and the steel pots, as shown in Fig. 6 and Fig. 7. The lateral displacement of the curved beam bridge causes the upper steel plates on the bearings to move along with it. Inspections have revealed a common occurrence of outward sliding of the upper steel plates in

Fig. 6. Compression deformation of lateral restraining steel bar

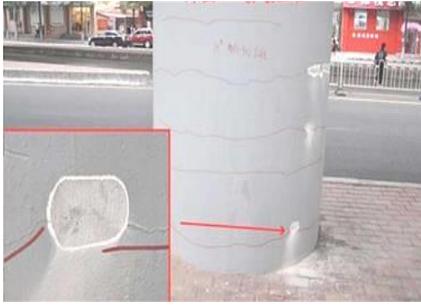
- The lower outer side of the bridge pier column is characterized by multiple semi-circular cracks, as shown in Fig. 9. The maximum width of the cracks is 0.26 mm, and the crack distribution is illustrated in Fig. 10. The analysis suggests that the presence of fixed pot-type bearings on top of the pier is the reason behind this. The lateral displacement trend of the main beam is constrained by the fixed bearings. According to the principle of force interaction, the main beam exerts a radial force on the bearings in the direction of displacement. This causes a transition in the compressive state of the bridge pier column from axial compression to eccentric compression, leading to tensile stress in the concrete on the outer side.

Fig. 9. Bottom half-ring crack in bridge pier concrete

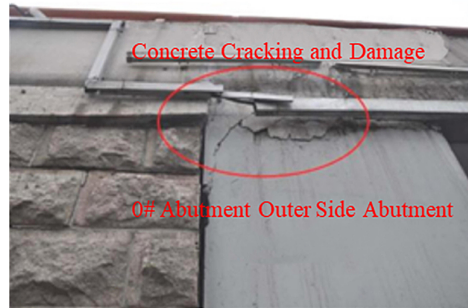
Fig. 36. D0# Abutment outer side abutment top settling and cracking
