# Capacity of connections on punched metal plate fasteners made of spruce wood reinforced with perforated plates and screws

**Abstract:** In Poland, until 2010, a number of buildings were built with the support structure of roofs in the form of timber trusses connections with punched metal plate fasteners. Standardisation changes, i.e. the introduction of Eurocodes in 2010, resulted in, among other things, increasing the values of recommended climatic loads. Due to the above, in structures built several years ago, the load capacity limit for both timber and fasteners is exceeded. Modernisation of structures with these trusses usually leads to the need to strengthen existing nodes. The issue of strengthening connections with punched metal plate fasteners is poorly recognised in experimental (failure) tests, and thus there are no detailed standard guidelines. The purpose of the experimental tests was to identify the behaviour of tension connections on metal plate fasteners and to evaluate the impact of the additional reinforcement in the form of perforated plates and screws. The analysis of the results obtained from the experimental tests allows us to conclude that the reinforced no

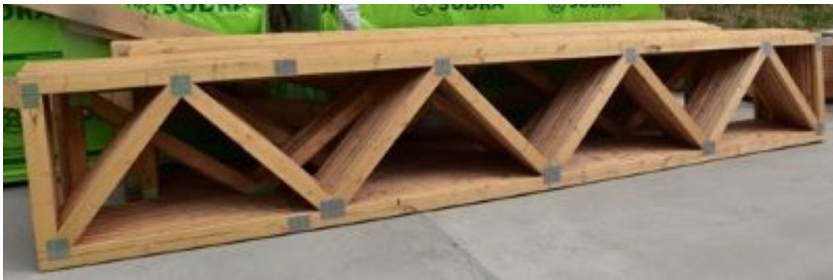
Fig. 1. Prefabricated timber trusses with parallel chords prepared for transport

In Poland, until 2010, a number of buildings were built with roof support structures of roofs in the form of timber trusses connections with punched metal plate fasteners. Timber roof trusses connected with punched metal plate fasteners constitute a wide range of construction solutions for roofing larger buildings with more complex structures. [1,2]. The truss production process allows a very economical use of material resources while reducing implementation time, replacing heavy concrete ceilings with light, ready-made wooden structures (Fig. 1), as well as better organisation of usable space [3,4].

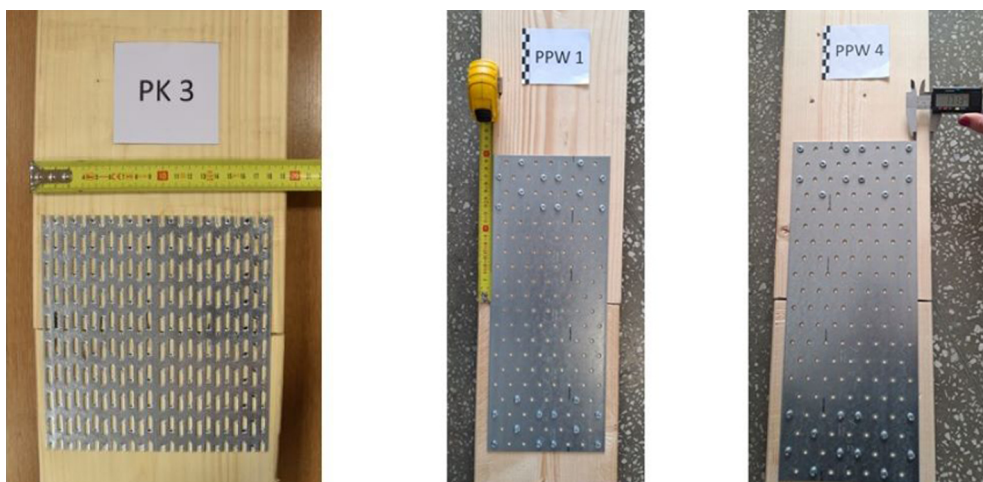
Fig. 6. Inventory of samples

The tensile strength testing of the elements in groups GB1, GB2 and GB3 was conducted at the Faculty of Structural Research Laboratory at Rzeszow University of Technology, using the INSTRON 1200kN-J1D strength testing machine. Experimental research was conducted in accordance with the applicable standards [19, 20]. Before testing, a geometric inventory of the test specimens was performed (Fig. 6). This inventory included measurements of both cross-sectional dimensions, the positioning of fasteners, and deviations from their straightness according to the norms [21, 22].

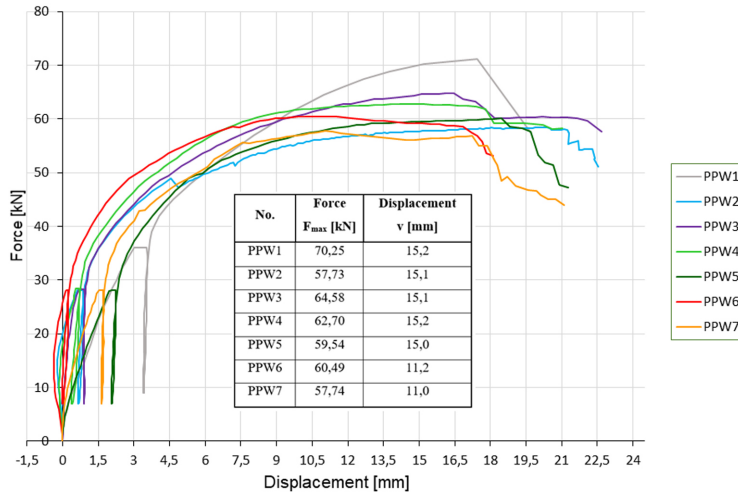
Fig. 9. The paths of static equilibrium and the values of the obtained results for the research group: (a) GB1, (b) GB2, (c) GB3

Fig. 9. [cont.]

The primary characteristic of the behaviour of the tested connections is the relationship between force and vertical displacement. Vertical displacement, denoted as  $v$ , was considered as the difference in displacements of measurement points marked on the wood elements. The points located farthest from the centre of the connection, as the most representative, were taken into account. The displacements measured by the ARAMIS system were obtained as the average of three distances between the aforementioned measurement points using the GOM Correlate software. The paths of static equilibrium obtained in this way were used to determine the ultimate force. The graphs of the obtained paths of static equilibrium and the values for each group of connections are shown in Figures 9a–c. The maximum recorded force during the test was considered the limit load for each connection or when the displacement reached 15 mm, according to Section 8 of standard [20].

Upon analysis of the above charts, two distinct stages of connection operation are clearly evident. The boundary of the first stage is the attainment of a value of approximately 50% of the destructive force. Displacement values are very small during this stage, indicating a minor

pulling of connectors from the wood. As the force continues to increase, the joint starts to operate in the second stage. This stage is characterised by the extraction of wooden dowels in the case of connection in group GB1, as well as the shearing and pulling out of dowels and screws in connection of groups GB2 and GB3. The second stage is also marked by a significant increase in displacements. The perforated plate does not deform and is not engaged in joint operation. Negative displacement values indicate the initial fit of the connectors to the wood, both in the supports and within the joint. The displacements recorded for the destructive force in the GB1 and GB3 were small, not exceeding 10 mm. Only in group GB2, which comprises connections with perforated plates and screws, were vertical displacements relatively

- group GB1  $\bar{F}_{\max} = 89,33$  kN,  $F_k = 74,61$  kN
- group GB2  $\bar{F}_{\max} = 61,86$  kN,  $F_k = 52,52$  kN
- group GB3  $\bar{F}_{\max} = 161,29$  kN,  $F_k = 131,21$  kN

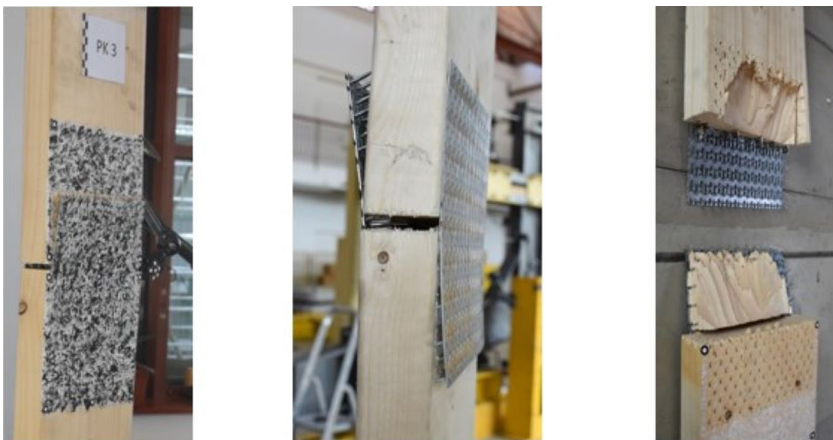
Fig. 10. Failure mode in group GB1: (a) pulling out of the spikes of metal plate fasteners, (b) symmetric form of failure, (c) block tearing

In the connections of group GB1 (unreinforced), the observed failure was the gradual pulling out of the spikes of the punched metal plate fasteners from the wood (Fig. 10a). The extraction of plate spikes occurred progressively, depending on the increasing load values applied to the connection. As a final result, for most of the examined joints, a symmetrical form of plate damage was recorded (Fig. 10b). In one tested connection, a block tearing failure of the joint was observed (Fig. 10c). At the point where the spikes detached, there was a bending of the metal plate fasteners. The failure mode in the joints of group GB2 was the pull-out and shearing of screws (Fig. 11). The connection failure occurred progressively, depending on the tensile force

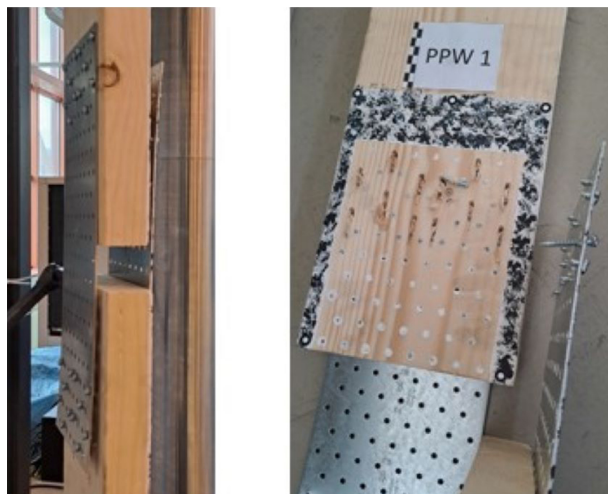
Fig. 11. Connection failure mode in group GB2

values. Similarly to the research described in the literature [24]. As a result, the joint failure was symmetrical. No significant damage to the perforated plate was noted; it was simply bent at the point of detachment and screw shear. Plastic deformation of the plate was not observed.

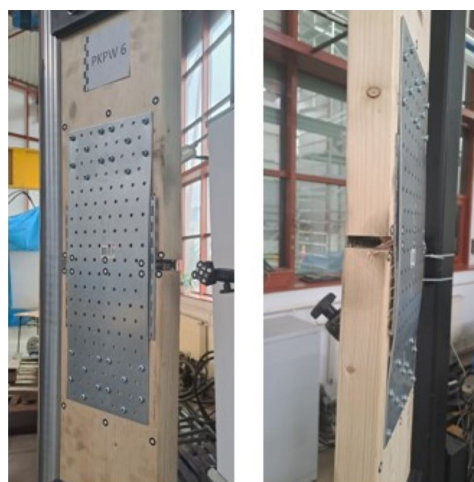
Fig. 12. Failure mode in Group GB3

In the reinforced connections of group GB3 (Fig. 12), slight pulling of the spikes of the punched metal plate fasteners and screws was observed. However, no shearing of connectors was recorded. There was no damage to the perforated plate and it did not exhibit plastic deformation. The effectiveness of reinforcement using perforated plates and screws can be observed.
