**Research paper**

# Historical and aesthetic compatibility of earth-based mortars on the example of ancient stone structures in the Black Sea Basin

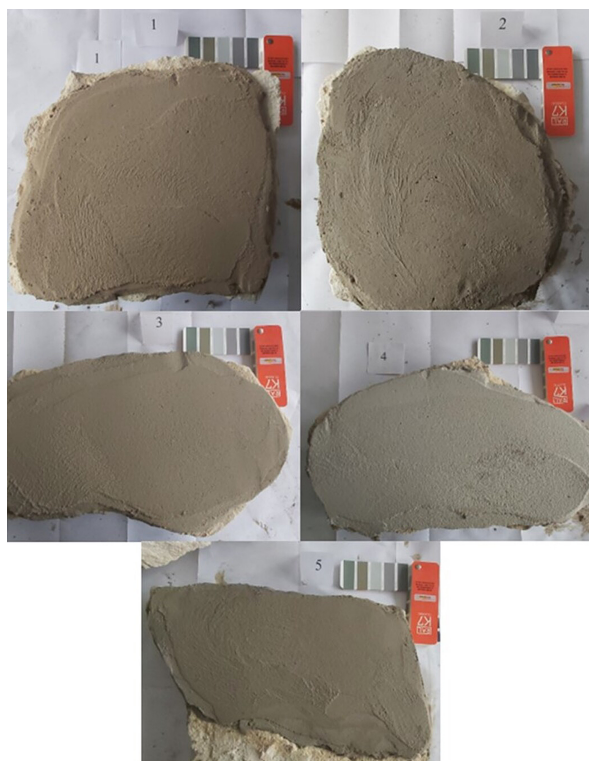
Fig. 6. Colour analysis of hardened mortars: 1 – 4060, 2 – composition 4060-15C-N, 3 – composition 3366-15C, 4 – composition 2575-15C-10L, 5 – composition 3366-25C

The colour analysis was carried out on both fresh mortar and mortar after a 28-day hardening period. For analysis, the mortar spread on the surface of the stone elements was used. The reference point will be earth-based mortar with a composition of 4060 – sample 1, as the mortar closest in composition, colour, and texture to the original mortar in stone walls in the Black Sea Basin. The stone elements together with the colour palette for fresh mortar are shown in Fig. 5, and for hardened mortar in Fig. 6.

Analysing the results obtained, it can be seen that fresh earth-based mortar and earth-based mortar with lime and cement additives do not show significant colour differences. The colour of earth-based mortar with composition 4060 – sample 1, was determined as RAL 7008 (khaki grey), the colour of compositions 16 (3366-15C) – sample 3, 22 (2575-15C-10L) – sample 4, and 200 (3366-25C) – sample 5, as RAL 7006 (beige grey). A visible difference can be seen in the case of mortar with composition 4060-15C-N, where the colour was assessed as RAL 7005 (mouse grey). In the case of hardened mortar, the colours undergo visible changes. The colour of the earth-based mortar can still be described as RAL 7008, while the colour of the mortars with cement added (16-3366-15C and 3366-25C) deviates slightly towards grey tones – it has been described as RAL 7034 (grey yellow). In the authors' opinion, the slight grey colouration in this case remains at an acceptable level of colour difference. In the case of mortar with a composition of 22 – sample 6, the colour of the sample deviates much more towards the grey colour scale (defined as RAL 7035 – light grey). In this case, it can be concluded that the addition of lime contributes to the grey colour of the sample to a much greater extent than the addition of cement alone. In the case of sample 10 (4060-15C-N), the colour returned to brown after drying, slightly darker than the mortar with composition 1. Based on the above considerations, it can be concluded that among the selected compositions, the mortars with

the addition of cement alone are closest to the original colour of the mortar – composition 16 (3366-15C) – sample 3 and composition 3366-25C – sample 5. The colour of the mortar with composition 4060N-15C-N is also acceptable in its final form, but the initial colour may cause concern during reconstruction work. In the authors' opinion, the mortar with composition 2575-15C-10L deviates too much from the base mortar (towards a grey colour).

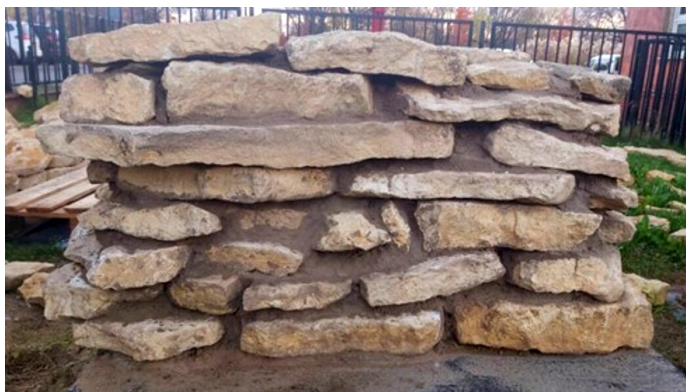
Fig. 9. Stone wall built with earth-based mortar without additives – composition 4060

As part of semi-technical research, test walls were built using Tertiary limestone available in Poland (Pińczów limestone) on selected earth-based mortar compositions in the autumn (September 2022). The first composition was earth-based mortar without additives –4060 (Fig. 9). The second application was selected mortar 3366-25C (Fig. 10). The main objectives of the test research in the context of historical and aesthetic assessment are analysis of possible changes in the colour and texture of the mortar over time due to leaching, sun exposure, wind impact, the appearance of salt efflorescence, etc. The first verification of the mortar used was carried out 6 months after the construction of the described structures (beginning of March 2023) and then every six months until July 2025. No changes in the colour and texture of the

solution used were noted for any of the analysed walls during this period. The mortar did not change colour, nor were there any visible changes in the texture or efflorescence on its surface. It can therefore be concluded that the analysis of historical and aesthetic compatibility was carried out correctly.

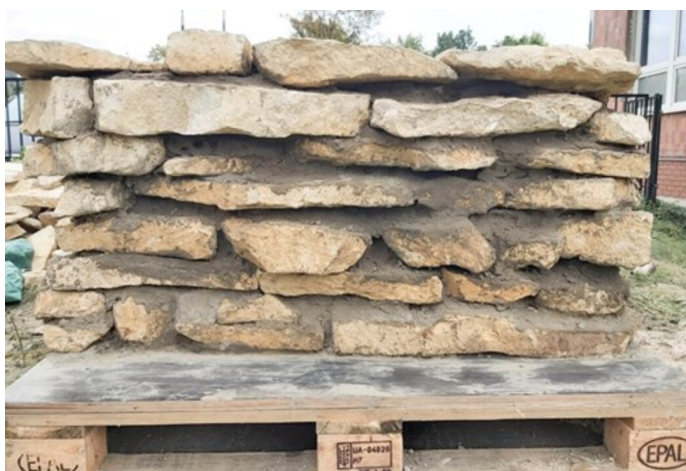
Fig. 10. Stone wall on mortar 3366-25C
