**EROSIVE WEAR OF INCONEL 625 ALLOY COATINGS DEPOSITED BY CMT METHOD**

*Keywords:* Inconel 625, erosion wear, solid particles erosion, alloys

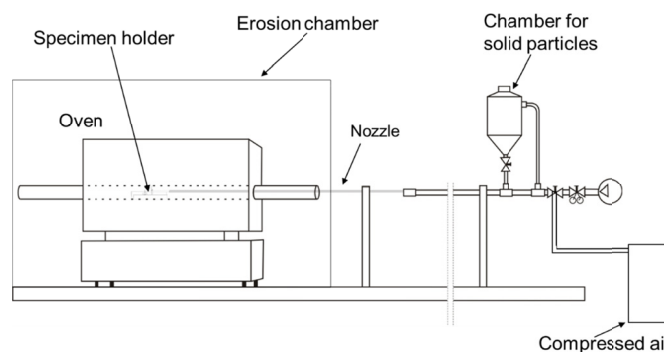
The erosive wear tests were performed using the author's testing stand. The abrasion wear testing stand is shown in (Fig. 1). The proposed concept of the device for erosive wear process simulation refers to the method that reproduces the mechanism of impact erosion that is caused by the impact of hard particles, where the abrasive carrier is a stream of compressed air [17]. The basic objective was to enable the tests to be conducted under high-temperature conditions. To be able to perform the tests not only at ambient temperature, but also at an elevated temperature, the device was equipped with a pipe furnace, for which a special holder was designed to enable the control of the impingement angle of abrasive hitting the specimen. The erosive wear process simulation stand according to ASTM G 76 consisted of a compressed air source, an abrasive batching system, a mixing chamber and a nozzle [18]. Compressed air and solid particles are delivered to the mixing chamber, from where the mixture is discharged via a 1 mm-diameter 570 mm-long nozzle. After leaving the nozzle, accelerated abrasive particles carried by the air stream hit the surface of a test sample positioned at a distance of 5 mm from the nozzle, with a specified kinetic energy. During testing, the velocity of solid particles discharged from the nozzle should be approx. 90-110 m/s. The air flowrate should be maintained at a level of approx. 16 m<sup>3</sup>/h at a pressure of 0.3 MPa. The tests were conducted, respectively, at ambient temperature, i.e. 20°C, and at a temperature of 650°C, which simulates the boiler operation temperature. The test specimens, in the form of an 12×20×2 mm rectangular prism, were fixed on the table at an appropriate abrasive particle impingement angle.

Fig. 1. The diagram showing the position of to simulate erosive wear

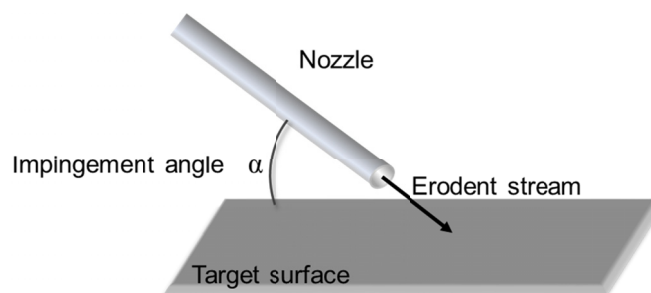
Fig. 2. Schematic diagram depicting the impingement angle of solid-particle erosion [19]

To determine the erosion wear resistance, the weld clad layer of the Inconel 625 alloy and the same material after plastic working condition, were subjected to erosive wear testing at different abrasive solid particle impingement angles of, respectively: 30°, 45°, 60° and 90°. The differentiation of abrasive particle impingement angles, as well as the temperature, allowed the determination of the course of erosive wear processes. As the abrasive, Al<sub>2</sub>O<sub>3</sub> with a grain size distribution of 180-220 μm was used. The particles of the abrasive used were characterized by high hardness – above 2000 HV, and the presence of sharp edges. Using a precision laboratory balance, all specimens were weighed prior to and after the erosive wear test. On that basis, the ratio of the specimen mass loss to the mass of the abrasive striking the specimen was determined. In the erosive wear tests, the impingement angle of incidence of abrasive particles was measured between the particle incidence direction and the disc surface (Fig. 2).

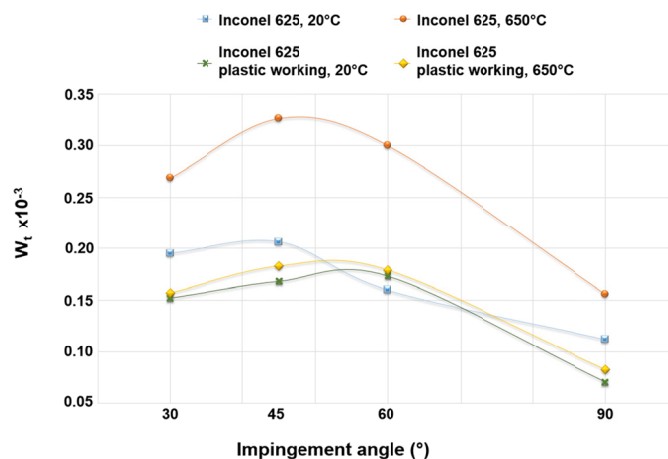
Assuming the coefficient as the intensity of the material erosive wear ( $W_t$ ), a diagram has been plotted (Fig. 3), which illustrates the dependence of the material erosive wear on the abrasive particle incidence angle for two materials tested at two temperatures. It can be noticed from the diagram that the material wears faster at elevated temperature, which may suggest that erosive wear intensity at higher temperature (650°C) is often due to the erosive wear of the surface and the formation of an oxide protective layer on the material surface, which is brittle and more prone to chipping off as a result of erosion. It is supposed that the greater mass loss of Inconel 625 clad layer compared to the material after plastic working may be due to the greater inhomogeneity. Then Inconel layer has worse mechanical properties for example elongation or tensile strength in comparison with plastic worked alloy. Therefore material after

plastic working has higher corrosion resistance than clad layer. During heating, the surfaces of the specimens become oxidized before undergoing erosion. Thus, if the oxide film on the layer is thicker, the erosion loss will be greater. It was also found that the greatest mass loss, for the investigated Inconel 625 alloy and for the same material after plastic working, took place at an abrasive impingement angle of 45°. The smallest mass loss for all of the tested materials was found at an impingement angle of 90°. Inconel 625 after plastic working is characterized by a much smaller mass loss compared to the weld clad made of the same material (Fig. 3) [19].

Fig. 3. Graph showing the dependence of erosive wear ( $W_t$ ) with respect to the impingement angle incidence of the abrasive material

At an elevated temperature, the wear profile is distinct at the impingement angle 45° for both materials, as confirmed by the data in (Fig. 3).

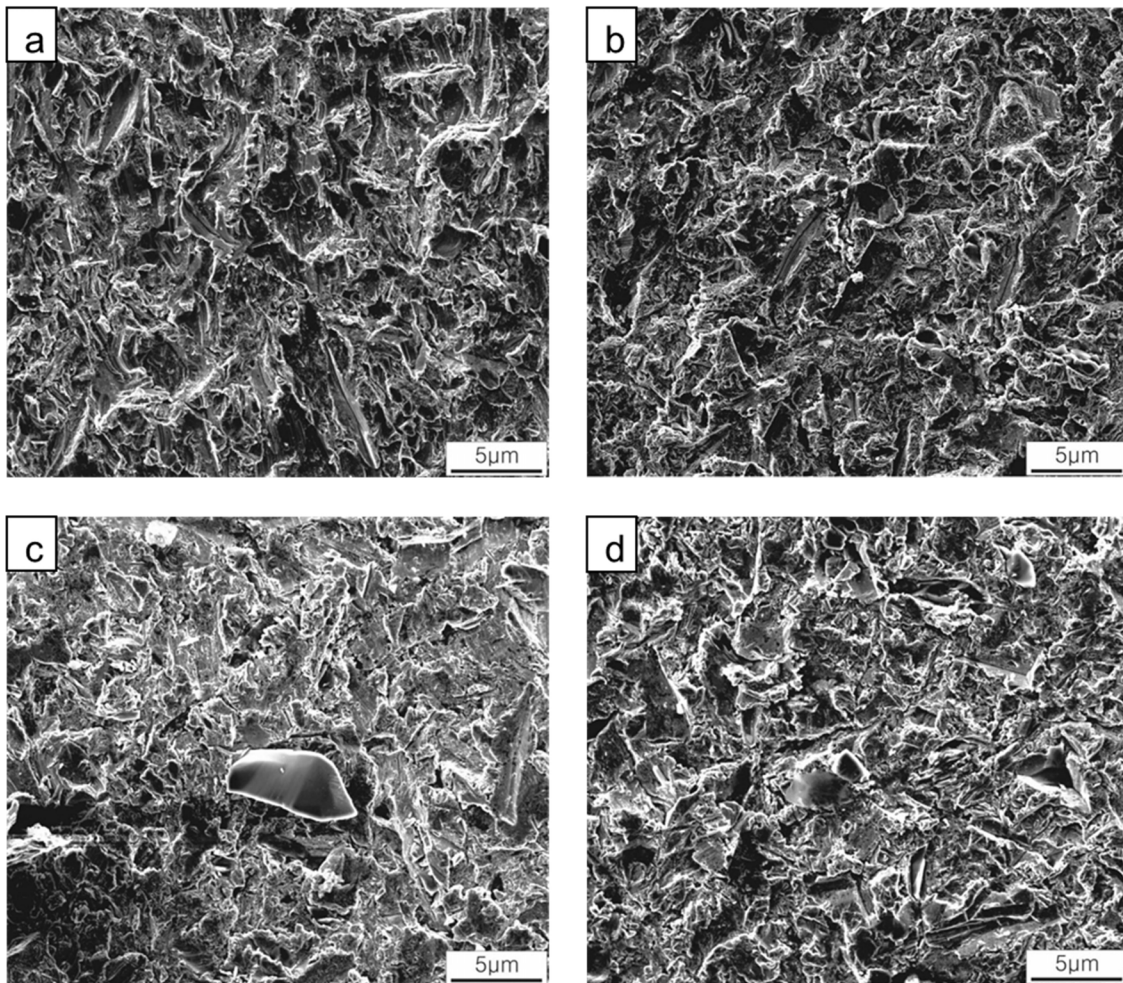
The examination of the eroded surface, illustrated in figure 4, shows that, at the abrasive particle impingement angles of 30° and 45° (Fig. 4a,b), a visible removed material occurred due to microcutting, while at greater abrasive particle impingement angles of 60° and 90° (Fig. 4c,d), due to microcutting and microfussiring – the removal of the material occurs due to the formation of sub-surface cracks. At greater impingement angles, the contribution of abrasive solid particles, which were stuck in the eroded material surface, was also observed. This relationship

was observed for all investigated materials. The SEM pictures taken in eroded specimen regions indicate that the predominant mechanisms responsible for the erosion process are microcutting and microfussiring. They depend on the shape of erodent particles and their kinetic energy at the moment of hitting of the tested material. In the fussiring process, after plastic working in the form of an elongated furrow with characteristic creases occurs on the material surface. The detachment of material from the groove is a sign of erosive wear.

Fig. 4. Typical erosion scars and SEM micrographs of Inconel 625 eroded areas with impingement angles of: a) 30°, b) 45°, c) 60°, d) 90°. Erodent  $\text{Al}_2\text{O}_3$

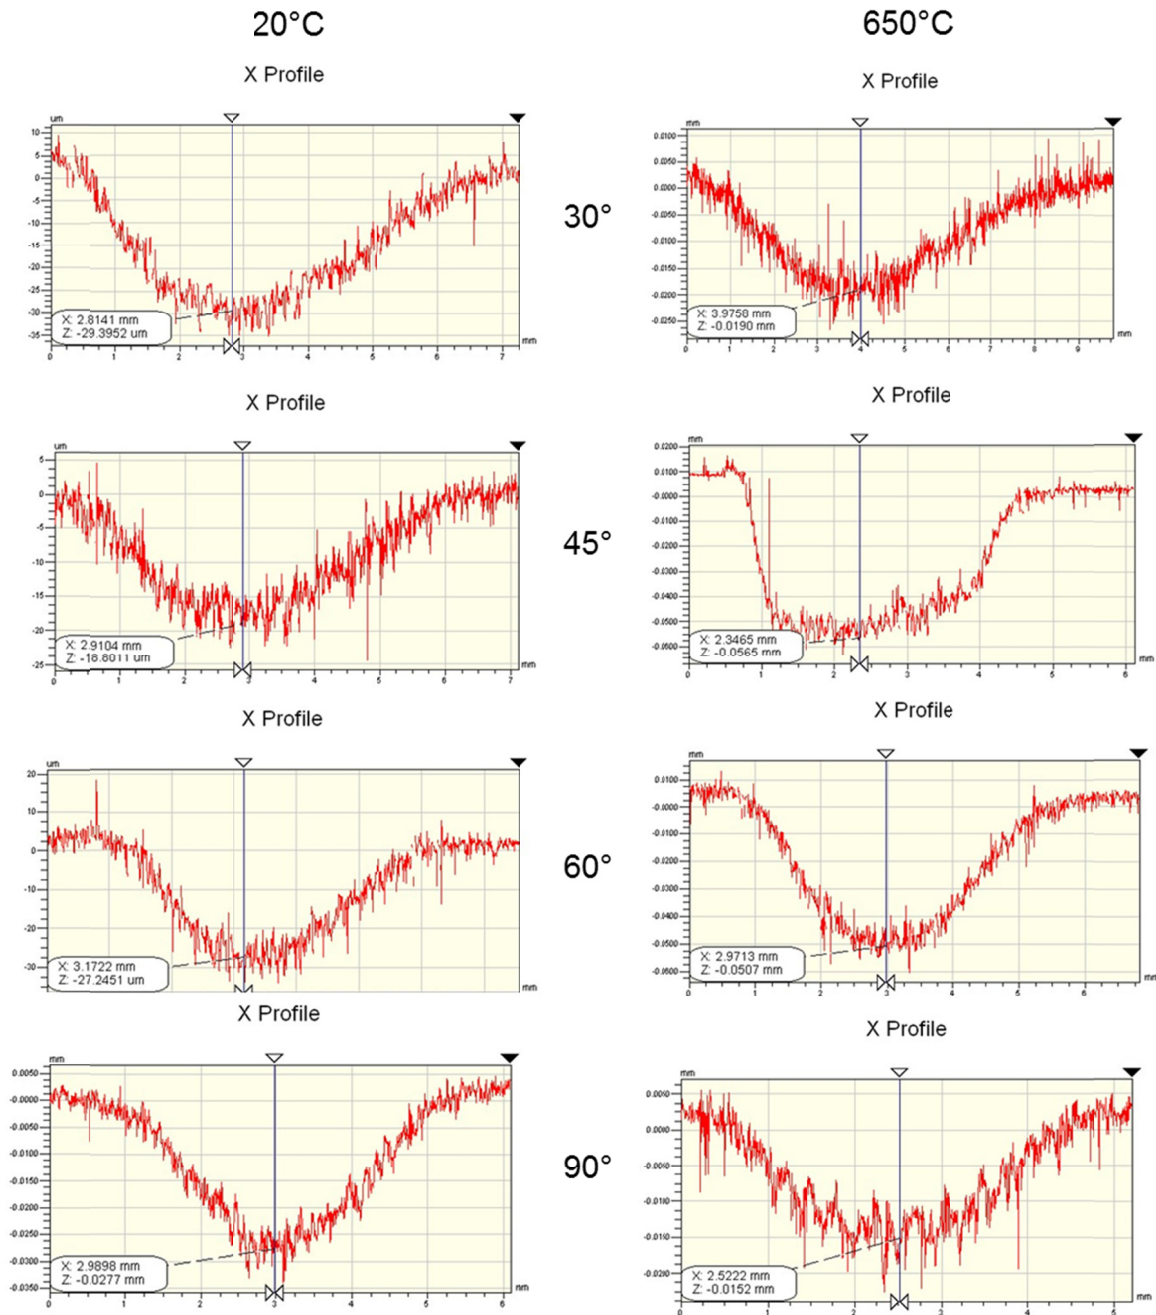
The changes in the shape of the eroded material surface are very well illustrated by surface profiles recorded using an optical profilometer. (Fig. 5) shows the surface profiles of Inconel 625 alloy and after plastic working after erosive wear for the temperatures 20°C and 650°C. While (Fig. 6) shows the surface profiles of Inconel 625 weld clad layer after erosive wear. Changes in the surface shape with increasing impingement angle are perfectly visible in these profiles. For smaller impingement angles, the shape is elongated in the direction of the x axis, whereas for angles equal to 90° it is more symmetrical. At an elevated temperature of 650°C, the shape changes for the eroded surface are, for both materials, more visible than for the temperature 20°C; this is especially true to the angle 90°.

Fig. 5. Erosion crater profiles in Inconel 625 after plastic working

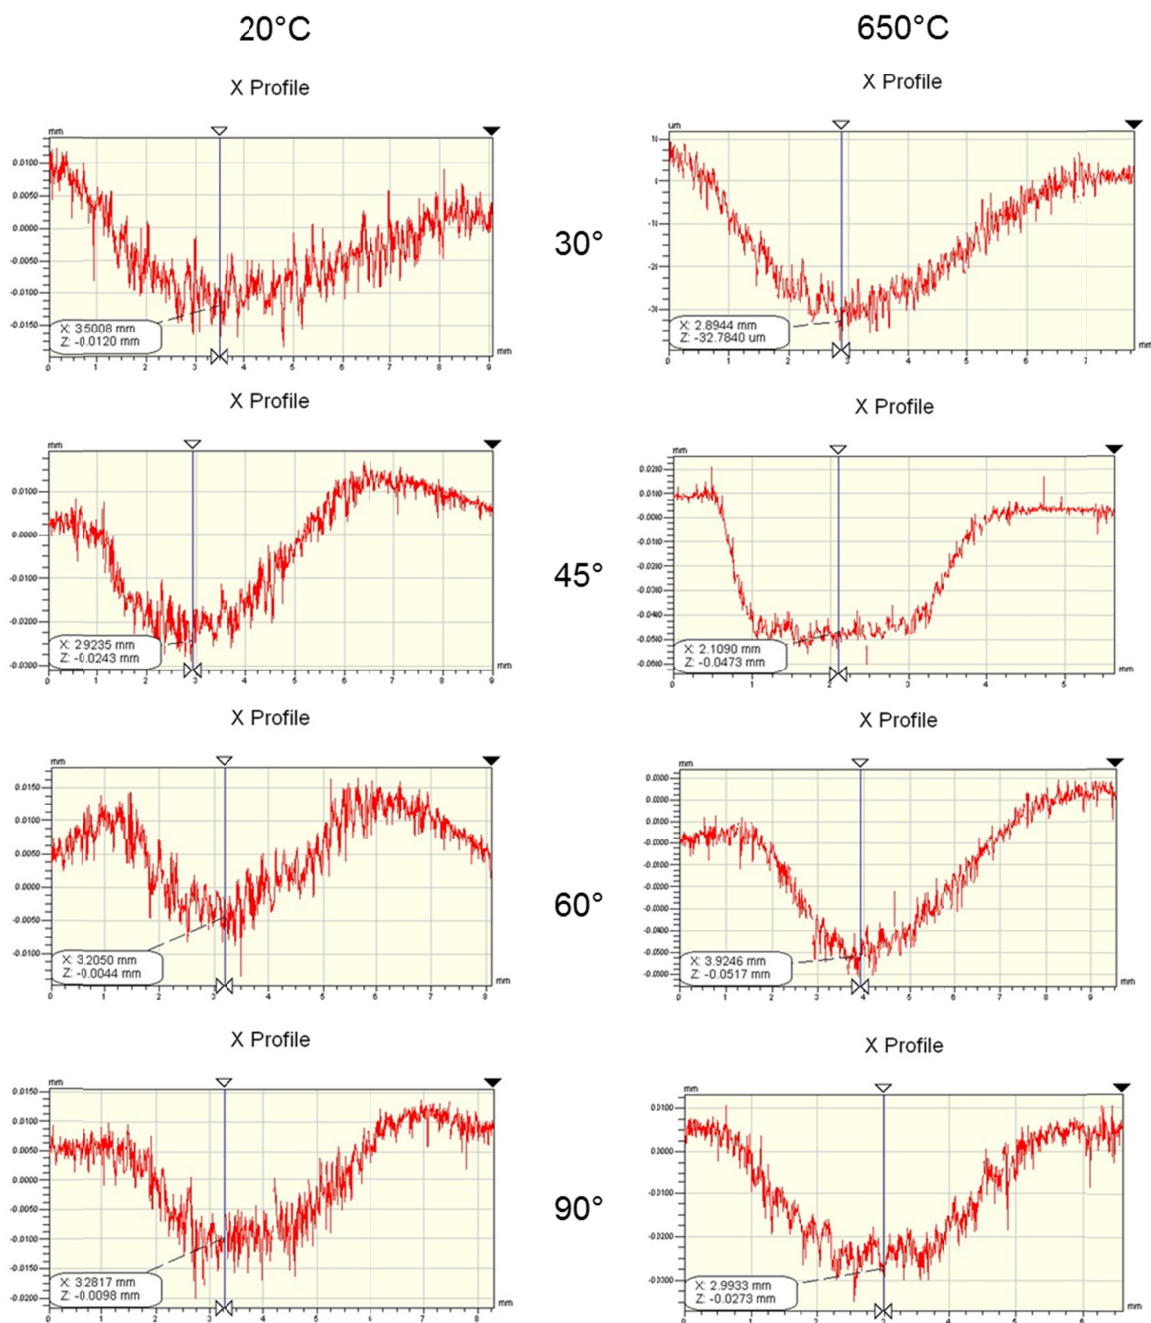
Fig. 6. Erosion crater profiles of the Inconel 625 clad layer with impingement angles of 30°-90°
