GRZEGORZ OLSZYNA*, ANDRZEJ SIOMA**, ANDRZEJ TYTKO*

ASSESSMENT OF THE CONDITION OF HOISTING ROPES BY MEASURING THEIR GEOMETRIC PARAMETERS IN A THREE-DIMENSIONAL IMAGE OF THEIR SURFACE**METODA OCENY STANU LIN WYCIĄGOWYCH POPRZEZ POMIAR PARAMETRÓW GEOMETRYCZNYCH NA TRÓJWYMIAROWYM OBRAZIE ICH POWIERZCHNI**

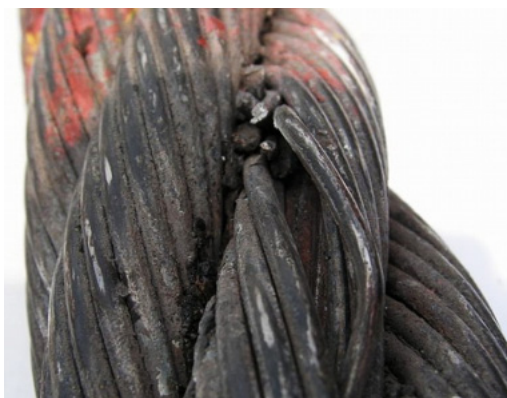
Fig. 1. Example of clearly visible damage to the rope in the form of broken wire

Ropes are used in numerous rope transport devices, both in industry and in tourism and recreation. Ropes used in industrial devices are exposed to very difficult and different operating conditions. Sometimes, the defects and anomalies that appear in ropes are very small and difficult to detect even by experts experienced in diagnosing ropes. There is a search for newer methods of assessing the condition of both steel ropes and ropes made of modern materials (Kevlar ropes, ropes with plastic inserts, etc.). There are strict rules for testing steel ropes defined by law (*Regulation of the Minister of Economy...*, 2006) or recommended by manufacturers. The most common types of damage that occurs in ropes include wire cracks, wear, missing wires, corrosion, geometrical deformation or damage to the core. Some of those defects are easy to detect (wire cracks), while other are very hard to identify (corrosion, change in geometry) (Kwaśniewski, 2004). Figure 1 shows examples of damage that occurs during operation.

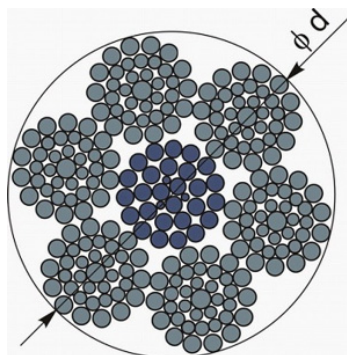
Fig. 2. Definition of the diameter of a twisted-pair cable

interpretation of damage allows safe operation of rope devices. While working in equipment, ropes change their geometry, i.e. lay length of rope strands and diameter of the rope itself. Those changes are caused by bending and when the rope passes through shafting, vibration, and wear factors involving the loss of mass. The geometry of a rope has a considerable influence on its co-operation with other elements. Changes in the geometry of ropes are also caused by rotation around the axis as a result of untwisting torque (Nowacki & Tytko, 2009). This phenomenon may be the main reason for the development of defects and anomalies in the hoist rope during operation. How the rope works depends, to a large extent, on the device (Olszyna & Tytko, 2009). Changes to the mechanical and structural properties of ropes in the process of their operation is inevitable. By using appropriate methods of rope condition assessment, detection of certain forms of wear, and recommendations for further use, one can increase their durability. Measuring the diameter of a rope is the most widely used method to assess its geometrical parameters, but the instruments currently used do not allow reliable detection of locations of the lowest diameter on the rope, which may indicate disqualifying defects such as core damage. One of the motivations for research to explore new techniques for assessment of the technical condition of ropes is primarily the fact that the methods used currently to measure the diameter are inaccurate and do not offer the possibility of measuring lay length along the entire length of the rope. Also, it has not been clearly defined how to measure rope diameter so that this parameter could be used as a reference. The basic definition of rope diameter is the diameter of a circle as shown in Figure 2. Measured actual rope diameter is a key parameter for selecting ropes, associated components, etc.

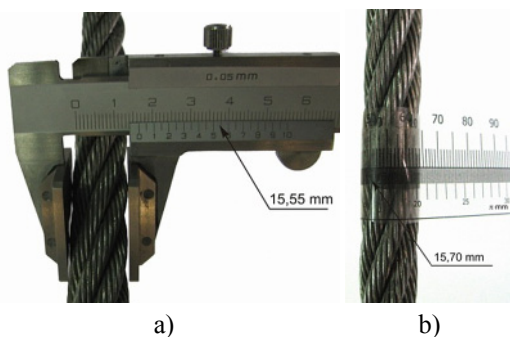
Fig. 3. Methods of measuring rope diameter: a) – a vernier calliper, b) – a ruler with an appropriate scale which takes into account the number π

Measurement with a vernier calliper with wider jaws allows such grasping of the rope that the jaws cling to the strands that lie directly opposite each other and the measurement is more accurate (Olszyna & Tytko, 2010). There is also the method of measuring rope diameter developed by Prof. Bittner from the Technical University in Vienna. It involves measurement of the circumference of a rope with a special ruler, which is wrapped around the rope, and its scale uses unit of length multiplied by π . This way you can directly determine the diameter of the rope. The ruler must be firmly tightened so that it becomes circular. This original way of measuring rope diameter, which is no longer in use, is shown in Figure 3.

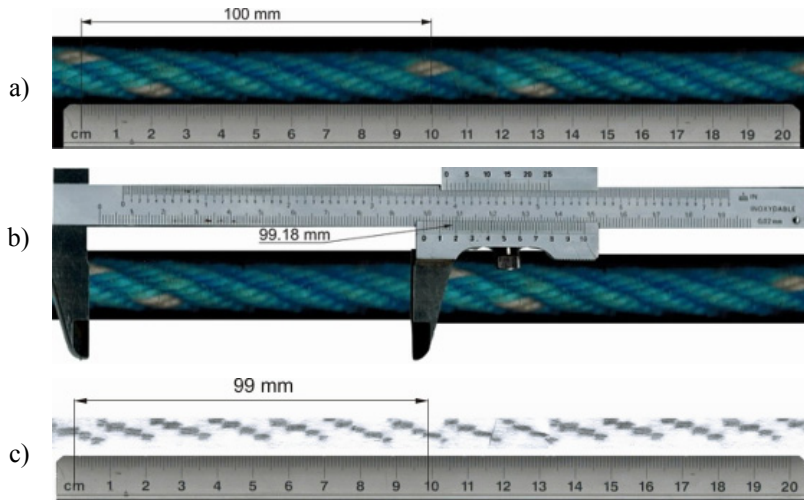
Fig. 4. Examples of measuring the lay length of a strand rope, where: a) measurement with a ruler b) measurement with a vernier calliper, c) measurement using a imprinted image on paper and, for example, graphite

Measurements are usually made at selected locations throughout the length of the tested roped and using the chosen method. Figure 4 shows measurements of the lay length of a strand rope directly on the rope, using several methods.

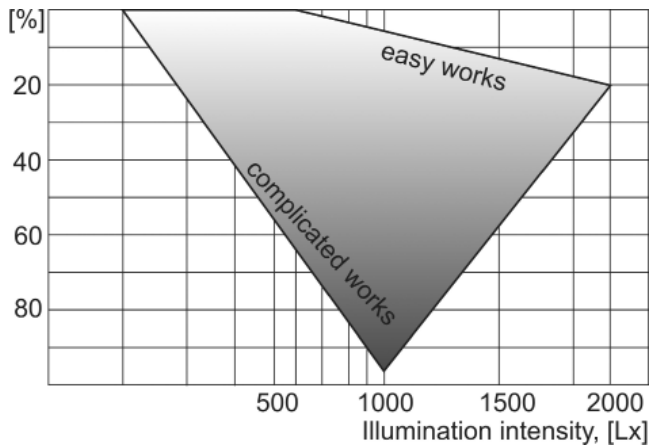
Fig. 5. Reducing the number of errors in visual assessment methods depends on illumination intensity

Both the measurements of rope diameter and of lay length provide quantitative information on the state of the rope. Measurement of the above parameters is complicated by several side factors, which include: predisposition of the personnel performing the measurements and evaluation of the rope, lubrication of the rope, and intensity of illumination. Illumination of tested ropes in mining is, in most cases, artificial, which may contribute to human error. This relationship is shown in Figure 5. Increase in illumination intensity has an effect on the number of errors (Hlebowicz, 2002).

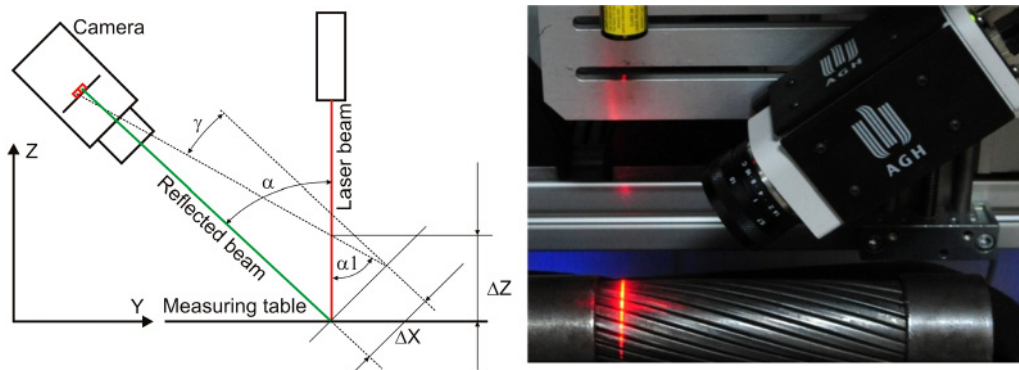
Fig. 6. Geometry of a 3D vision system and view of the laser line illuminating the rope

Measurement and evaluation of rope parameters should be carried out continuously along the entire length of the rope. This will enable assessment of the changeability in the determined parameters along the length of the rope and make it possible to assess changes in the selected parameters during operation of the rope. A three-dimensional image of the surface of a rope can be obtained by two methods (Tytko & Sioma, 2011). In the first method, a laser line illuminates the rope, and the laser line is set perpendicularly to the axis of the rope, as presented in Figure 6. The rope is scrolled through the measuring station along its axis, allowing determination of subsequent cross-sections and construction of a three-dimensional image of the surface of the illuminated part of the rope. For the adopted configuration of the station, one needs to determine resolution ΔX , ΔY , ΔZ in each of the three axes of the coordinate system of the station (Kowal & Sioma, 2010, 2012).

An image constructed in this configuration enables precise evaluation of the surface of the rope illuminated by the laser. A three-camera system allows assessment of the entire surface of the rope on the basis of three fragmentary images of its surface. It is extremely important in tasks involving inspection of damage to rope surface, in particular broken wires and abrasions on the surface of wires in the rope. Figure 7 presents an image of the surface of two types of ropes generated in the adopted system of alignment of the rope and a 3D vision system (Sioma, 2010).

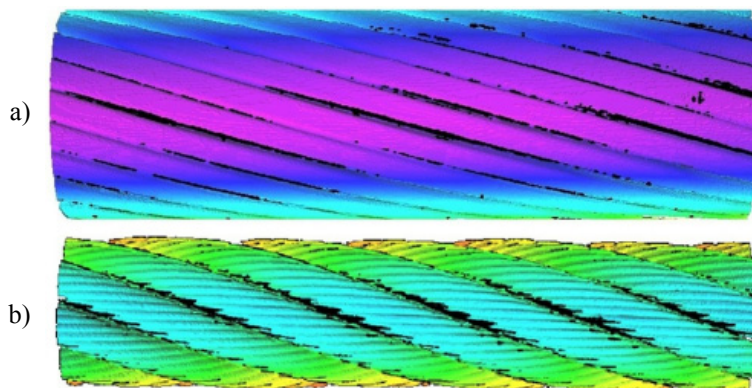
Fig. 7. 3D image of rope surface: a) – locked-wire rope with 23 “Z” wires in the outer layer, b) – 8-strand rope

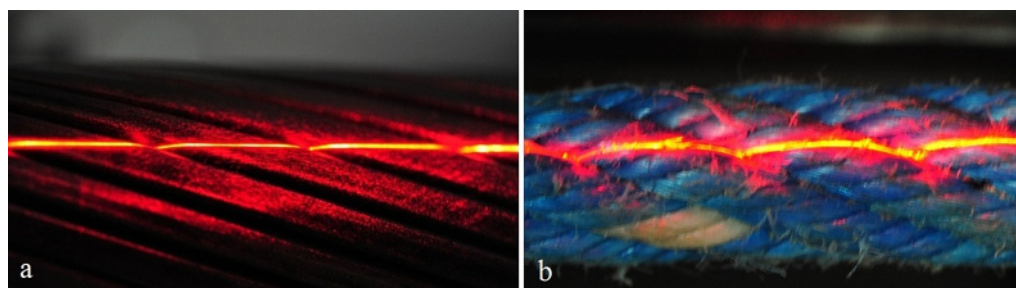
Fig. 8. Construction of a 3D image of rope surface: a) – locked-wire rope with 23 “Z” wires in the outer layer, b) – 8-strand fiber rope

The second method of generating an image of rope surface is such setting of laser line in relation to the rope so that it is parallel to the rope axis (Fig. 8). By rotating the measuring system around the rope, one gets a full three-dimensional image of the surface of the rope, which is its projection.

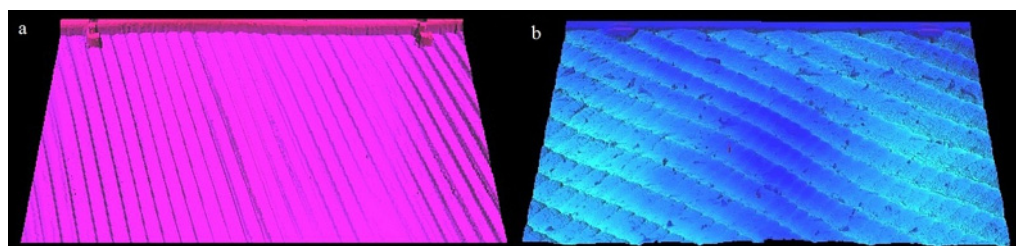
Fig. 9. 3D images of rope surface projections: a) – locked-wire rope with 23 “Z” wires in the outer layer, b) – 8-strand fiber rope

Figure 9 shows full images obtained by this method in the form of a full projection of rope surface. During full rotation around the rope 720 profiles were obtained. A projection of two ropes is presented: steel rope and fibre rope. A detailed image of the entire surface area covered by the measurement is shown on figure 9.

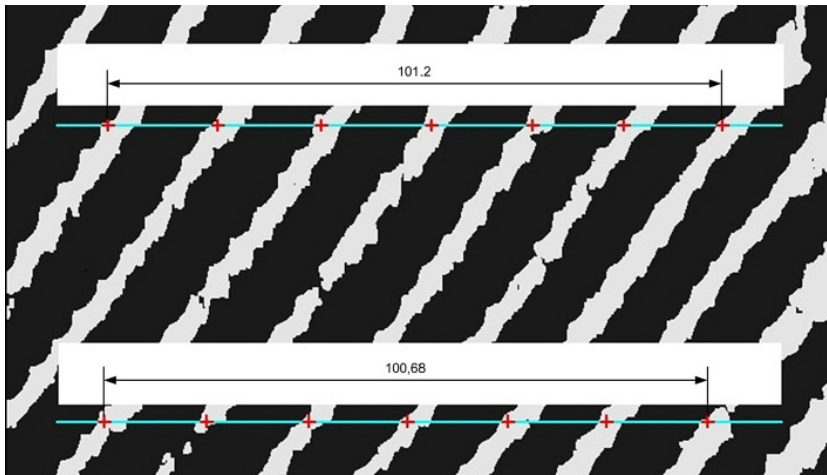
Fig. 10. Three-dimensional images of rope surface projections and method of determining lay length in two locations

A three-dimensional projection of the surface generated from a full rotation of the laser system around a 6-strand rope enables observation of the lay on all the strands making up the surface of the rope. Figure 10 presents a measurement of lay length taken simultaneously for two selected strands on the image of rope surface. By measuring lay length for all the strands shown in Figure 9, the average lay length was calculated. In this case, it is 100.04 [mm].

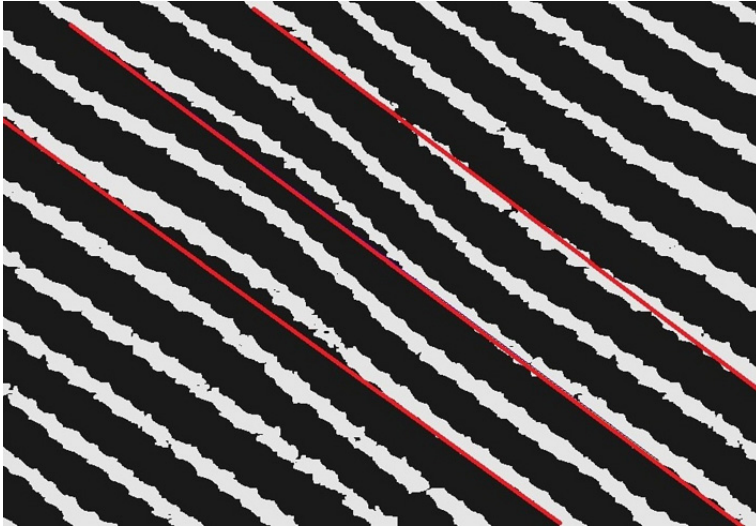
Fig. 11. Three-dimensional images of rope surface projections with a visible local disruption to the strand arrangement in the outer layer

In the image of rope projection, one can also observe local twisting of strands. This is evident in the form of straightness disorder visible as white areas in the valleys between the strands. This is shown in Figure 11. For selected strands, two control points were determined. A straight line was drawn between the points. This enabled evaluation of the deviation of the visible edge of the strand relative to that line. Local deviation of strand edge relative to the line indicates a local change of geometrical parameters. Those changes can be caused by a local change in diameter of the rope (bottlenecks, creases, etc.). Similarly, they can be caused by points of interruption or thickening of the rope core, which is one of the most dangerous types of damage, and very difficult to detect by other methods. Figure 11 shows the incompletely, as yet, identified diagnostic potential of the method.

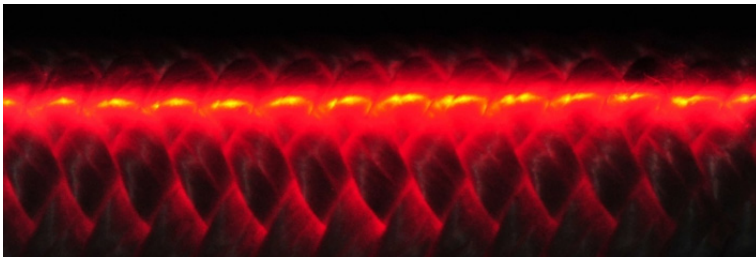
Fig. 12. Tightly-woven fibre rope

for which a dedicated method of selection of laser parameters has been developed. Figure 12 shows the effect of combined scattering and absorption of laser light on the surface of the rope. The parameters were chosen so that the vision system shows the outline of the surface shown below in Figure 12.

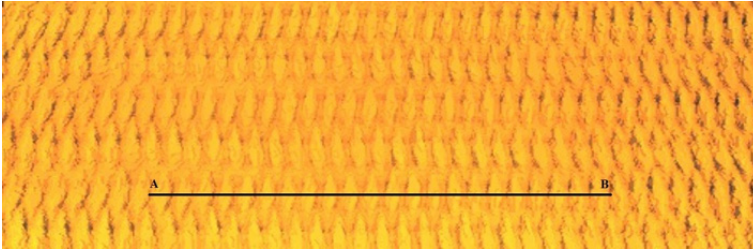
Fig. 13. Three-dimensional image of the surface of a multi-strand fibre rope

As a result of using a three-dimensional vision system, an image of the projection of the surface of a fibre rope was obtained. The rope diameter is 17 [mm]. The rope did not display typical pitch due to the fact that the rope is braided in its outer layer. Only the interlace was defined, which is the distance between successive 12 tucks in the weave, shown as a photograph of the surface in Figure 13.

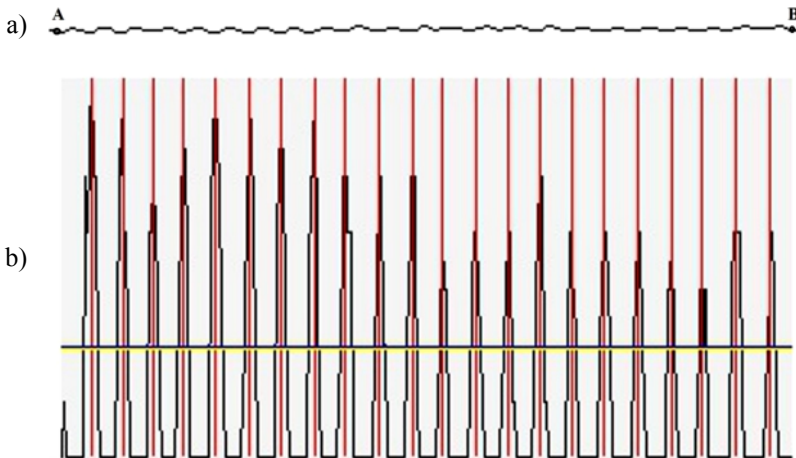
Fig. 14. Analysis of the profile of a fibre rope in segment AB (Fig. 13)

Figure 14a shows the height profile of the surface of a rope at its axis, in the location presented in Figure 13 as segment AB. The profile shows a weave of the strands making up the surface of

the rope. Figure 14b shows an analysis of the changes in profile heights carried out for selected profile points of the rope. The height of each of the strands was scaled in order to present relative height differences in the profile. Assessment of such a rope profile makes it possible to assess the quality of rope surface. It is also possible to detect surface deformations arising from the use of the rope and damage to fibres in the strands.

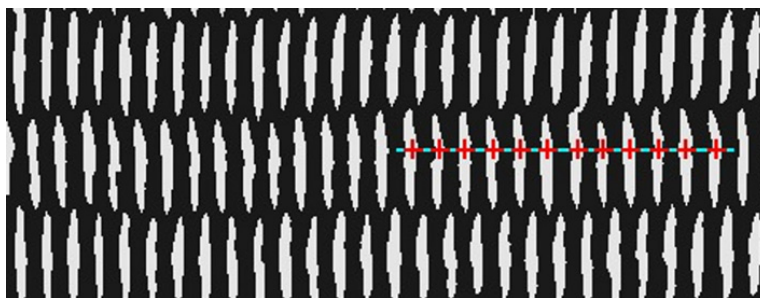
Fig. 15. Measurement of interlacing defined as the distance between successive 12 tucks in the weave

The distance between successive 12 tucks in the weave was measured using single-threshold binarization of a three-dimensional image. Due to the use of this operation, segmentation of the vertices of each of the strands illuminated by laser light was possible. As a result, an image resembling a collection of spots, which are the vertices of strands forming the surface of the rope, was obtained.

Visualization and measurement of the geometry of surface shown in Figure 15 concerns fibre ropes, which are not used in the Polish mining industry as hoisting ropes, but it shows the general diagnostic capabilities of the method as a visual testing (VT) method. As a result of image analysis, one can detect abrasions, deformations or indentations of single wires on rope
