An Influence of Nitrogen Corrosion on Microstructural and Mechanical Features of the X5CrNi18-10 Steel

E. Kantoríková ⓘD

University of Žilina, Slovak Republic
Corresponding author: E-mail address: elena.kantorikova@fstroj.uniza.sk

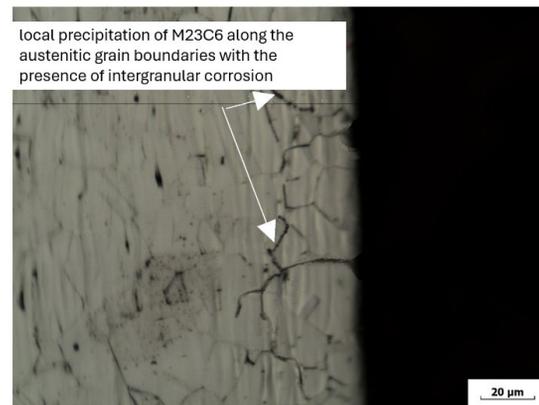
Fig. 3. Microstructure X5CrNi18-10

In Fig. 3 shows the microstructure of X5CrNi18-10, where intercrystalline corrosion can already be clearly seen along the material boundary. samples. We can observe the local exclusion of $M_{23}C_6$ carbides along the austenitic grain boundaries [27, 28, 29].

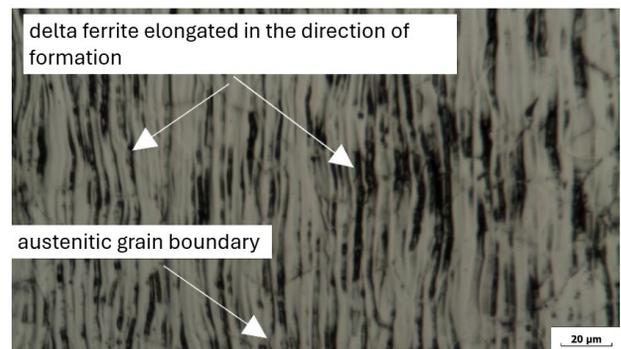
Fig. 4. Material microstructure elongated in the direction of forming

Since the test material in our case is used as a frame, welded from sheet metal, it has a characteristic structure after hot rolling. In Figure 4, we observe X5CrNi18-10 steel stretched in the form of forming.

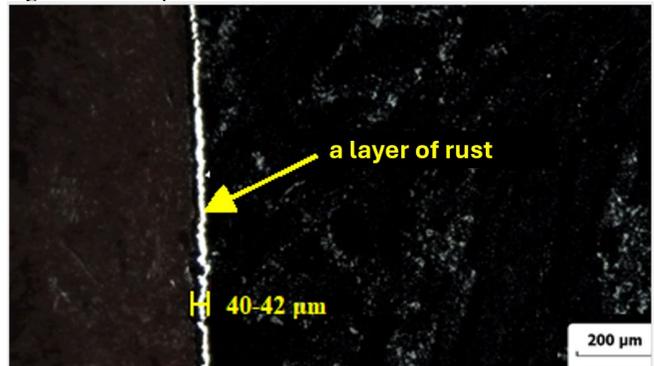
Fig. 7. Image of a layer of rust in a dark field

Since the frame is made of X5CrNi18-10 steel, which is not heat-resistant, the frame corroded quite quickly. Since the grid is repeatedly placed in the continuous furnace and exposed to temperatures from 570 to 630 °C, the black color and the formed ironwork on the frame are a common phenomenon in the given working environment. Therefore, X5CrNi18-10 steel was not the

most suitable choice for these frames. However, after a certain period of use, these frames turned black and showed significant elements of corrosion. Their condition can be seen in the following figure 6. Figure 7 presents the ironwork layer.

Determining the thickness of the rust layer is one of the first verification methods. The thickest layer measured was 42 μm on a digital microscope.

min. 12%, as little as possible of carbon, which increases susceptibility to intercrystalline corrosion [30]. By alloying with the elements Ti, Nb, Ta, which have a higher affinity to C than to Cr, we can also prevent the occurrence of corrosion, because corrosion is a very undesirable phenomenon, it causes deterioration of the material and, in more advanced stages, dysfunction of parts and components, and other additional costs are closely related to this in operation. Stainless or anti-corrosion steels are largely resistant to aggressive corrosion environments.

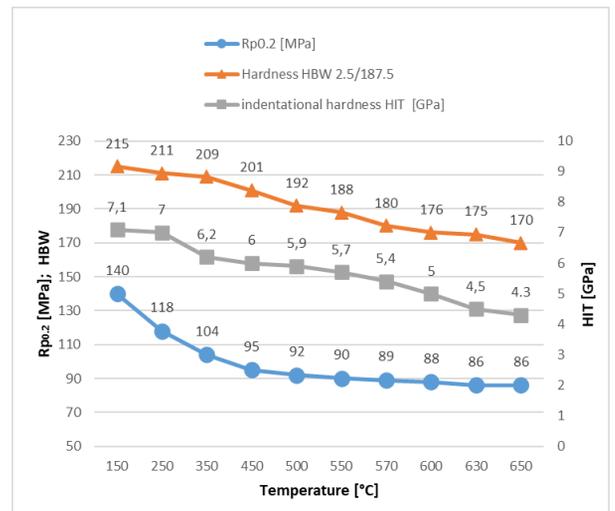
Fig. 8. Rp0.2 [MPa] – blue; Hardness HBW 2.5/187.5 – orange; HIT [GPa] – grey

Figure 8 presents a graphical evaluation of individual experimental tests. The mechanical properties have a decreasing character depending on the temperature in the nitrogen atmosphere. Knowledge of how the material reacts in the furnace atmosphere is important for practice. The obtained data show that X5CrNi18-10 steel is not suitable for working in a nitrogen atmosphere. High temperatures have a degrading effect on steel.
