Research paper

From legend to discovery – historical and geotechnical conditions related to the discovery of tunnels under The Castle Hill in Szczecin

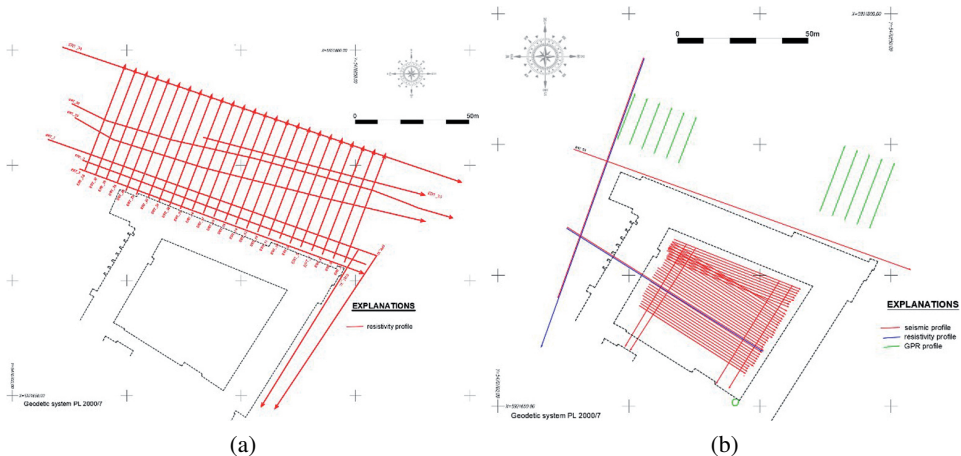
The scope of geophysical investigation included 36 ERT profiles (Fig. 3a), with total length of over 3000 m. Assumed methodology included a spacing of 2 m, 1 m and 5 m for the electrodes, using a measuring system 4×21 and 2×21 , which resulted in high accuracy and investigation up to $15 \div 17$ m b.g.l., depending on the length of the profile.

Fig. 3. Schematic of geophysical profiles at the Castle of Dukes of Pomerania in Szczecin: (a) ERT profiles during the I stage (along the terrace and the slope) [8]; (b) SRT profiles and additional ERT profiles stage II [9]

In terms of SRT seismic profiling, a total of 44 profiles (Fig. 3b) were conducted with the total length of approx. 2400 m, mostly in the area of the Castle's courtyard; tests were conducted using parallel system of profiles every 1 m, with geophones spaced every 2 m. It allowed for obtaining a prospection up to approx. 20 m b.g.l. In the courtyard area, the measurements were taken as parallel profiles every 1 m. The distance between geophones was 2 m. The signal was generated with a 10 kg hammer at every other geophon (every 4 m). 10 Hz geophones were used (registering >10 Hz). The investigation was done using 2D method. Measurements were difficult due to car traffic vibrations nearby. In order to improve the quality of the signal, multiple seismic excitation (up to 15 times) was implemented.
