**Research paper****Safety issues related to the use of closed profiles  
in steel girders****Marcin Górecki<sup>1</sup>, Małgorzata Snela<sup>2</sup>,  
Ewa Błazik-Borowa<sup>3</sup>, Anna Halicka<sup>4</sup>**

**Abstract:** This paper analyses the stress state in the walls of a closed steel profile caused by freezing water filling the interior of the profile. The study focuses on a specific case of two damaged girders, where the failure was attributed to freezing water trapped inside the upper chords of the girders. The analysis revealed that the resulting stresses exceeded the steel's strength, leading to deformation and rupture of the upper chord profiles. The article describes the damage observed in the girders, including outward deformation of the walls and cracks along the bending edge. The presence of water and corrosion products inside the profiles was confirmed through inspections. Finite element calculations were performed to assess the pressure effects, showing that the tensile stresses in the corner of the profile exceeded the yield and tensile strength of the steel. The article concludes that damage caused by freezing water expansion is unpredictable and emphasises t

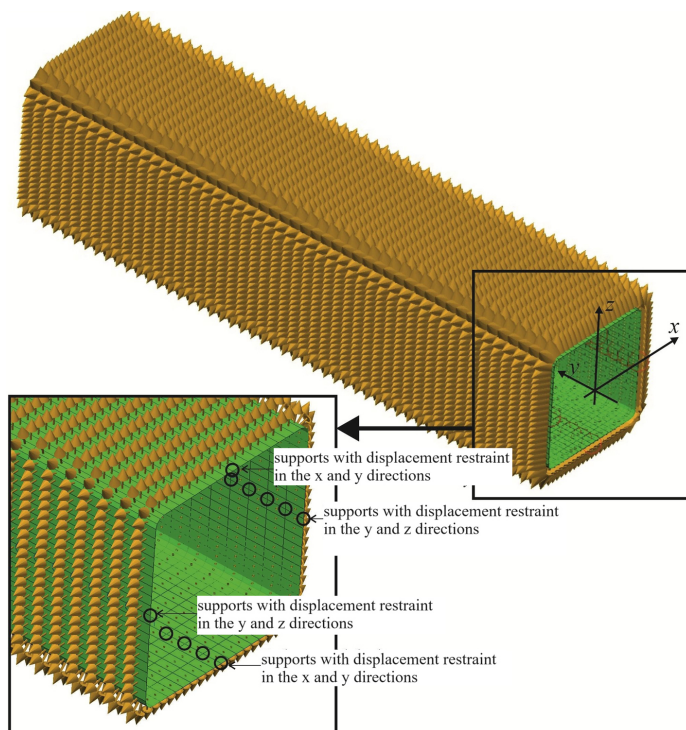
To assess the pressure effects, finite element calculations were performed (Autodesk Algor Simulation 2011 [4]). A 1-metre section of a  $200 \times 200 \times 6$  cold-formed square tube was modelled and subjected to increasing internal pressure. The model is shown in Fig. 7. Shell elements modelling the pipe surface were inserted in the middle of the wall thickness. Elastic-plastic material model calculations were used, with a yield strength  $f_y = 355$  MPa and a tensile strength  $f_u = 490$  MPa, corresponding to S355 steel according to EC3 [5]. Based on the plasticity criterion, the material followed the plastic flow law and the kinematic hardening law. Additionally, a Young's modulus value of  $E = 2.10 \cdot 10^8$  kPa and a hardening modulus of  $E_t = 0.01 \cdot E$  were assumed [6].

Fig. 7. Numerical model of a rectangular tube with pressure loading and supports
