THE INFLUENCE OF HIGHER MODES VIBRATIONS ON LOCAL CRACKS IN NODE OF LATTICE GIRDERS BRIDGES

S. PRADELOK¹

Several previous investigations on failure of a certain type lattice girders railway bridge (on so called BJD line) have not convincingly explained reasons nor have they described potential hazards. This paper attempts to provide an answer, employing static, dynamic, and fatigue analysis of the structure, focusing on previously not analyzed vibrations of elements constituting a lattice node. Detailed models of two types of such nodes – damaged and non- damaged were compared, inside carefully defined limits of applicability.

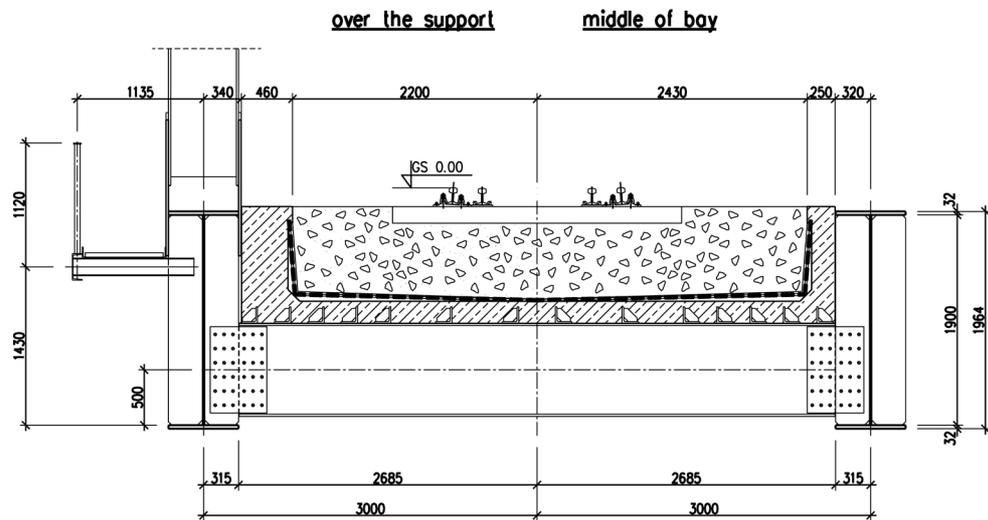
Fig. 2. Cross section.

regular railway tracks of Katowice – Krakow line. The track is laid in a reinforced concrete channel filled with rubble, as shown on cross section (Fig. 2).

through steel angles with the concrete element is questionable in any case (Fig. 2). The influence of the omitted concrete elements was modelled with additional mass placed in the bridge nodes.

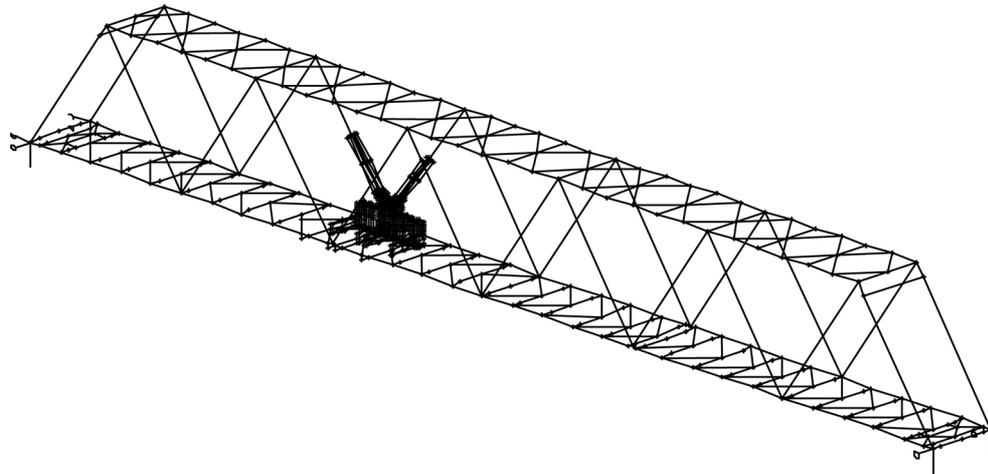
Fig. 4. Connection of membrane model of the node to the truss one.
Rys. 4. Zamocowanie powłokowego modelu węzła w prętowej kratownicy

Instead the node model was nested in a three – dimensional model of the truss, which was in turn supported on rigid supports that restrict the same number freedom dimensions as the actual bearings (Fig. 4). The connection of the node and truss models allows for correct freedom of movement.

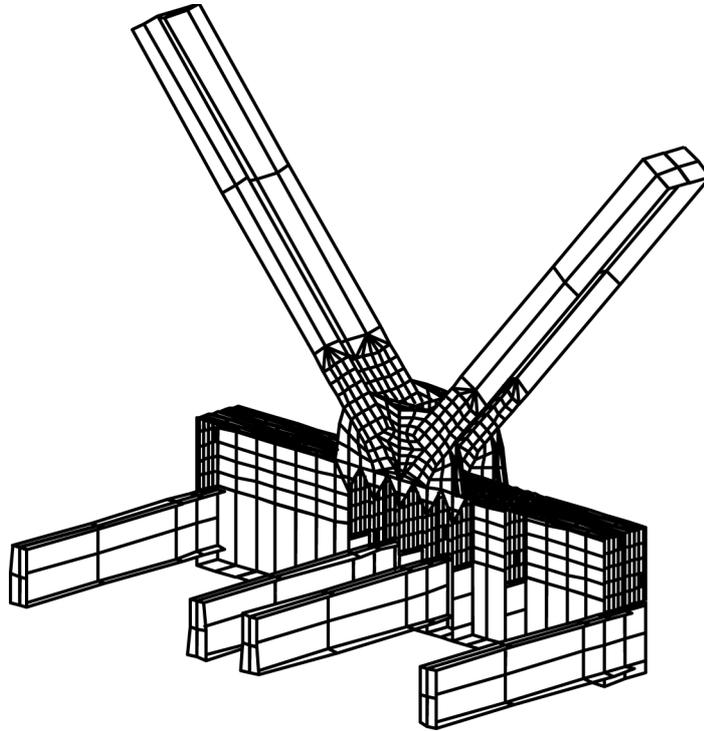
Fig. 5. Membrane model of the node.

The model purposefully did not include the concrete channel (200 mm thick), as that would prevent movements of the cross beams. Connecting of the cross beams

As it can be observed, the differences in the level of strain between the identically loaded models of the “twin” bays are substantial. There are big differences of normal stress σ_{xx} in the top and middle layers which indicate principal influence of local bending of the top flange in the bottom truss chord.
