Poznan University of Technology  
Chair of Thermal Engineering  
Poznań

## Analysis of heat load in a biomass-fired boiler

This paper discusses an exemplary cooperation between a research center, industry and technical inspection authorities. The purpose of the investigations (carried out to find the failure of a biomass-fired boiler in a heating plant) is an analysis of the effect of operating water boiler conditions on the heat load of the heating surface. The analysis concerns the reasons for failure of the membrane heat exchanger of the water-gas type being a basic heating surface of the boiler burning biomass. During the operation of the boiler some cracks perforated the bottom and smoke tube endings occurred.

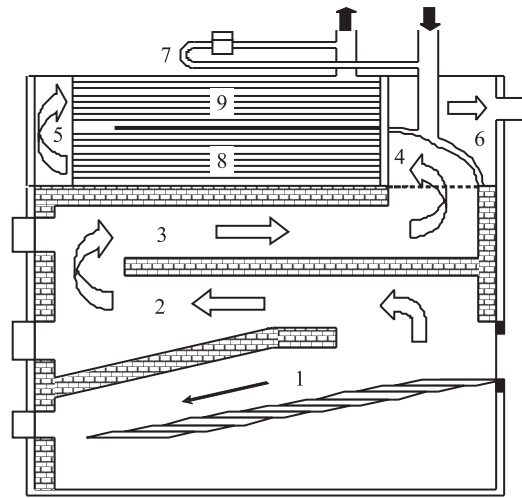
The schematics of a water boiler, which was heated with woodchips and fitted with a steel membrane heat exchanger, has been presented in Fig. 1. The boiler consisted of a ceramic combustion chamber and a mechanical stoker cooled with water (1), ceramic exhaust gas manifolds (2, 3), a membrane heat exchanger of exhaust gas-water type consisting of a return chamber (4) directing the exhaust gas flow towards the first bank of smoke tubes (8), a back return chamber (5), the second bank of smoke tubes (9), a collecting chamber with a flue and a heat exchanger (7) protecting the boiler against an excessive temperature increase. In order to ensure complete fuel combustion possible the boiler was made of chamotte brick.

Figure 1. The schematics of water biomass-fired boiler.

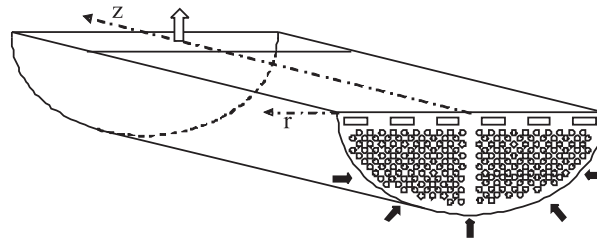
The schematics of the bottom part of the steel heat exchanger (exhaust gas-water type) have been shown in Fig. 2. The heat exchanger consisted of two perforated bottoms of 1.970 m in diameter, between which there were four bundles of pipes with dimensions of  $D = 60 \times 3.2$  mm and length of 5 m. The two lower bundles formed the first exhaust gas draught of the heat exchanger closed by a return chamber and two upper bundles from the second exhaust gas draught closed by a collecting chamber with the flue.

Figure 2. The model of pipe banks in the first draught of the heat exchanger.

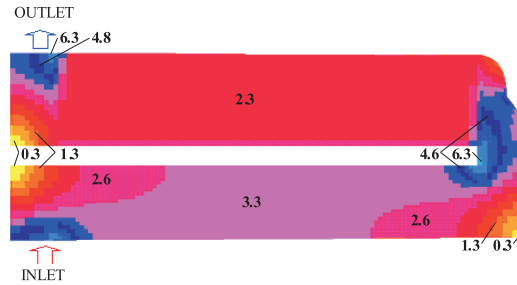
The presentation of the results concerning the exhaust gas is limited to the last ceramic draught and the first draught of the heat exchanger. A distribution of velocities in the considered fragment has been shown in Fig. 3. The presented figures indicate some diversification of the exhaust gas velocity values caused by different shapes of the exhaust gas manifolds and their sizes.

Figure 3. The distribution of velocity, [m/s].

The exhaust gases flowed in the last ceramic draught of the boiler through the rectangular opening. Then, the exhaust gases changed their direction into horizontal according to the manifold arrangement. The exhaust gases flowing into the heat exchanger flow in a two-arc manifold properly shaped enabling a uniform exhaust gas distribution among the first draught smoke tubes of the heat exchanger. As it can be seen in the relevant drawings there is a correct distribution of the mass flows because a mass flow is a linear velocity function. Figure 3 shows that there was no significant velocity change along the perforated bottom height which denotes a non-uniform flow of the exhaust gases in the first bank of the smoke tubes.

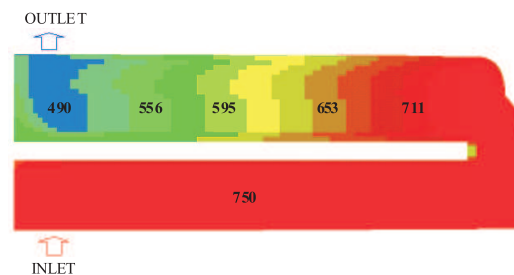
The next parameter which was analyzed in the numerical calculations was the exhaust gas temperature decrease during the flow in the heat exchanger pipes. A distribution of the exhaust gas temperature change during its flow through the manifold of the last ceramic boiler draught and the first heat exchanger draught has been presented in Fig. 4. After analyzing the distribution of the exhaust gas temperature and comparing it with the velocity distributions a uniformity of dis-

Figure 4. The distribution of temperature, [°C].

tributions in the cross-sections of the exhaust gas manifolds has been seen. There was a significant decrease in the exhaust gas temperature along the way of the exhaust gas flow through the heat exchanger, resulting from the heat exchange between the hot exhaust gas flowing inside and water outside the piping. These changes were small across the exchanger. There were no significant temperature changes in the ceramic part.

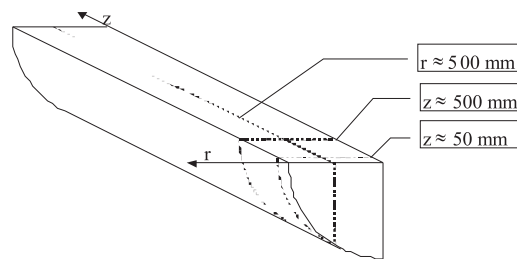
The next step of the investigations dealt with an analysis of the water flow inside the heat exchanger and included the determining of the velocity distributions. The structure of a flow inside the jacketed exchanger is very complex. It is determined by the location of the input openings and an arrangement of pipes in the individual bundles in relation to the direction of the water outflow. In order to explain the mass transport mechanisms three control sections were used. The location of the control sections has been shown in Fig. 6. Two control sections were located in the transverse plane in the distance of 50 mm and 500 mm from the perforated bottom, respectively, and one in the longitudinal plane in a distance of 500 mm from the axis of the heat exchanger. The redistributions of the velocity in sections were normalized by the local maximum velocity.

Figure 6. The principal section in first part of heat exchanger.
