APPLICATION OF GUIDED WAVE PROPAGATION IN DIAGNOSTICS OF STEEL BRIDGE COMPONENTS

M. RUCKA¹, B. ZIMA², R. KĘDRA³

Keywords: non-destructive testing, damage detection, condition assessment, guided wave propagation, steel bridges

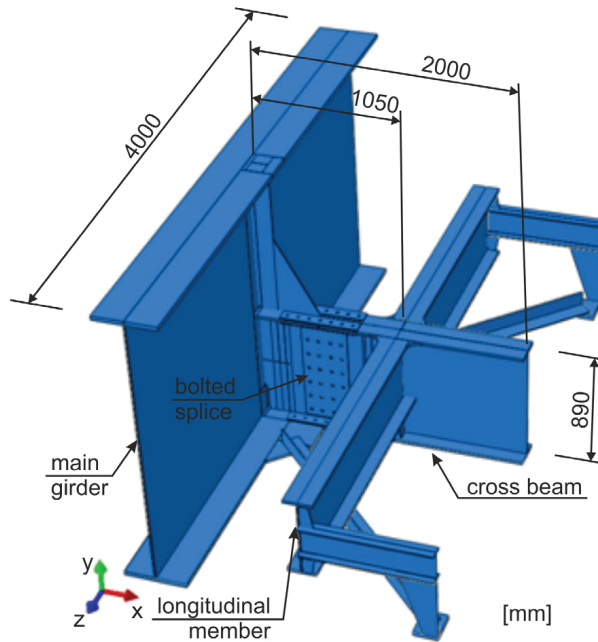
Fig. 3. Considered fragment of steel railway bridge

In order to verify the possible use of diagnostic methods based on guided wave propagation to bridge structures, numerical analysis by the finite element method (FEM) has been performed. One section of a typical through plate girder railway bridge with the open road was investigated. The geometry of the model is shown in Figure 3. It consists of the main girder with a length of 4000 mm which is connected in the middle of the span to the cross beam with a length of 2000 mm. In the place of their connection stiffening plates are applied. The longitudinal member is situated in parallel with the main girder at a distance of 1050 mm from it. All these elements were designed as I-beams composed of plates of dimensions given in Table 1. The connections between the web and flanges were performed as welded with fillet welds. The wind bracing is connected to the main girder and the cross beam by a gusset plate. The splice is symmetric with respect to the vertical axis and it consists of 7 steel cover plates and 56 prestressed bolts with a diameter of 20 mm. In the vertical part of the joint the connectors are arranged in 7 rows and 4 columns. The examined joint of the web and flanges of the cross beam was designed as a double lap connection of class C (slip-resistant at ultimate limit state) and bolts are class 8.8 [15]. All other connections i.e. the connection of the longitudinal member with the cross beam or the connection of the stiffening plate with the main girder and the cross beam are designed as welded joints.

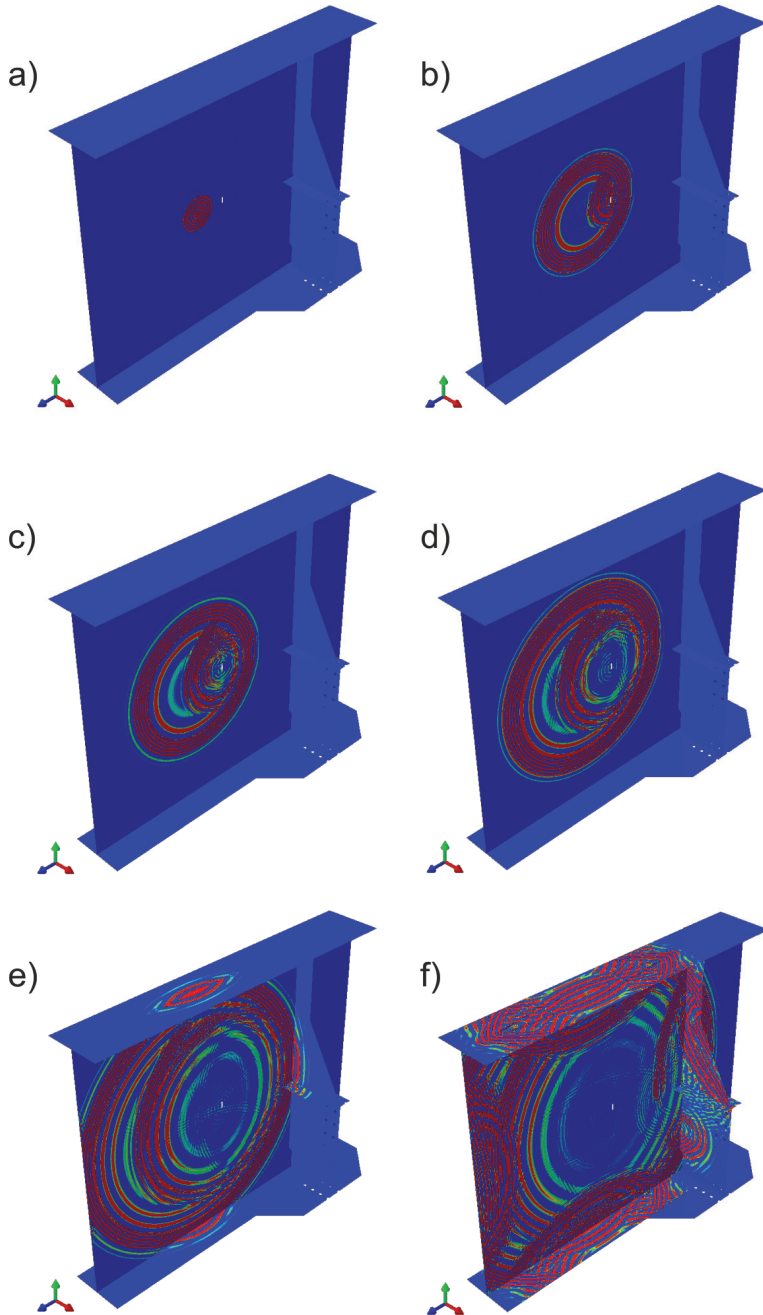
Fig. 6. Maps of velocity field propagated in plate girder at selected time instances: a) 0.05 ms; b) 0.15 ms; c) 0.20 ms; d) 0.25 ms; e) 0.35 ms; f) 0.45 ms

Visualization of the propagating wave in the form of maps of the velocity field (perpendicular to the surface of the plate) at the selected time instances is presented in Figure 6. In Figures 6b and 6c the disturbance reflection from the notch is visible and in Figure 6f wave with much higher energy is reflected from the edges. In the case of damage with small dimensions, the differences between amplitude values reflected from edges and reflected from damage are very high. Thus, a general problem of non-destructive testing based on the phenomenon of guided wave propagation is to extract appropriate information from the signal. Individual reflections interfere with each other that cause additional problems with interpretation of results. If the notch is located closer to the edge, a risk that the reflection from it would be unnoticed without special techniques of signal processing or without checking the same damage scenario for different configurations of sensors arises.

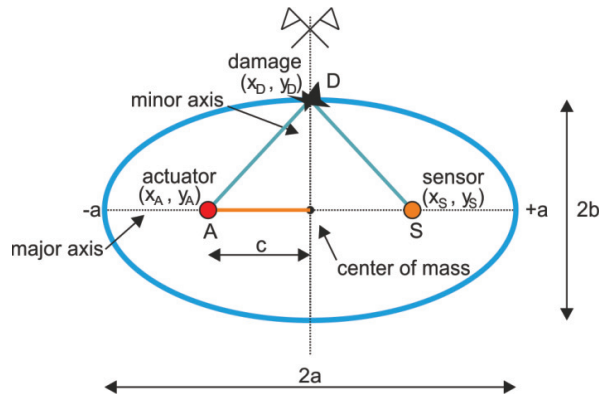
Fig. 7. Geometrical relationship between location of actuator (excitation point), sensor (registration point) and damage

It can be noticed that the distance is equal to the sum of position vectors in the ellipse which presents all possible damage locations in a plate (Figure 7). Because from a single signal only one value of the time-of-flight can be extracted, one solution in the form of the ellipse can be plotted. To obtain accurate position of damage, at least three ellipses must intersect with each other. A simple scheme of the procedure of determining the location of damage for configuration of three sensors and one actuator is presented in Figure 8.

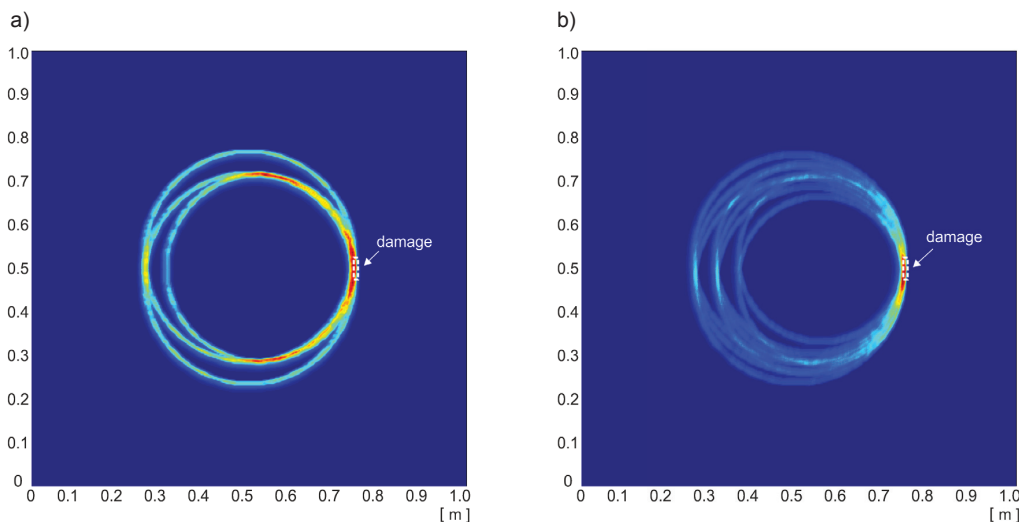
Fig. 10. Damage map for plate girder calculated on the basis of numerical wave propagation signals registered by: a) three sensors (configuration #1); b) eight sensors (configuration #2)

The sensitivity of damage localization algorithm is strictly correlated with the number of sensors and their configuration. The bigger number of signals is used during analysis, the more accurate results are obtained. To show the influence of the number of sensors which take part in investigation, the same damage scenario with another configuration of sensors (configuration #2) was examined. The location of the excitation point was shifted from the plate centre and additional registration points were taken into account. The damage map obtained for eight signals is presented in Figure 10b. The identification of damage position is much more precise than for configuration #1 as a result of non-symmetrical configuration of sensors and a large number of signals that were used in the process of damage map creation.

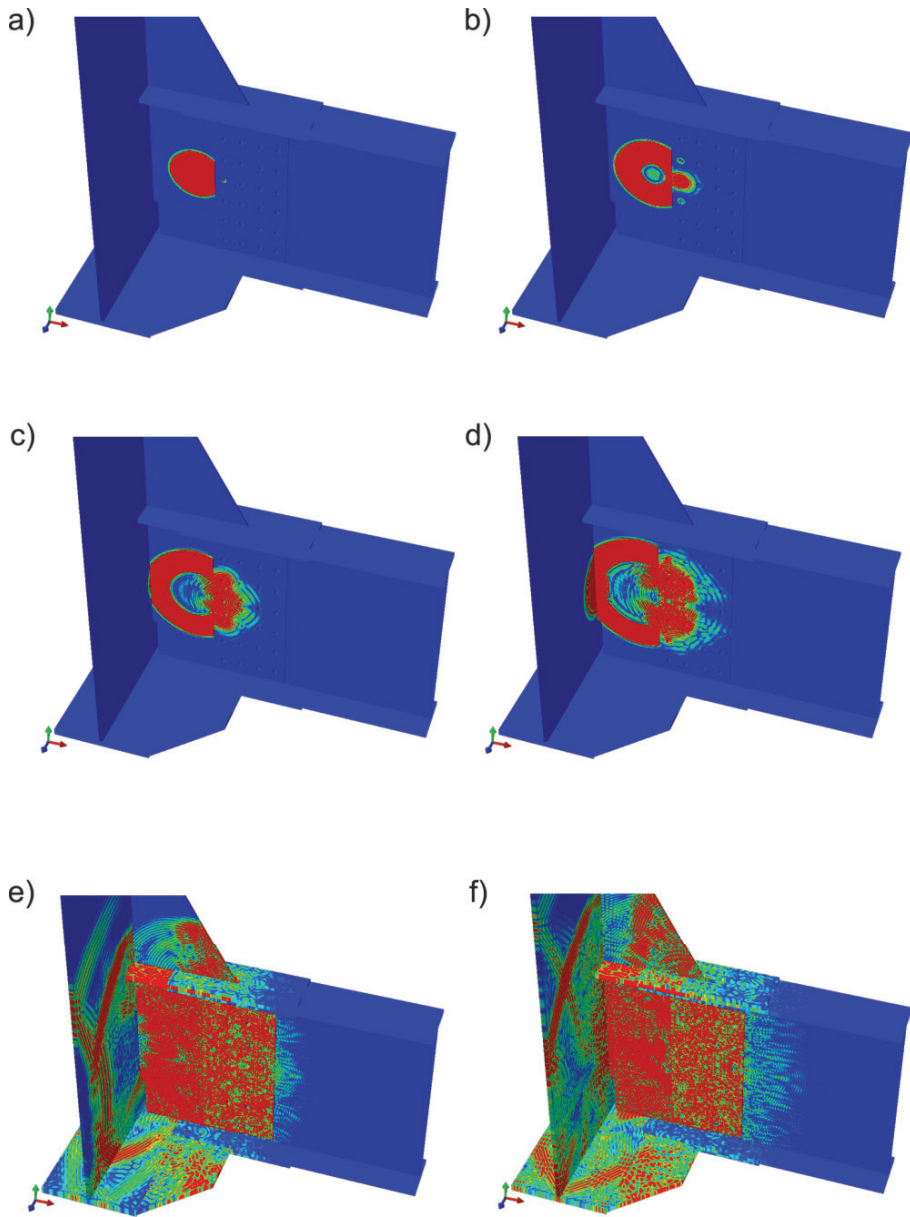
Fig. 11. Maps of velocity field propagated in bolted joint of cross beam at selected time instances: a) 0.048 ms; b) 0.68 ms; c) 0.88 ms; d) 0.108 ms; e) 0.26 ms; f) 0.32 ms

Visualization of propagating waves in the bolted joint at the selected time instances is presented in Figure 11. The wave packet was excited in the cross beam web, near the connection with the main girder. When the wave reached the location of the connection it propagated in the overlay plates by bolts. All connection points became sources of new waves and then disturbances passed into the attached part of the cross beam. Results of numerical analyses indicated strong scattering of waves in the bolted joints area.

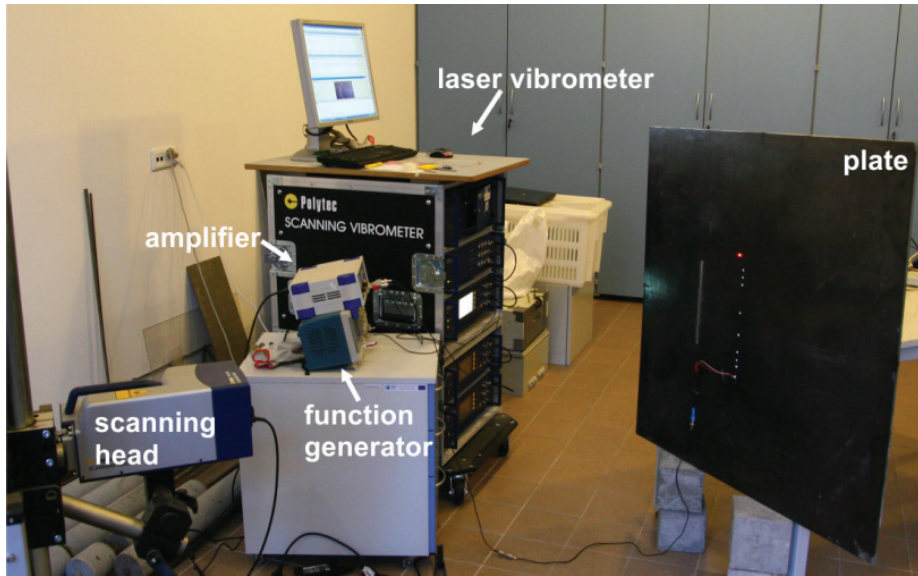
Fig. 14. Instrumentation for measurements of out-of-plane waves in steel plate

A steel plate of length $L = 1000$ mm, width $B = 1000$ and thickness $d = 5$ mm was considered as a testing structure. The experimentally determined mass density ρ was equal 7872 kg/m^3 , the modulus of elasticity E and the Poisson's ratio were 205.35 GPa and 0.28, respectively. Damage in the plate was introduced as a change of plate thickness on a rectangular area of $250 \text{ mm} \times 12.5 \text{ mm}$. The depth of the defect was equal to 2.5 mm. The photo of the experimental setup is given in Figure 14. Lamb waves were generated by the piezoelectric actuator Noliac CMAP11. The excitation was in the form of a five cycle sine modulated by the Hanning window. The value of the excitation frequency was equal to 150 kHz. Velocity signals $v(t)$ (i.e. components perpendicular to the plate surface) were recorded by the scanning laser vibrometer Polytec PSV-3D-400-M. Measurements were characterized by a very high degree of repeatability.

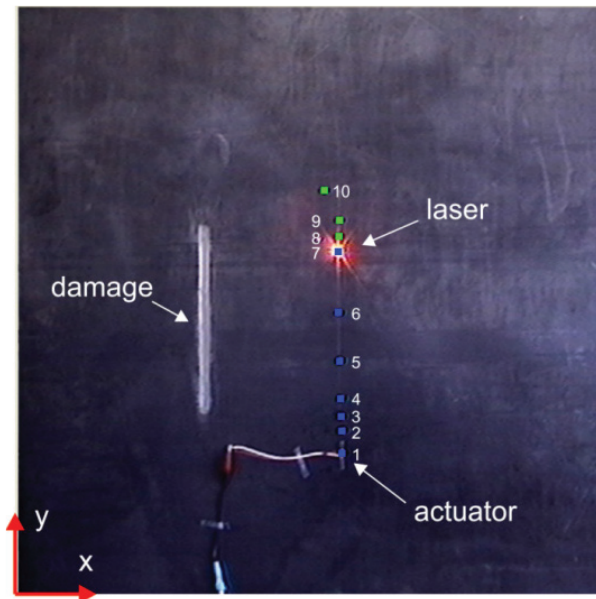
x [mm]	y [mm]
1	457.5	315
2	457.5	345
3	457.5	365
4	457.5	385
5	457.5	435
6	457.5	500
7	457.5	580
8	457.5	600
9	457.5	620
10	437.5	660

Fig. 15. Configuration of measurement points and actuator

During experiment one spatial configuration of measurement points was considered. The signal was generated at point no. 1 and sensed at points no.1 to 10. Almost all registration points were situated on a straight line, as it is shown in Figure 15. One point shifted from that line was required to assess the direction from which wave propagated. The difference between the value of the time-of-flight for point no. 9 and point no. 10 allowed avoiding the problem of the symmetry of results.

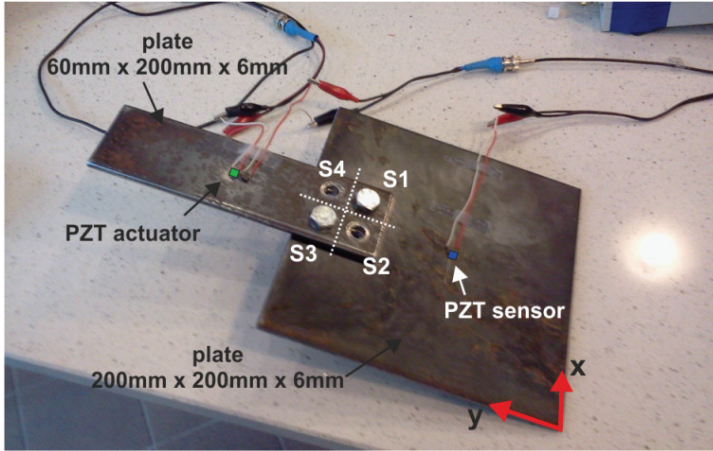
x [mm]	y [mm]
S1	113	157
S2	87	157
S3	87	183
S4	113	183

Fig. 18. Model of bolted lap joint and configuration of sensor and actuator

The research was conducted for a single lap bolted joint. It was made of two steel plates $6 \text{ mm} \times 60 \text{ mm} \times 200 \text{ mm}$ and $6 \text{ mm} \times 200 \text{ mm} \times 200 \text{ mm}$. In each plate four circular holes of 11 mm diameter were cut to assemble with the use of bolts (S1 to S4, as shown in Figure 18). Bolts of 10 mm diameter and 80 mm length were made with steel of class 8.8. The value of bolt torque moment applied to bolts with the use of a torque wrench was equal to 10 Nm. Guided waves were excited and registered in the transverse direction by PZT actuators Noliac CMAP11 of dimensions $5 \text{ mm} \times 5 \text{ mm} \times 2 \text{ mm}$ bonded at two side of the connection (Figure 18). The arbitrary waveform generator Tektronix AFG 3022 with the high voltage amplifier EC Electronics PPA 2000 generated the excitation voltage signal which was converted into a mechanical force by the PTZ actuator. The digital oscilloscope ScopeDAQ was used to register signals with a sampling frequency of 2 MHz.

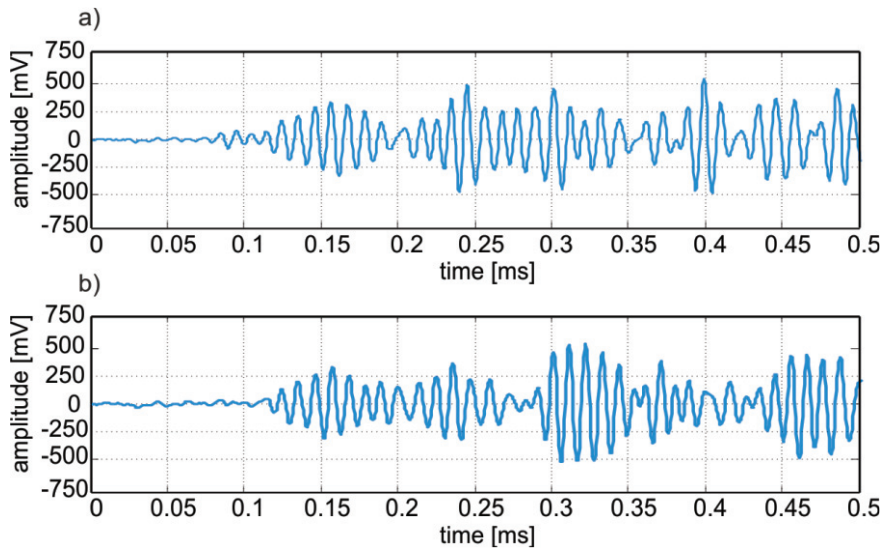
Fig. 19. Set of experimental wave propagation signals registered in bolted connection: a) damage scenario #1; b) damage scenario #2

Four damage scenarios of bolt loosening were considered (Table 3). Damage scenario #1 was a pristine joint with four bolts. In next scenarios (#2, #3, #4) one bolt (S2), two bolts (S3, S3) and three bolts (S2, S3, S4) were removed from the joint, respectively. The experimental results in the form of time signals of propagating waves for damage scenarios #1 and #2 are shown in Figure 19. The variation of these two signals is similar, but some qualitative changes can be observed. After removing one bolt (S2) the maximum amplitude of the signal in the time interval 0–0.3 ms decreased by 2%. For the pristine joint the separation of the wave packet in the time interval 0.1–0.2 ms can be observed. However, in damage scenario #2 this separation is not visible due to the interference of waves.

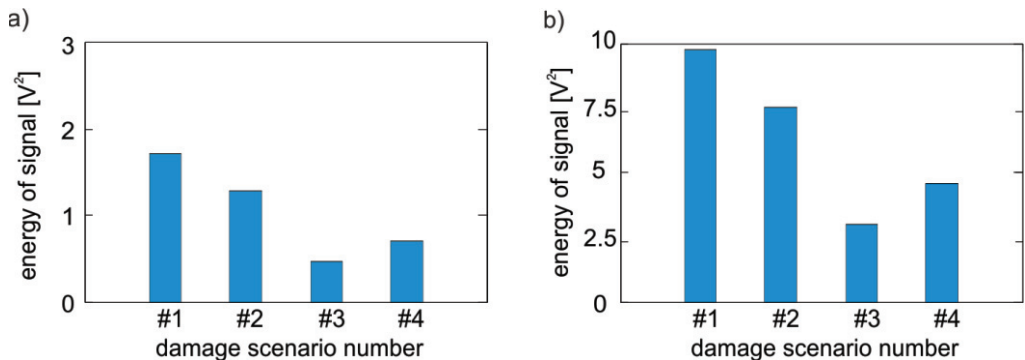
Fig. 20. Energy of experimental signals registered in bolted connection for different damage scenarios: a) in time interval 0–0.2 ms; b) in time interval 0–0.25 ms

The quantitative characteristics of the output signals for different damage scenarios were determined by the calculation of signal energies (Figure 20). Comparing energies of signals in time intervals 0–0.2 ms and 0–0.25 ms for all realised damage scenarios

a decrease in the signal energy can be observed with reference to the pristine joint. The scale of decrease was dependent on the position of the removed bolt. The results indicated that the damage index based on the energy of registered wave propagation signals gives a possibility for the state monitoring of the connection. However, it is worth noting that subsequent removing of fasteners does not always lead to a decrease in the signal energy values. It can be seen by comparing the signal energy for damage scenarios #3 and #4.
