ARCHIVES
of
FOUNDRY ENGINEERING

The Effect of a Thin-Wall Casting Mould Cavity Filling Conditions on the Casting Surface Quality

The paper presents results of metallographic examination of faults occurring in the course of founding thin-walled cast-iron castings in furan resin sand molds. A non-conformance of the scab type was observed on surface of the casting as well as sand buckles and cold shots. Studied the chemical composition by means of a scanning electron microscope in a region of casting defects: microanalysis point and microanalysis surface. Around the observed defects discloses high concentration of oxides of iron, manganese and silicon. A computer simulation of the casting process has been carried out with the objective to establish the cause of occurrence of cold shots on casting surface. The simulation was carried out with the use of NovaFlow & Solid program. We analyzed the flowing metal in the mold cavity. The main reason for the occurrence of casting defects on the surface of the casting was gating system, which caused turbulent flow of metal with a distinctive splash stream of liquid alloy.

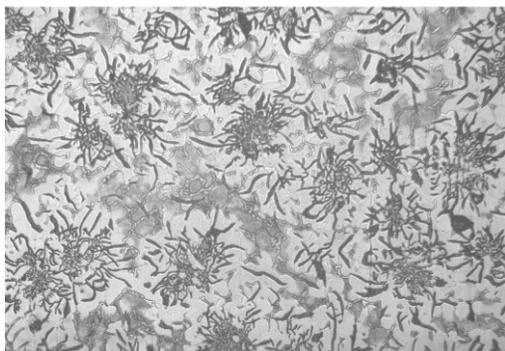
The subject of the presented study was a thin-walled casting made of cast iron with flake graphite and ferritic-pearlitic matrix, containing 3.3% C, 2.8% Si, and 0.5% Mn. The temperature at which the mould was poured with liquid metal (the pour point) was 1340°C. Microstructure of the cast alloy is shown in Fig. 1.

Fig. 1. An example microstructure of thin-wall casting. Note rosette pattern of flake graphite distribution and ferritic-pearlitic matrix. Etched with Nital ($\times 100$ magnification)
