Arch. Metall. Mater. 63 (2018), 2, 889-897

RESIDUAL LIFE OF BOILER PRESSURE PARTS MADE OF THE 13CrMo4-5 STEEL AFTER LONG-TERM OPERATION IN A CREEP CONDITIONS

This paper presents the method for determination of the time of further safe service for welded joints of boiler components after exceeding the design work time. The evaluation of the life of the parent material and its welded joints was performed. Microstructure investigations using a scanning electron microscope, investigations of strength properties, impact testing, hardness measurements and abridged creep tests of the basic material and welded joints were carried out. The investigations described in this paper allowed the time of further safe service of the examined components made of 13CrMo4-5 steel to be determined. The method for determination of the time of safe service of boiler components working under creep conditions allows their operation beyond the design service life. The obtained results of investigations are part of the materials database developed by the Institute for Ferrous Metallurgy.

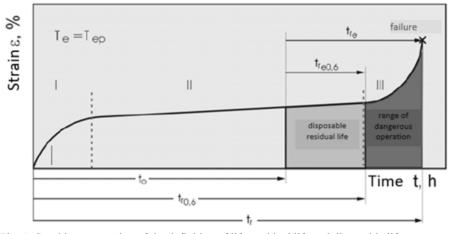
t_o – design life time t_b – disposable life t_r – life time t_{be} = t_b – t_o – disposable

residual life t_{re} = t_r – t_o – residual life t_{e} – operating temperature

Fig. 1. Graphic presentation of the definition of life, residual life and disposable life

In practice, in addition to the life time, the concept of residual life t_{re} , which relates to the extension of the time of safe service of power system components working under creep conditions, especially beyond the design service time, is also used frequently. It is defined as a difference in time between the practical time to rupture t_r and the real time of service t_e , i.e. $t_{re} = t_r - t_e$. However, the determination of residual life is not sufficient to determine the time of safe service. Therefore, the concepts of disposable life t_b and disposable residual life t_b were introduced. The disposable life t_b (t_{be}) is a part of the lifetime t_r (t_{re}). The value of this life time is the time corresponding to the end of viscous creep of the examined material [1]. The graphic presentation of the definition of life, residual life and disposable life is shown in Fig. 1.

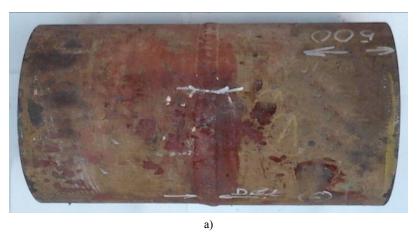
Fig. 2. Material for investigations as a test specimen of: a) primary steam pipeline after more than 200,000 h service; b) RH2 header (second-stage secondary steam superheater) after 150,000 h service, consisting of the parent material and circumferential weld joint

Based on the diagnostic tests and measurements, including nondestructive materials testing on industrial facilities and operating experiences, the primary steam pipeline and the second-stage secondary steam superheater header (RH2) were selected out of the examined 13CrMo4-5 (15HM) components and test specimens for investigations, along with a peripheral welded joint after long-term service, were taken from them (Fig. 2).

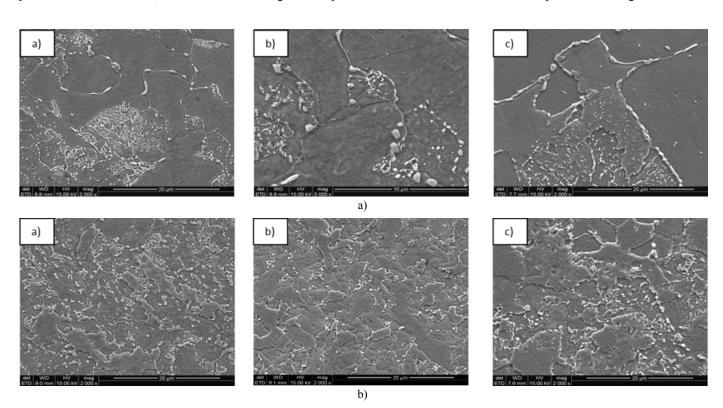
Fig. 3. Structure of the material of test specimen at circumferential welded joint of the 13CrMo4-5 primary steam pipeline after more than 200,000 h service, observed with a scanning electron microscope a) and b) parent material – left-hand side; c) parent material – right-hand side

The test results in the form of the microstructure images of the material of primary steam pipeline after more than 200,000 h service are shown in Fig. 3a, while the microstructure image of the circumferential welded joint, and in particular of the heat affected zone on the left and right-hand side of the weld and the material of weld, is shown in Fig. 3b. The test results in the form of the microstructure images of the material of RH2 header after 150,000 h service are shown in Fig. 4a, while the microstructure image of the circumferential welded joint, and in particular of the heat affected zone on the left and right-hand side of the weld and the material of weld, is shown in Fig. 4b.

The parent material of the steam pipeline (Fig. 3a) (left and right side) was characterised by the ferritic microstructure with pearlite and bainite areas, which due to the long-term impact

of temperature and stress were partially degraded, revealing the disappearance of the lamellar microstructure of pearlite and coagulation of precipitates in bainitic areas. Few very fine precipitates within the ferrite grains were also visible, whereas, at the grain boundaries, numerous fine precipitates forming chains in places were observed. The heat-affected zones of the examined joint were characterised by a fine-grained bainiticferritic microstructure with numerous precipitates at and within the grain boundaries (Fig. 3b).

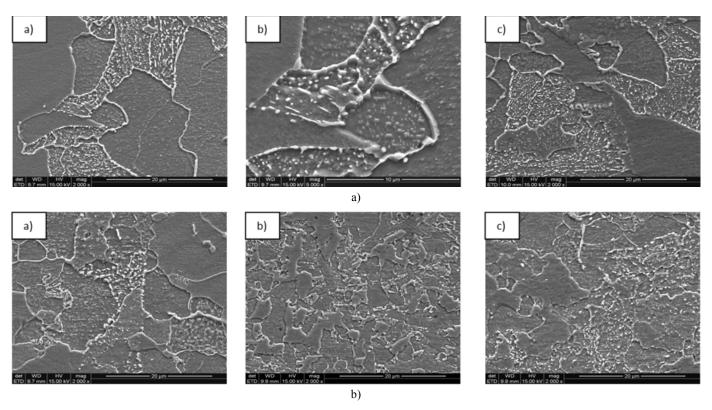
Fig. 4. Structure of the material of test specimen at circumferential welded joint of the 13CrMo4-5 RH2 header after 150,000 h service, observed with a scanning electron microscope: a) and b) parent material – left-hand side; c) parent material – right-hand side

Similarly to the steam pipeline's material (Fig. 3a), the parent material of the RH2 steam header (Fig. 4a) (left and right side) was also characterised by the ferritic microstructure with pearlite and bainite areas. However, the bainite/pearlite areas were characterised by a lower degree of degradation. A slight decomposition of the lamellar microstructure of pearlite and the coagulation of precipitates within the bainite areas was visible only. Within the ferrite grains, single very fine precipitates were observed, whereas, at the grain boundaries, single fine precipitates were observed. In the heat-affected zone of the examined header joint, fine-grained microstructure, mostly with very fine precipitates at the grain boundaries, was observed (Fig. 4b).

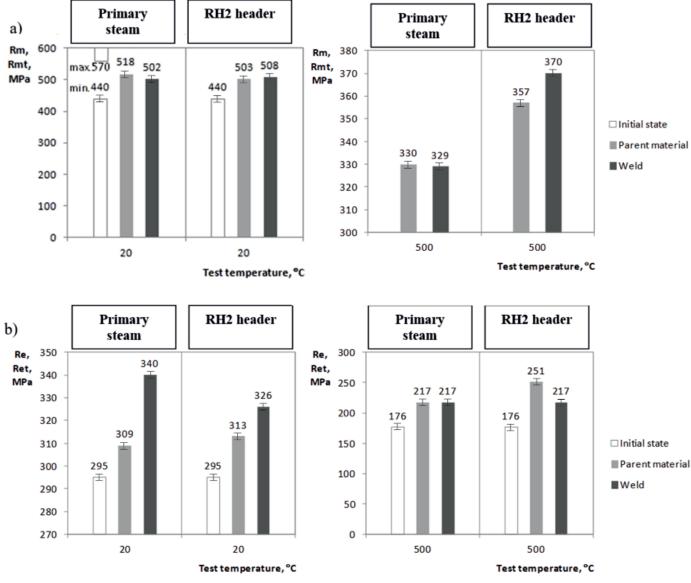
Fig. 5. Comparison of the results of investigations of mechanical properties of the primary steam pipeline and RH2 header test specimens after 200,000 h service under creep conditions, at room and elevated temperature: a) tensile strength; b) yield point

The investigations of strength properties were carried out as part of the tensile test at room temperature and the elevated temperature similar to the operating one. The comparison of obtained results of investigations on tensile strength (R_m, R_m^t)

depending on test temperature is shown in Fig. 5a and on yield point (R_e , R_e^t) is shown in Fig. 5b for the examined materials of 13CrMo4-5 (15HM) primary steam pipeline and RH2 header test specimens after long-term service.

The analysis of the results of mechanical tests, obtained in the static tensile test at room and elevated temperature close to the long-term operation temperature of the examined components, shows that the properties of both the material of the steam pipeline and the material of the steam superheater's RH2

header are higher than the minimum properties required for 13CrMo4-5 steel in the as-received condition. Yet, their loss cannot be determined unambiguously, as there are no results of acceptance tests available for these materials.

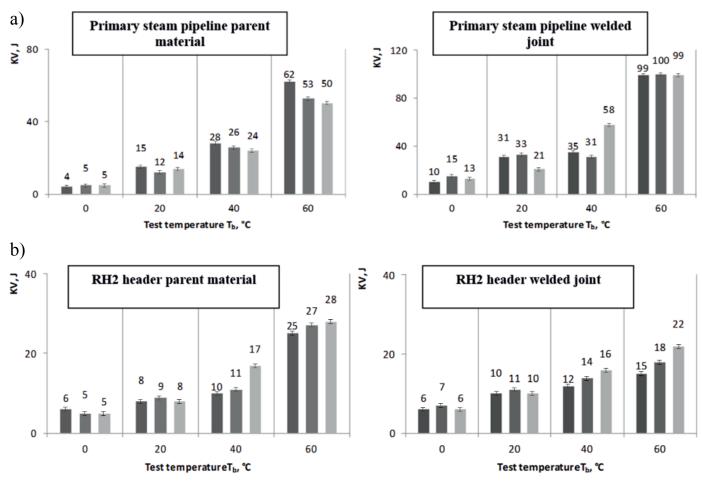
Fig. 6. Comparison of impact strength results for the material of test specimens and circumferential welded joint of: a) the primary steam pipeline and b) RH2 header after long-term service under creep conditions

Impact tests were carried out on longitudinal test specimens with the V-notch perpendicular to the surface of the examined elements of the primary steam pipeline and RH2 header test specimens after long-term service. The longitudinal test specimens were broken with Mohr-Federhaff impact testing machine with the maximum impact energy of 294J. The tests were carried out within the temperature range from 0 to 60°C. The values of temperature were selected for the examined component from case to case. The comparison of the obtained test results and curves made for the material of pipeline and header and the element of the circumferential weld joint from 13CrMo45 (15HM) steel are shown in Fig. 6a and 6b, respectively.

The nil ductility transition temperature of the examined components of the primary steam pipeline is approx. +40°C, while for the weld it is approx. +15°C. The brittle fracture appearance temperature of the RH2 header is +60°C, while for the weld it is above +60°C.

The obtained results of impact tests indicate that there is no correlation between the impact energy and the degree of degradation of microstructure and strength properties of 13CrMo4-5 steel. In contrast, the high values of brittle fracture appearance temperature of the examined components and their welded joints show the need to take them into account when starting up and shutting down the boiler.

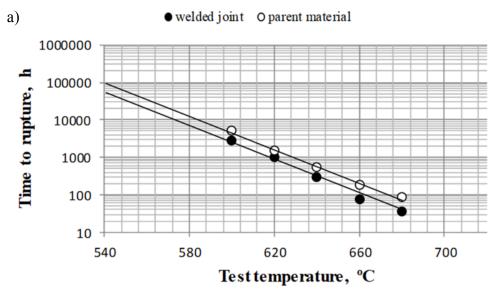
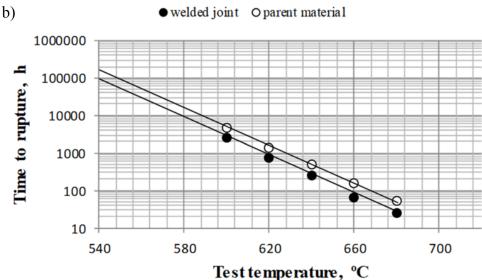
Fig. 7. Disposable residual life t_{be} for test stress in function of working temperature level T_{ep} ; a) for material and circumferential weld joint of primary steam pipeline after more than 200,000 h service; b) for material and circumferential weld joint of RH2 header after 150,000 h service

The results of creep tests for the examined materials and circumferentially welded joints are shown in comparative graphs

(Fig. 7a,b) as $\log t_z = f(T_b)$ at $\sigma_b = \text{const}$, where t_z is the time to rupture in the creep test.

The obtained results of abridged creep tests allowed the residual life of the examined materials and circumferentially welded joints of the examined pipeline and header test specimens after long-term service under creep conditions to be determined by extrapolation.
