Biological and chemical corrosion of cement materials modified with polymer

Abstract. The article presents the effect of the addition of polymer to mortars with CEMI and its influence on durability under conditions of sulfuric acid or nitric and sulphur bacteria or nitrogen (nitrification and denitrification). Both acids corresponds to the products of metabolism of bacteria *Acidithiobacillus thiooxidans* and *Thiobacillus denitrificans*, *Paracoccus denitrificans* by the literature is about 0.15 mmol/dm³. The changes in tightness materials studied by determining moisture mass and absorption. Corrosion processes were identified by examination in a scanning microscope equipped with an X-ray microanalyzer and a mercury porosimeter. The research results presented showed that the solution has a significantly weaker effect on the composite cement and cement-polymer compared with the action of bacteria. The action of both environments caused two opposing processes: unsealing the structure and deposition of corrosion products.

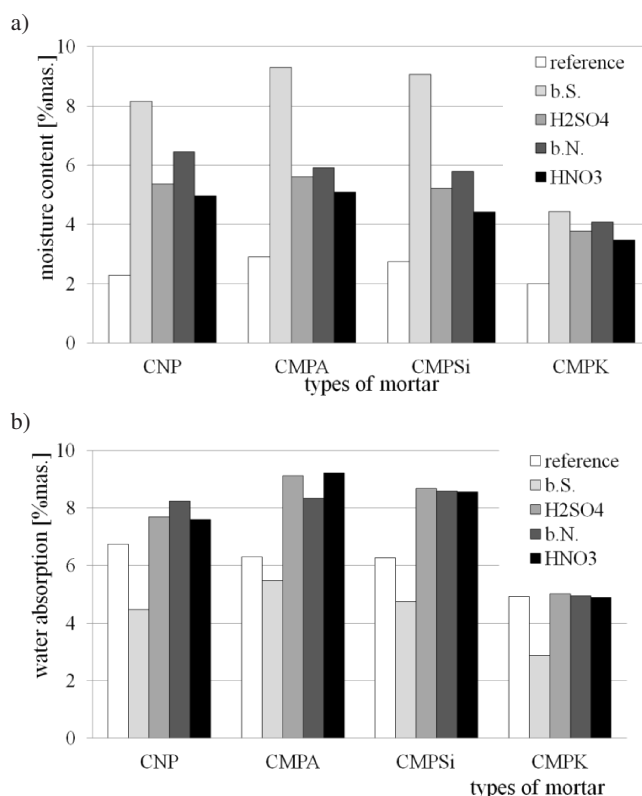
The obtained results regarding mortar humidity and absorability are presented in Fig. 1. The means of 6 measurements made after keeping the samples in solutions of sulphuric and nitric acids and sulphur and nitrogen bacteria for six months. The scatter of the results did not exceed 0.1%.

Fig. 1. Changes of a) moisture content and b) water absorption with respect to different types of mortars

The action of sulphur bacteria causes more than three-fold increase of moisture content in mortars under investigation. The composite with polycarboxylic resin had the lowest moisture content, however, 2.5 times greater than that of the reference (control) sample. For sulphuric acid the moisture content increased twice, and the mortar with polycarboxylic resin admixture showed also the lowest moisture content.

The moisture content resulting from the action of sulphuric acid is significantly lower (from about 15 to 42%) compared to sulphur bacteria. The mortar with polycarboxylic resin admixture shows the smallest difference.

When analysing the absorability results one can note that sulphur bacteria reduces this parameter by 13% for CMPA and by more than 40% for CMPK. However, the solution of

H_2SO_4 increases absorability up to 2% for CMPK and up to 45% for CMPA compared to the control samples. When comparing the sorption parameters under examination it is possible to conclude that the moisture content of a material exposed to biological environment (bacteria action) is almost two times higher than absorability. However, the absorability of materials after acid action is about 1.5 times higher. Such anomaly may be explained partly as a more intensive bacteria action and the so called biofilm formation. This is a biological membrane adhering to the solid surfaces or cell surfaces of other organisms [22–24]. It may contain bacteria, fungi, algae and protozoans [25]. A biofilm is formed by complex multi-cell structures, where numerous cells of microorganisms are enclosed with a mucus layer [26].

The exposure of tested materials to nitrogen bacteria for 6 months has a strong effect on the moisture content. The moisture content in samples exceeds more than two times the moisture level in materials not exposed to corrosive environment. The mortar without polymer admixture shows the greatest difference (almost 3-fold). However, the mortar modified with polycarboxylic resin demonstrates the lowest absorability (0.46%mas) compared to that of the control samples. The remaining values increase by 22% for CNP and by 37% for CMPSi.

The moisture content in samples exposed to nitric acid increases by 61% for CMPSi and by 118% for CNP regarding the moisture content of the control samples. The absorability of the mortar modified with polycarboxylic resin shows practically

no changes after exposure in the solution of HNO_3 . For other materials it increases by 12% for CNP and by 46% for CMPA.

When comparing the corrosive action of nitrifying bacteria and the solution of nitric acid, the biological environment causes a higher moisture content. It increases by 16% for CMPA and by 31% for CMPSi compared to the materials in the nitric acid environment. The mortar without modifier (CNP) shows the greatest changes of this feature in both environments. The absorbability of the CMPSi and CMPK samples contaminated by nitrogen bacteria is comparable with that of the sample exposed to the solution of nitric acid. The unmodified mortar shows an increase in absorbability by about 8%. In the case of polyacrylic resin the action of nitric acid increases absorbability by 10% compared to the action of bacteria.

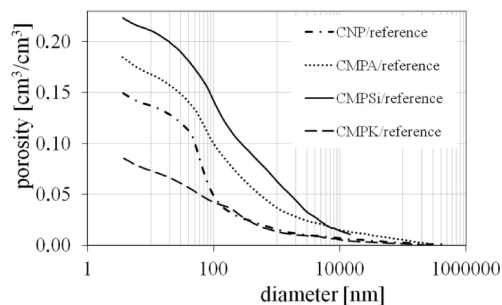
The results of porosity examination of cement and cement-polymer mortars not exposed to the action of corrosive environment by using the mercury porosimetry method are presented in Fig. 2. The results for the samples contaminated with sulphur and nitrogen bacteria are shown in Fig. 3, while for the samples exposed to the solutions of H_2SO_4 and HNO_3 are illustrated in Fig. 4.

Fig. 2. Change of porosity of cement materials not exposed to corrosive media

The examined cement mortars without polymers show the highest contribution of pores of diameters within the range of 10–100 nm in a porosity structure and its total content is $0.15 \text{ cm}^3/\text{cm}^3$. The modification of materials with polysiloxane and polyacrylic resin increases the pore content up to $0.25 \text{ cm}^3/\text{cm}^3$ and $0.18 \text{ cm}^3/\text{cm}^3$, respectively with the highest contribution of pores with diameter in the range of 80–800 nm. Polycarboxylic resin fills up the mortar pores, decreasing its content two times.

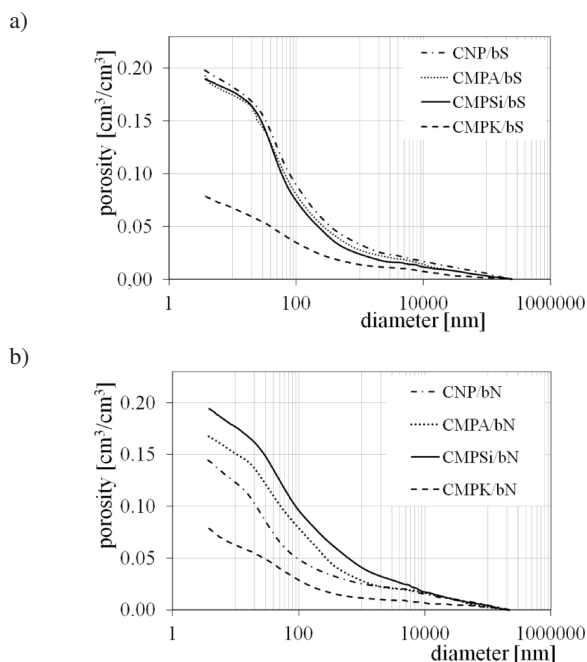
Fig. 3. The change in porosity of cement materials by the action of: a) sulfur bacteria, b) nitric bacteria

Effects of sulphur bacteria:

- increase the total pore content in the unmodified mortar (CNP) in which both porosity and pore distribution are comparable with those of material modified with acrylic resin (CMPA) and polysiloxane (CMPSi). The porosity of CMPA and CMPSi decreases compared to materials not exposed to corrosive agents, and pores of diameters between 10 and 80 nm predominate,
- do not affect the pore content and distribution in the mortar with polycarboxylic resin.

When comparing the effects of nitrogen bacteria and the solution of nitric acid on the materials under examination it is possible to state as follows:

- solution of HNO_3 causes the largest porosity changes in mortars with polyacrylic resin (CMPA). The pore content increases up to $0.8 \text{ cm}^3/\text{cm}^3$ (mortars not exposed to corrosive environment) and up to $0.25 \text{ cm}^3/\text{cm}^3$, while the pores of diameters in the range 50–100 nm. Other tested materials show no significant changes in porosity structure,
- action of nitrogen bacteria, like sulphur ones, decreases the total porosity in mortars under investigation, while the mortars modified with polysiloxanes underwent the largest changes.

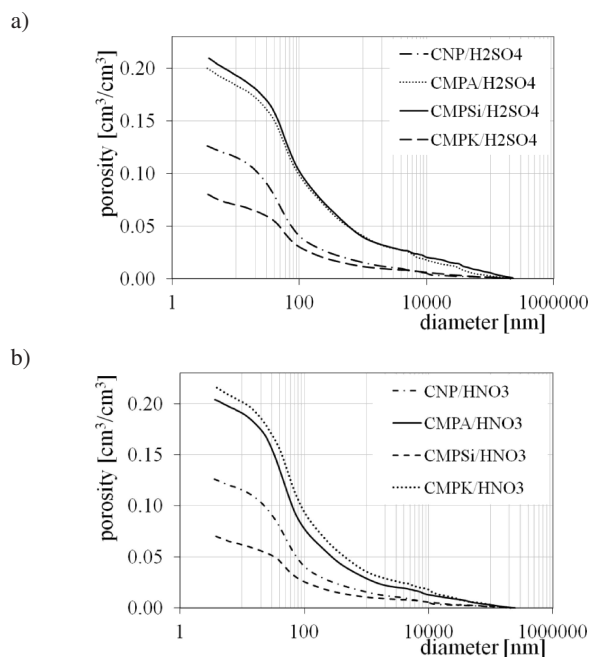
Fig. 4. The change in porosity of cement materials by the action of: a) sulfuric acid, b) nitric acid

Effects of the solution of H_2SO_4 of concentration of $0.15 \text{ mmol}/\text{dm}^3$:

- causes no significant changes in porosity structure of CNP and CMPK,
- slightly increases the porosity in CMPSi and CMPA with predominating fraction of pores of diameters of 80–500 nm.

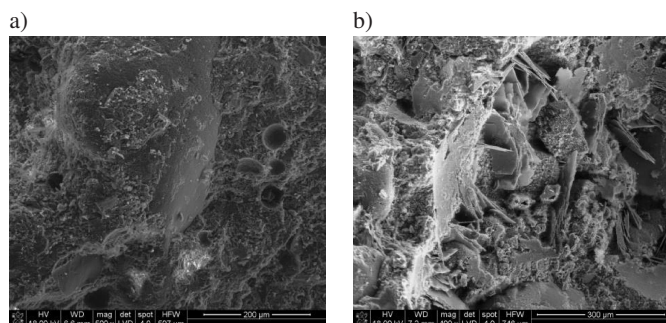
Fig. 5. Mortar a) CNP, b) CMPK – reference samples

In Fig. 5 the photographs of examined mortars not subjected to corrosive agents are present as a reference for analysing photographs of materials exposed to the corrosion process. The microstructure sealing of materials under investigation and exposed to bacterial activity is shown in Fig. 6. This results from accumulation of CaCO_3 in pores. Calcium carbonate comes from the reaction [27] of calcium and carbon dioxide accumulated in a biofilm [4]. The corrosion products are presented in Fig. 7 and 8.

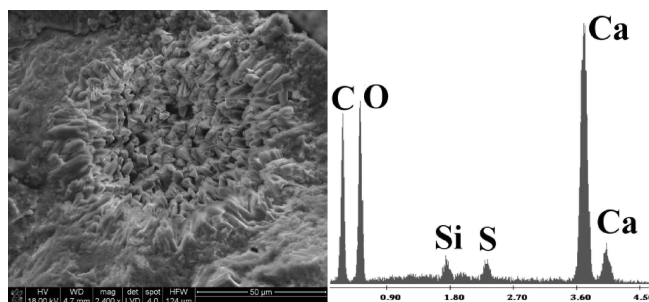
Fig. 6. Unsealing CMPSi microstructure by the action of nitrifying bacteria. EDS analysis shows the presence of CaCO_3

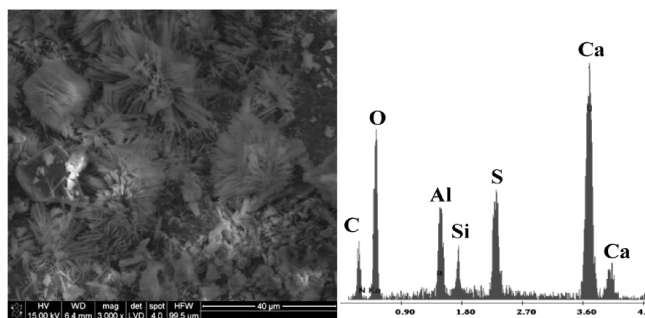
Fig. 7. Corrosion products formed in the mortar CMPA by the action of sulfur bacteria. EDS analysis in pt.1 shows the presence of ettringite

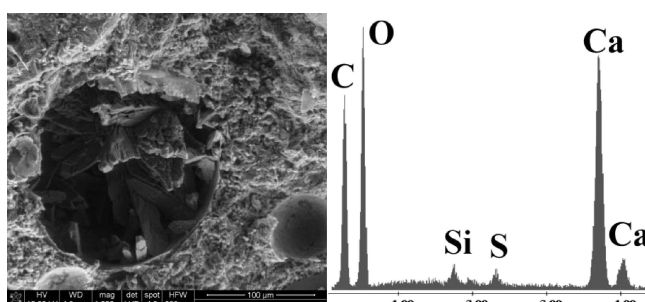
Fig. 8. The product of corrosion in mortar CMPA formed by the action of sulfuric acid. EDS analysis in pt.1 shows the presence of ettringite
