J. WIECZOREK*[#], B. OLEKSIK**[#], J. MIZERA***[#], K. KULIKOWSKI****[#], P. MAJ***[#]

EVALUATION OF THE QUALITY OF COATINGS DEPOSITED ON AZ31 MAGNESIUM ALLOY USING THE ANODISING METHOD

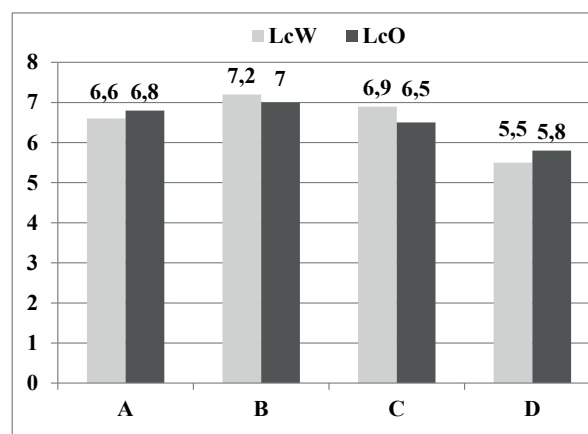
Fig. 2. Critical loads for the investigated coatings at 1 N to 15 N: (LcW – critical load resulting from the friction force analysis, LcO – critical load determined in the wear trace analysis)

The evaluation of produced layer quality was based on results of scratch resistance testing by means of the scratch test. The test was performed using a CSM tester with a diamond indenter (spherical tip radius 200 μm; Rockwell, no. C-233). During the test, the specimen surface was scratched with an indenter of known stylus geometry. The specimen is moved at a constant velocity perpendicular to the stylus which, when a defined force is applied, penetrates its surface. Throughout the test, contact force, penetration depth, friction force, acoustic signal related to cracking and detaching of the coating were measured. The analysis of the layer adhesion strength was based on a microscopic observation and profilometric measurements of the scratch. As a result, the critical load that leads to characteristic defects was determined. Moreover, an analysis of the friction coefficient changes was performed and the critical load (LcW), corresponding to the layer rupture, was determined. Also, the critical load (LcO), based on the analysis of the wear trace, was specified. The critical load values, at 1 N to 15 N, were identified based on three test runs. Durability and a quality of the obtained coating can be compared when the wear trace length until the substrate exposure is determined. Mean critical load values are presented in a bar chart (Fig. 2). Mean values of the friction coefficient, measured during the scratch test, are presented in Figure 3.

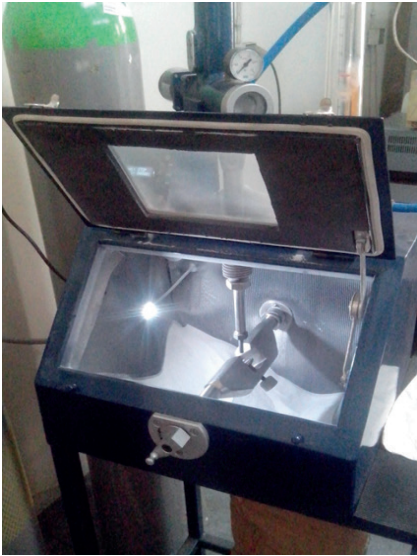
Fig. 9. A device for erosive testing of the coatings

In order to determine performance characteristics of the produced coatings, erosive wear tests were performed. Due to potential applications of the magnesium alloy products in the aerospace industry, it was assumed that in addition to corrosion, erosive wear would be the essential factor affecting the coating durability. For each investigated specimen, two tests were carried out. During each test, 2 grams of an erodent agent were applied to the specimen at 45° for 1 minute. An image of the test device is presented in Figure 9 [7, 10, 15].
